AHRI Report No. 8014

EFFECTS OF LOW RETURN AIR TEMPERATURE ON GAS FIRED FORCED AIR FURNACES

April 2017

GAS CONSULTANTS, INC.
Walton Hills, Ohio

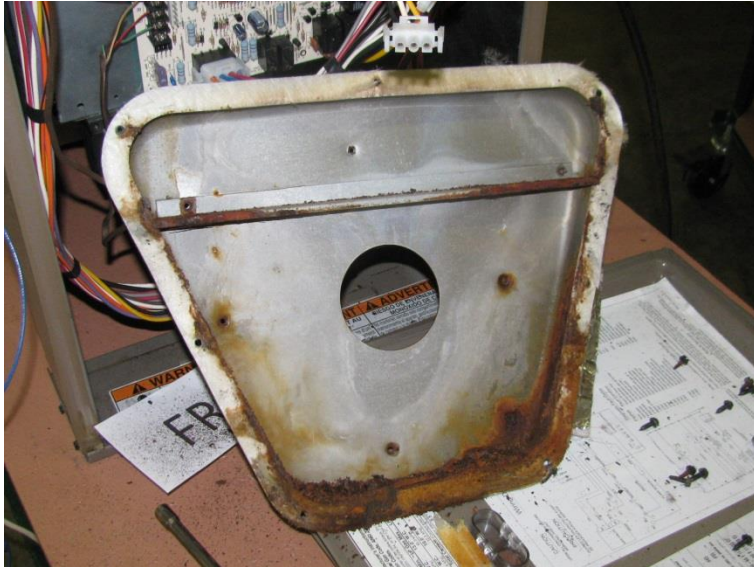
Photo A34

**Inside of Collector Box
Cover**

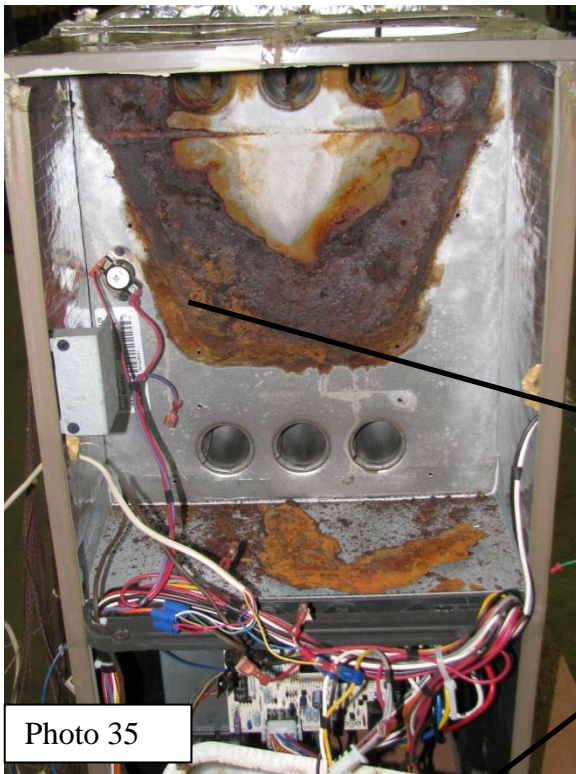
Photo 35

**Collector Box Removed
Showing Vestibule Panel
Behind Collector Box**

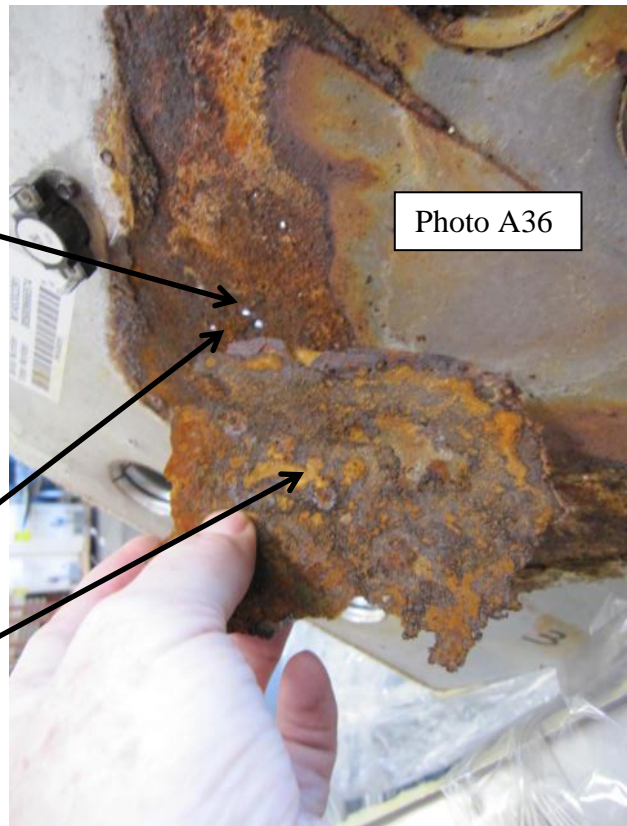
Photo A36

**Perforations Behind
Metal Scale on Vestibule
Panel. Scale Fell Off
Panel When Touch**

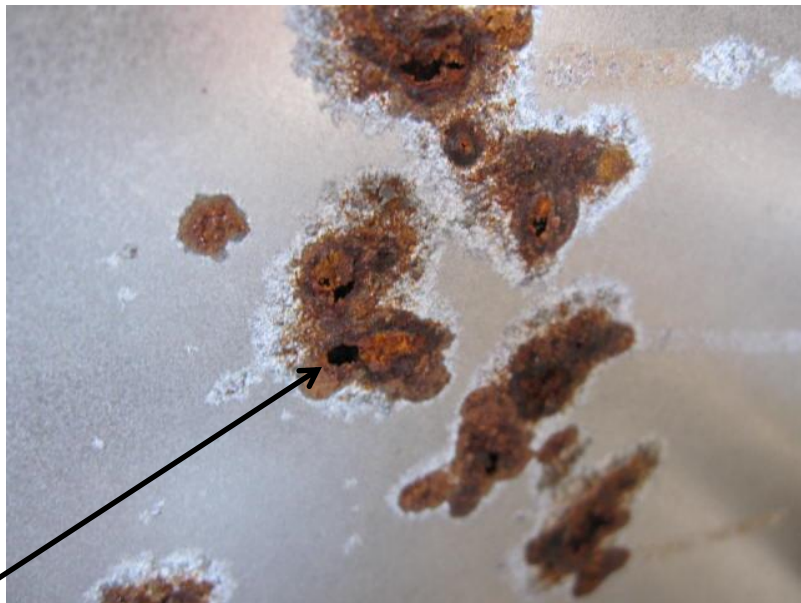
Photo A38

**Perforation (Previous Page) Viewed
From The Circulating Air Side of
Vestibule or Header Panel**

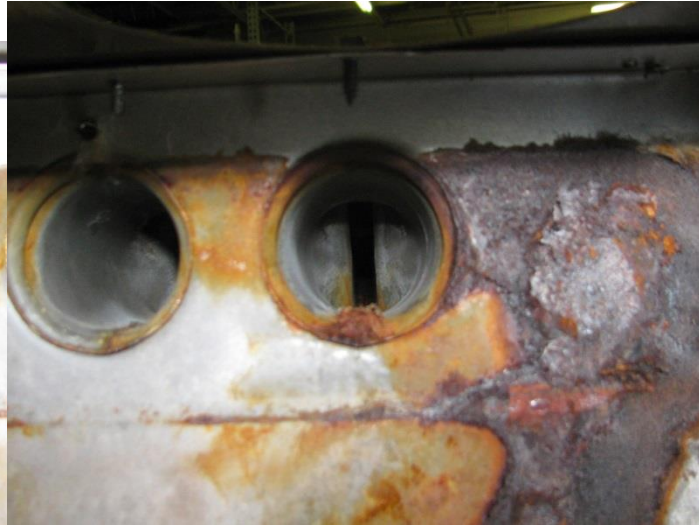
- The point where the heat exchanger tubes are swaged onto the header plate showed extensive rust on the flue gas side but none was found on the circulating air side. It is expected that if the system sat for 12 months in this condition and was not used, the rust condition would eventually penetrate at the swage point.

Extensive Corrosion Around Where Heat Exchanger Swaged to Header / Vestibule Plate, but No Loss of Integrity of Connection/Seal

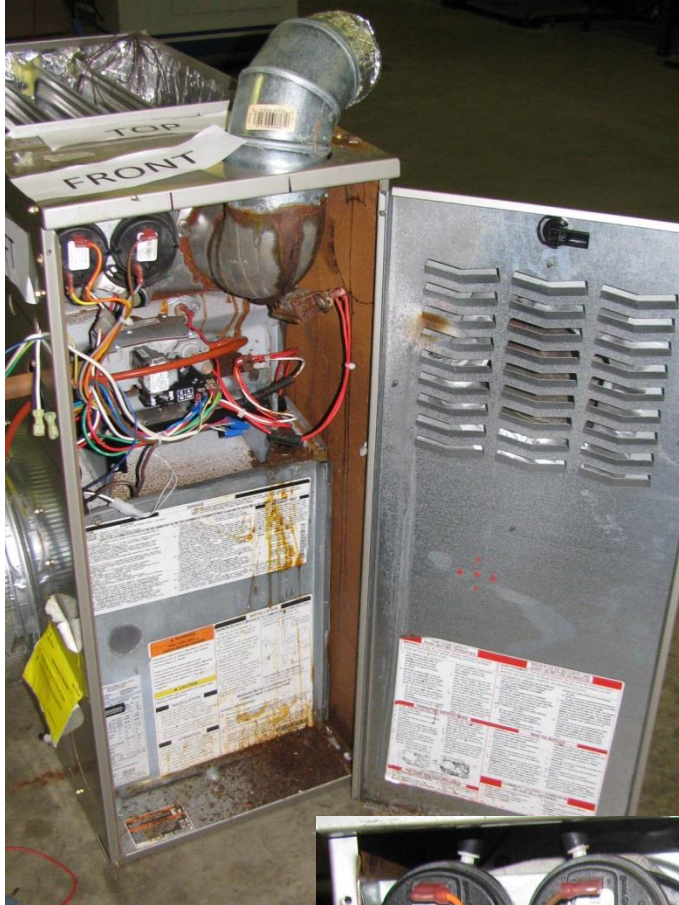
Photo A43

**Rust Found on Right, Inside
of Body Panel Caused by
Dripping Vent Pipe**

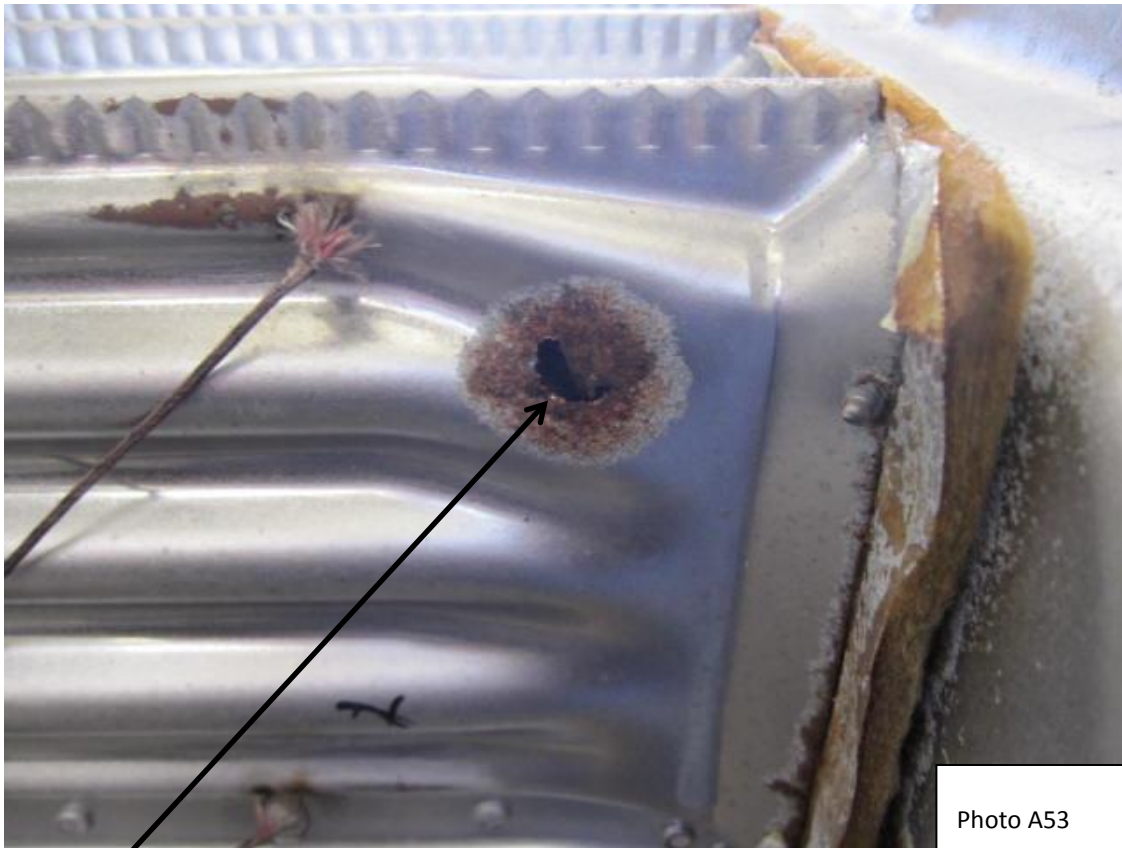
Photo A53

Approx. 60 Days After the Previous Photo Was Taken, the Corrosion Spot On the Heat Exchanger Was Found Substantially Enlarged and a Slight Pressure Caused the Above Hole To Be Created

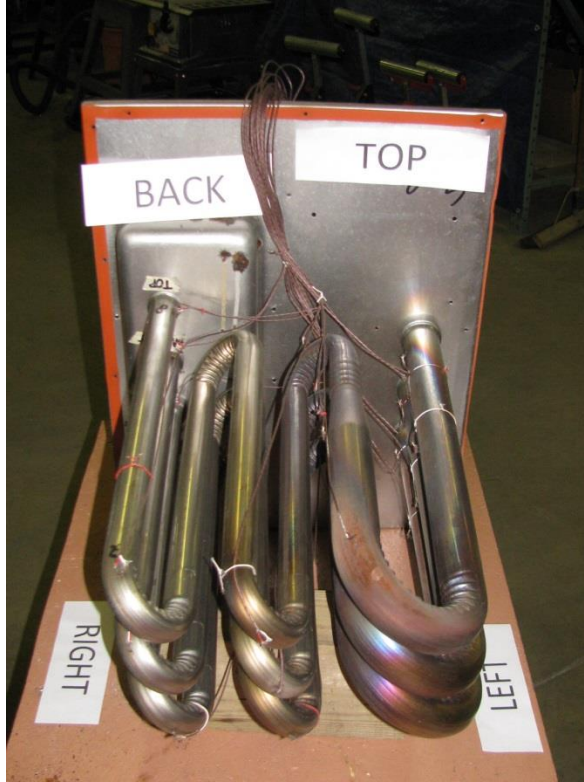
Photo A61

**Actual Heat Exchanger Tubes
Show No Signs Of
Perforations**

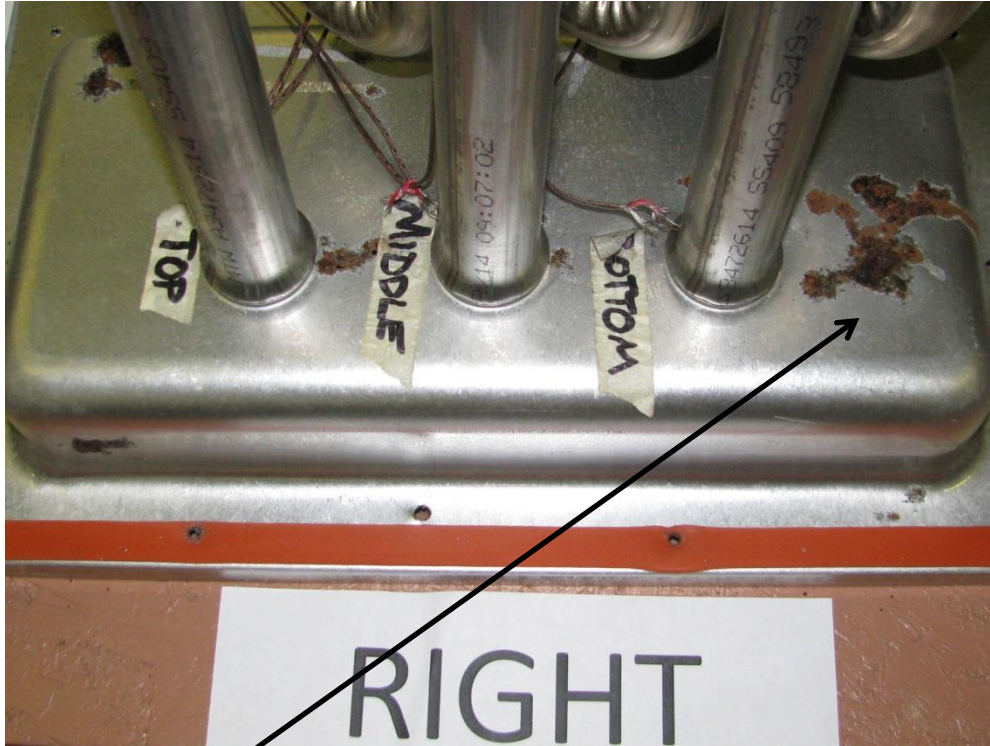
Photo A65

Any Area Where Rust Has Formed On Outside of Collector Box Is Indication of A Perforation from Flue Side to Circulating Air Side of Furnace.

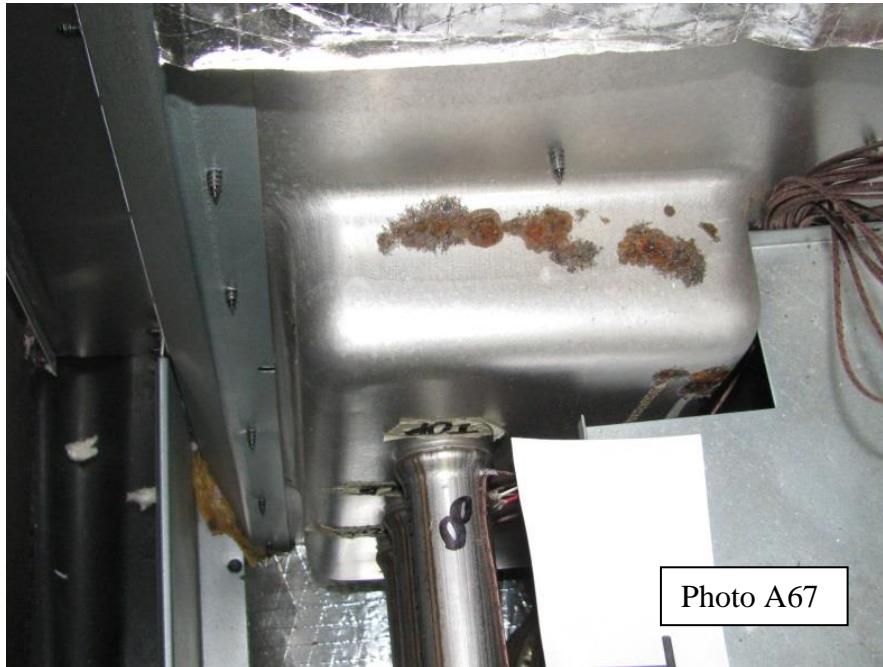
The Photo Above Was Taken 8 Days After Cycling Was Finished. Very Small Holes Present.

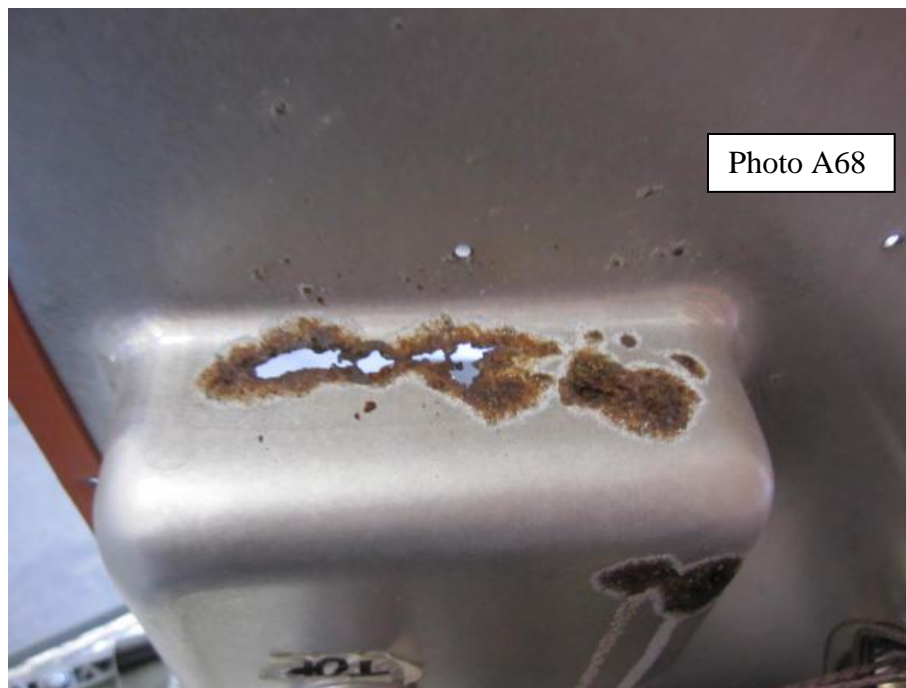
The Photo Below Was Taken of Same Spot After 60 Days in Storage After Cycling Was Completed.
