AHRI Report No. 8029

## ASSESSMENT OF INCOMPATIBILITY OF HVAC EQUIPMENT AND GROUND FAULT CIRCUIT INTERRUPTER (GFCI) BREAKERS

Phase I Report

November 6, 2023

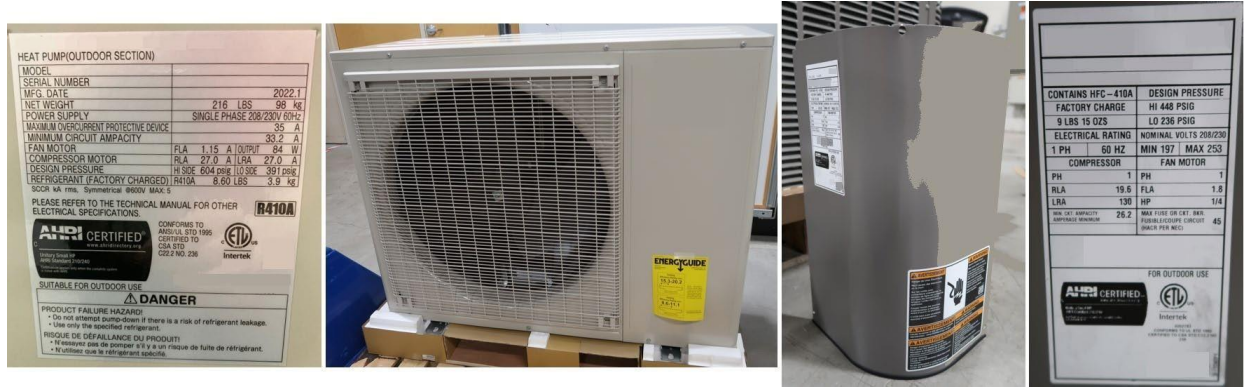
Figure 3-4  
Tested Units 1 and 6

The two units available in the lab for this initial phase of testing include Unit 1 and Unit 6— shown below in **Error! Reference source not found.**

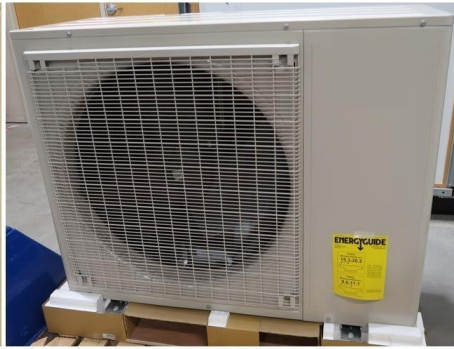
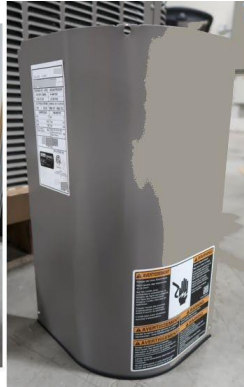
CONTAINS HFC-410A		DESIGN PRESSURE	
FACTORY CHARGE		HI 448 PSIG	
9 LBS 15 OZS		LO 236 PSIG	
ELECTRICAL RATING			
1 PH		60 HZ	
MIN 197		MAX 253	
NOMINAL VOLTS 208/230			
COMPRESSOR		FAN MOTOR	
PH	1	PH	1
RLA	19.6	FLA	1.8
LRA	130	HP	1/4
MAX LAT CAPACITY	25.2	MAX FUSE ON DET. PAK.	
IMPACT RESISTANCE		INDICATED CIRCUIT	45
		BRACH PER NEED

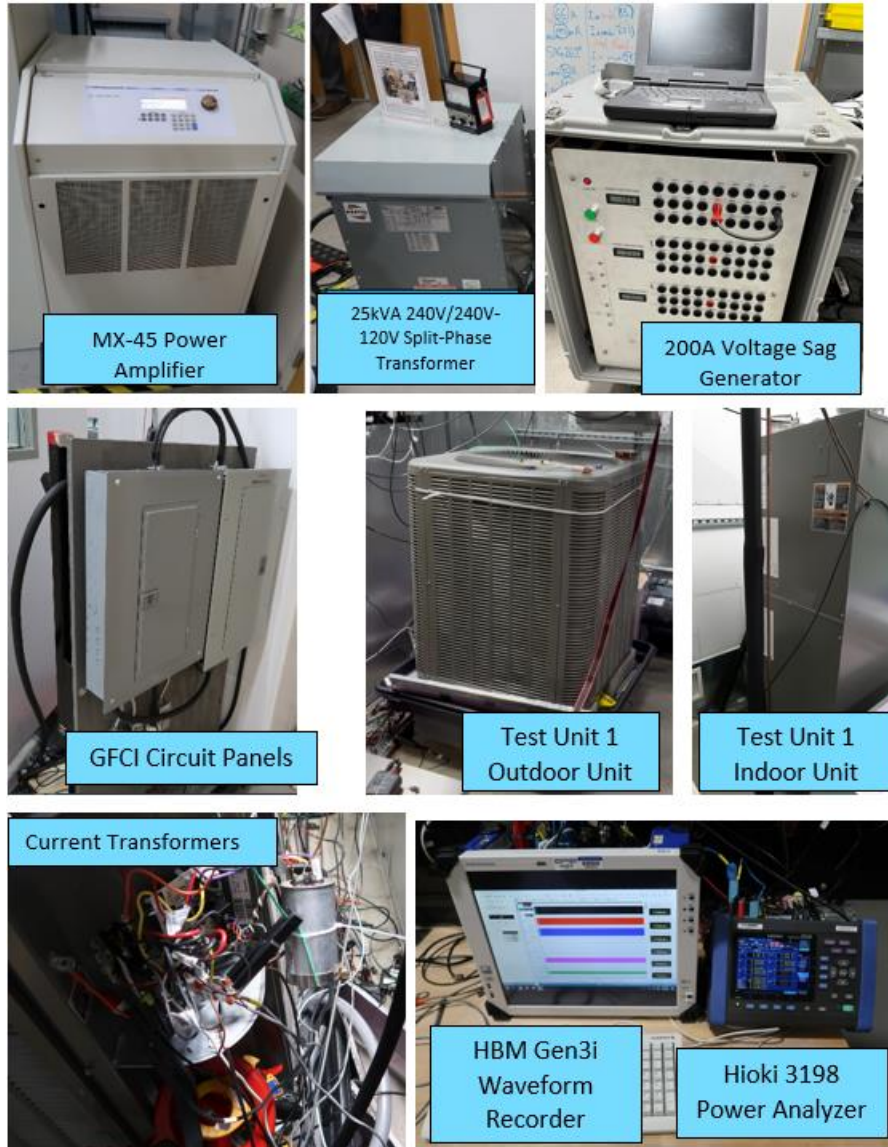
Figure 6-1  
AHRI Test Setup for Test Unit 1

This section will describe the test setup for the Unit 1 testing. Figure 6-1 is a collage of photos from the Unit 1 test setup. The test setup contained HVAC test unit 1, a 45-kVA power amplifier from California Instruments, the 200-amp voltage sag generator, and metering and measurement devices including the HMB Gen 3i waveform recorder and a Hikoi 3198 power analyzer.

Testing was conducted to determine what may be causing the GFCIs to trip when connected upstream of HVAC systems. The test objective was to discover conditions that created the highest leakage current. Figure 6-2 contains a block diagram of the test setup. Numbers 1, 2a, 2b, 3, and 4 are placed in Figure 6-2 to note the location where CTs were placed in the circuit. The numbers are associated to the CTs shown in **Error! Reference source not found.**

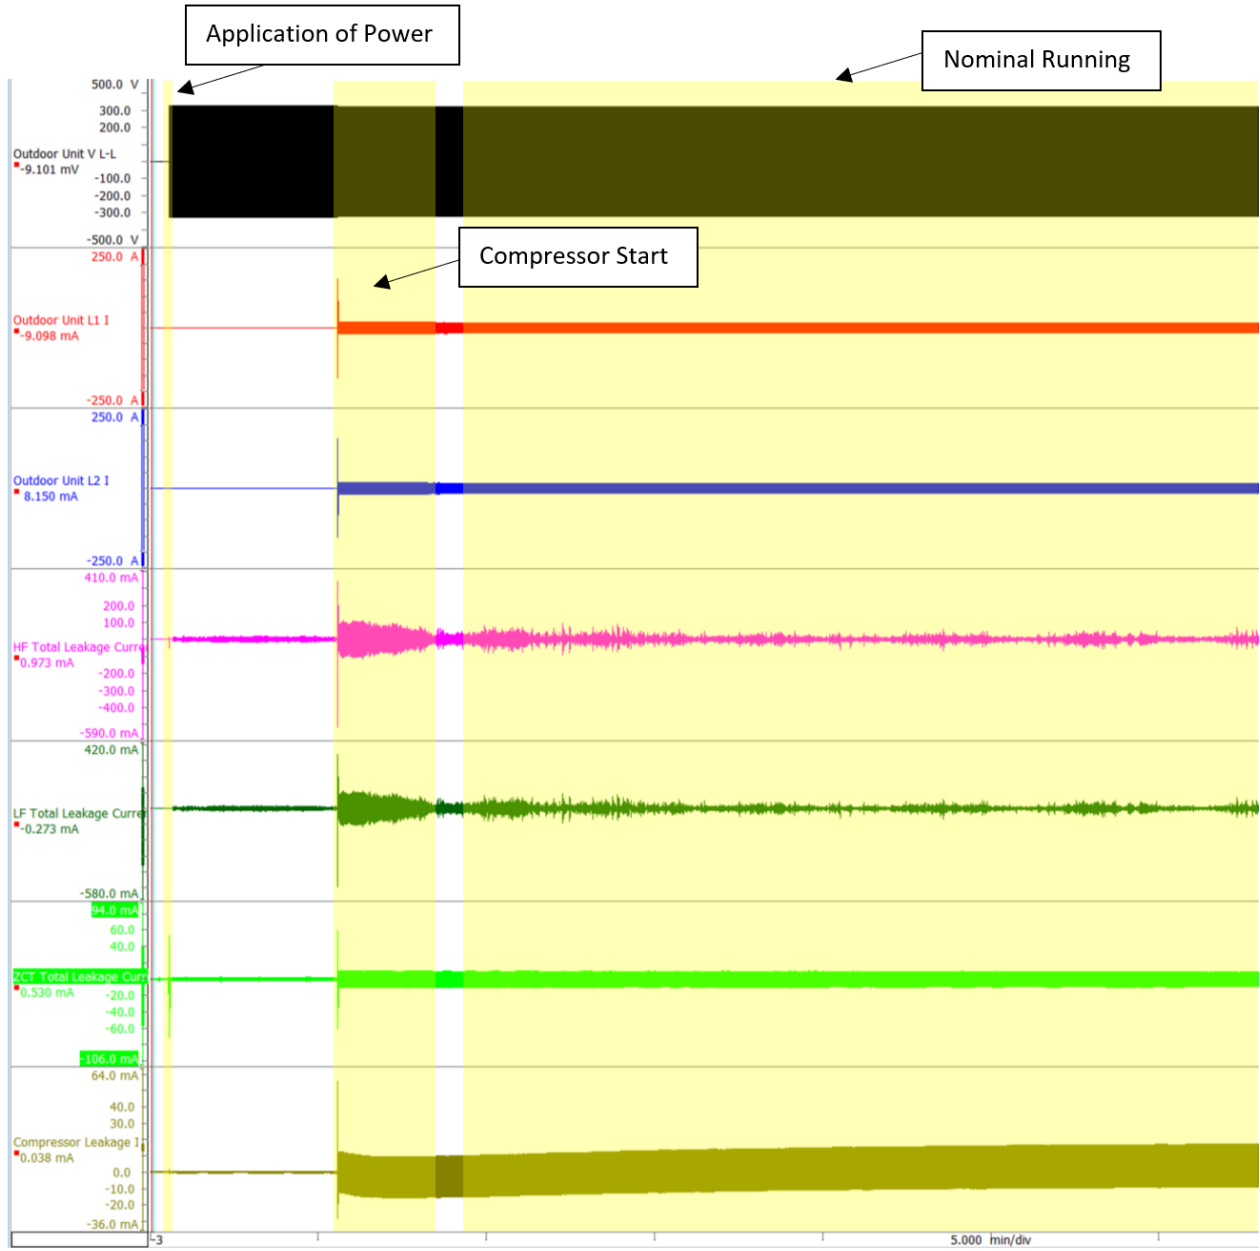
Figure 6-4  
 Test 0 Condition 1 Monitoring File 57

Figure 6-4 shows the oscillography captured by the waveform data logger with the system operating in Chamber Temperature Condition 1. The test was conducted for at least 30 minutes as per the test protocol. The test was initiated by applying power via a knife switch with power supplied for the 30-minute duration. Figure 6-4 shows the three timeframes—application of power, compressor start, and nominal running—where RMS leakage currents are shown in the following figures and tables. The 240-volt supply voltage, both phase currents that supply the outdoor unit, and current flow through the grounding conductor were measured with high-frequency and low-frequency response CTs. The difference in the line current was measured through an AEMC 2620 leakage current probe (Z-CT), while the compressor leakage current was monitored with an AMEC K110 low-frequency current probe. GFCI's react on differential current; therefore, the Z-CT was used as the standard to compare against the other current measurement devices. *Note: in all the charts, a value appears at left under the name of the leakage current being measured. This is an artifact showing the value registered at the location of the red cursor which may or may not be visible in the chart. This value has no relevance to the measurements of concern.*

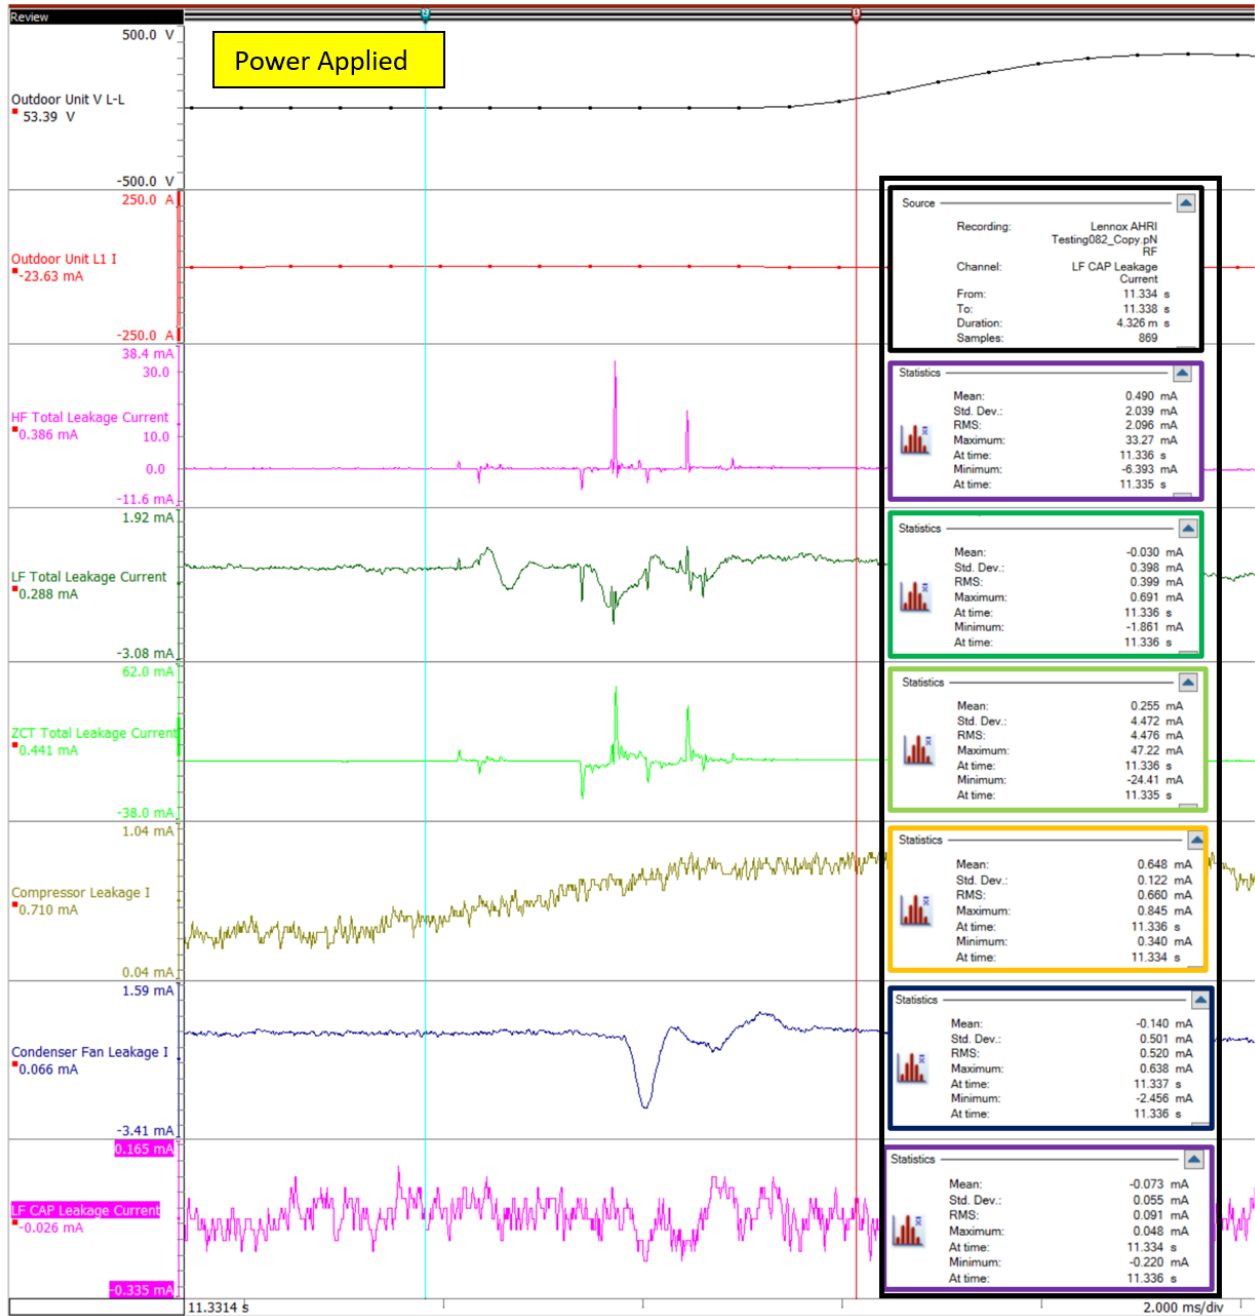
Figure 6-9  
Power Applied Leakage Current Measurements

Figure 6-9 shows a 'zoomed-in' view of the time when the knife switch was closed, and power was applied as well as the RMS leakage currents that resulted. The current probes measured a very short burst of current when the switch was closed. The RMS values during this short time period were below the time current requirements of UL 943 and a detailed chart may be seen in Figure 6-9 below.

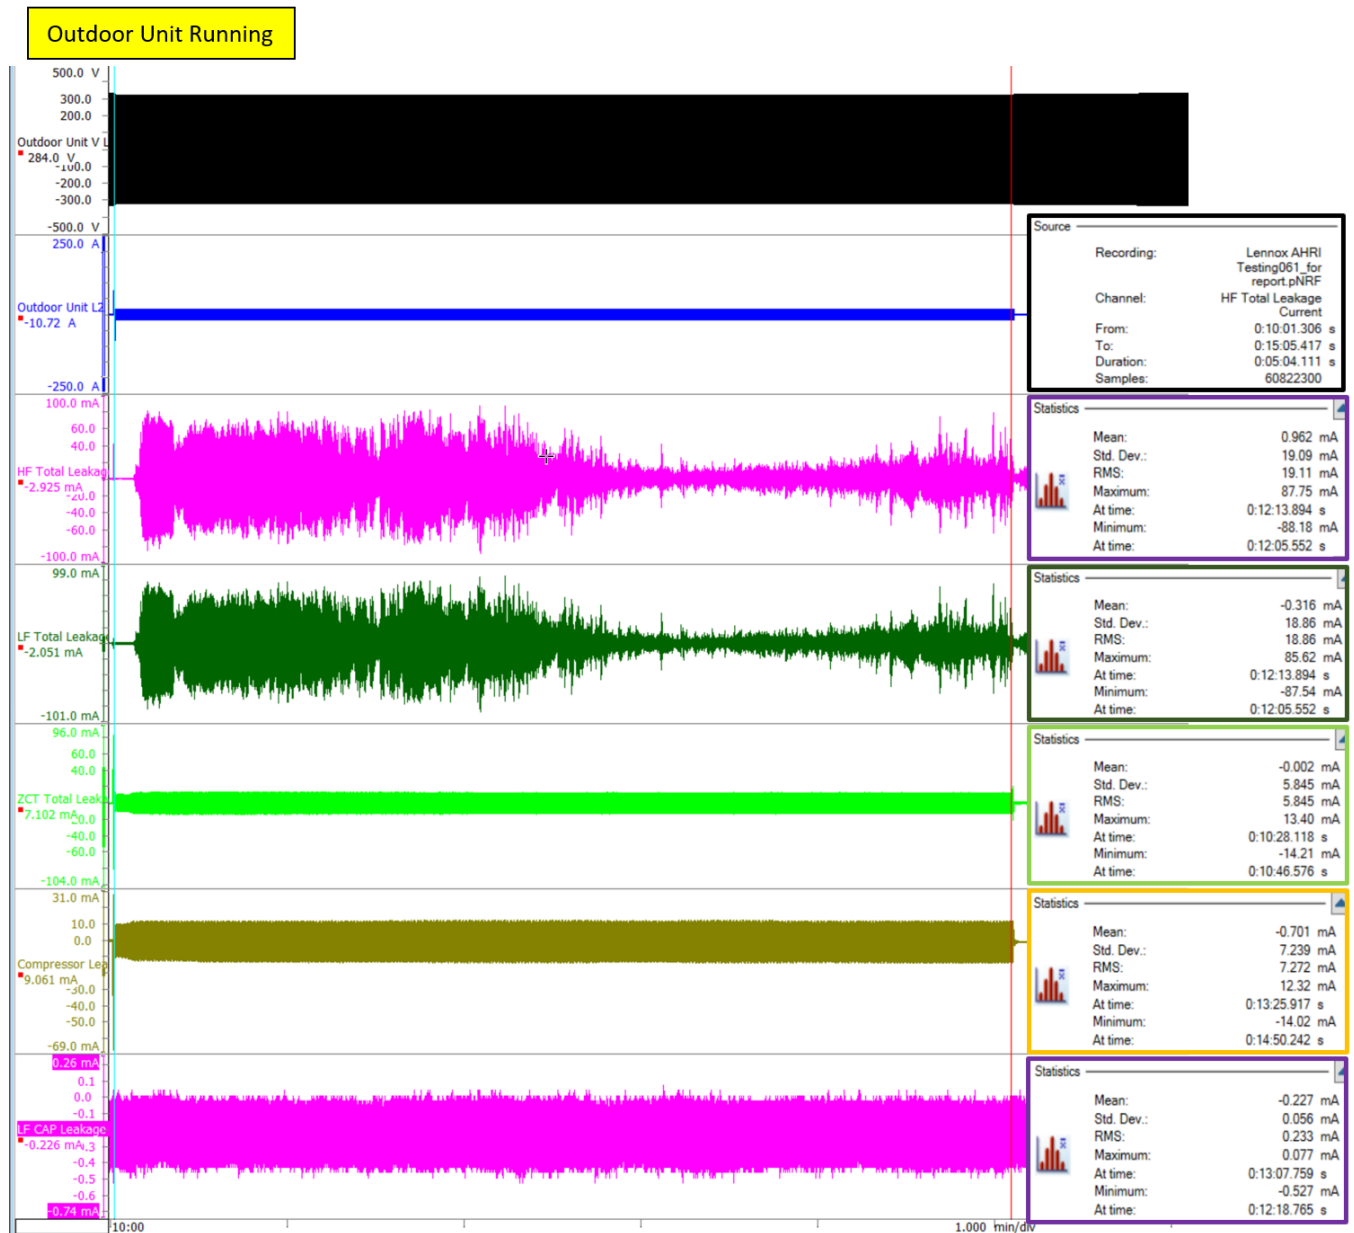
Figure 6-36  
Outdoor Unit Running Leakage Current First 20 Minutes

Figure 6-36 shows the waveforms during the 5-minute period after the compressor started and the outdoor unit was running. The statistics for each of the leakage current measurements may be seen in the statistic boxes to the right of each waveform.

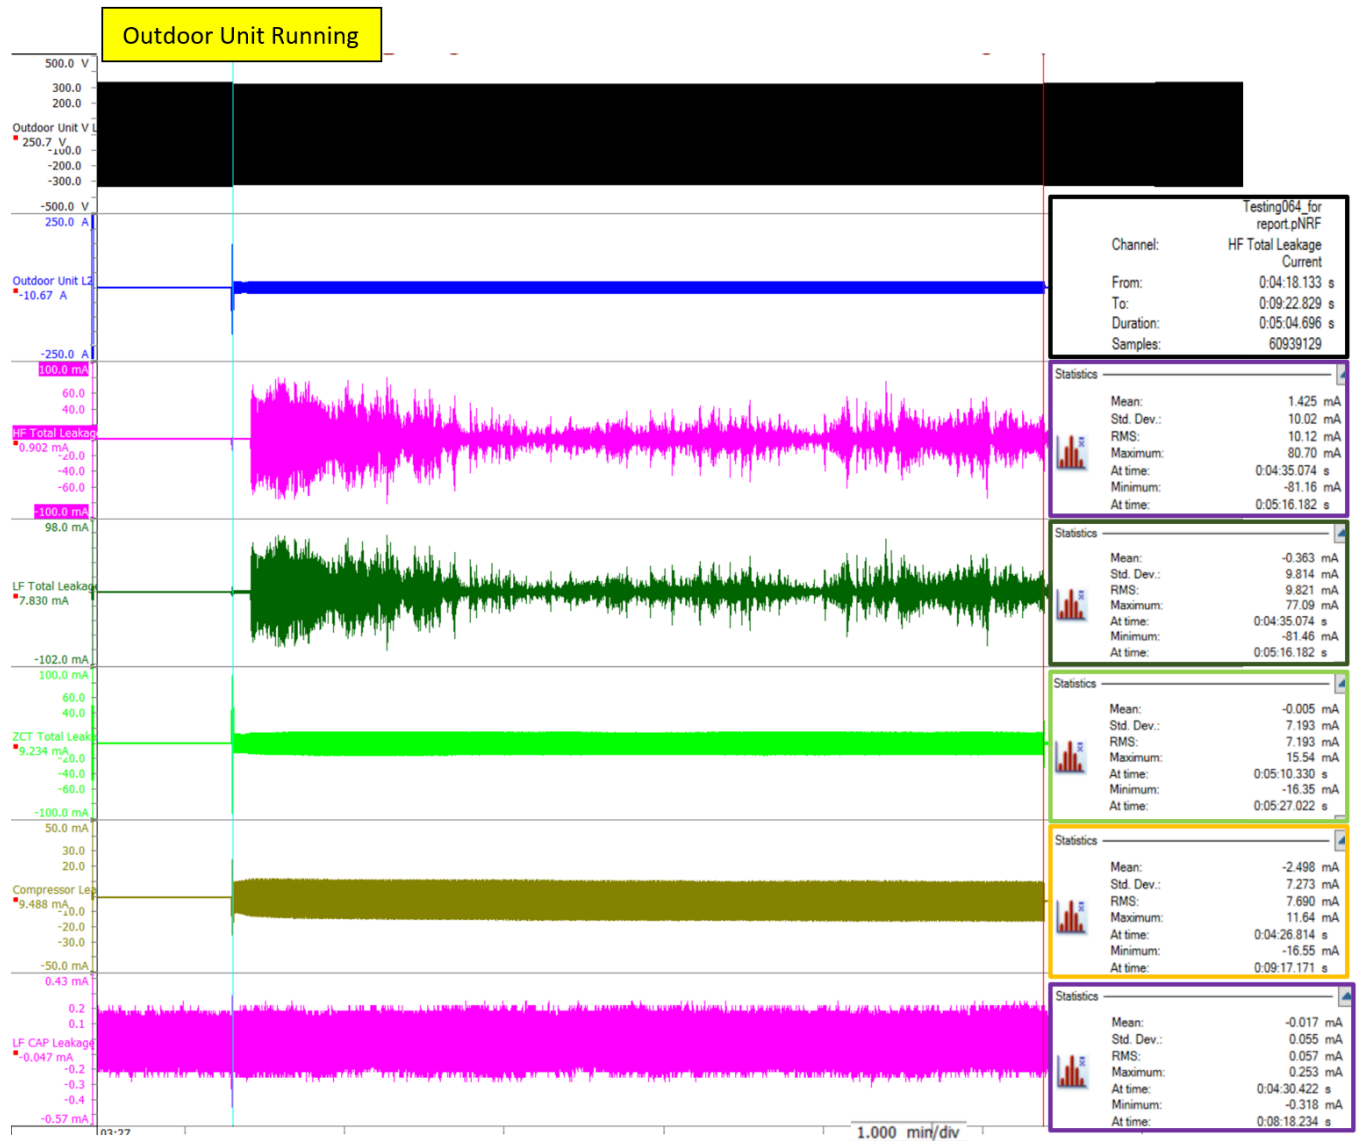
Figure 6-41  
Outdoor Unit Running Leakage Current, First 20-Minutes

Figure 6-41 shows the waveforms during the 5-minute period after the compressor started and the outdoor unit was running. The statistics for each of the leakage current measurements may be seen in the statistic boxes to the right of each waveform.

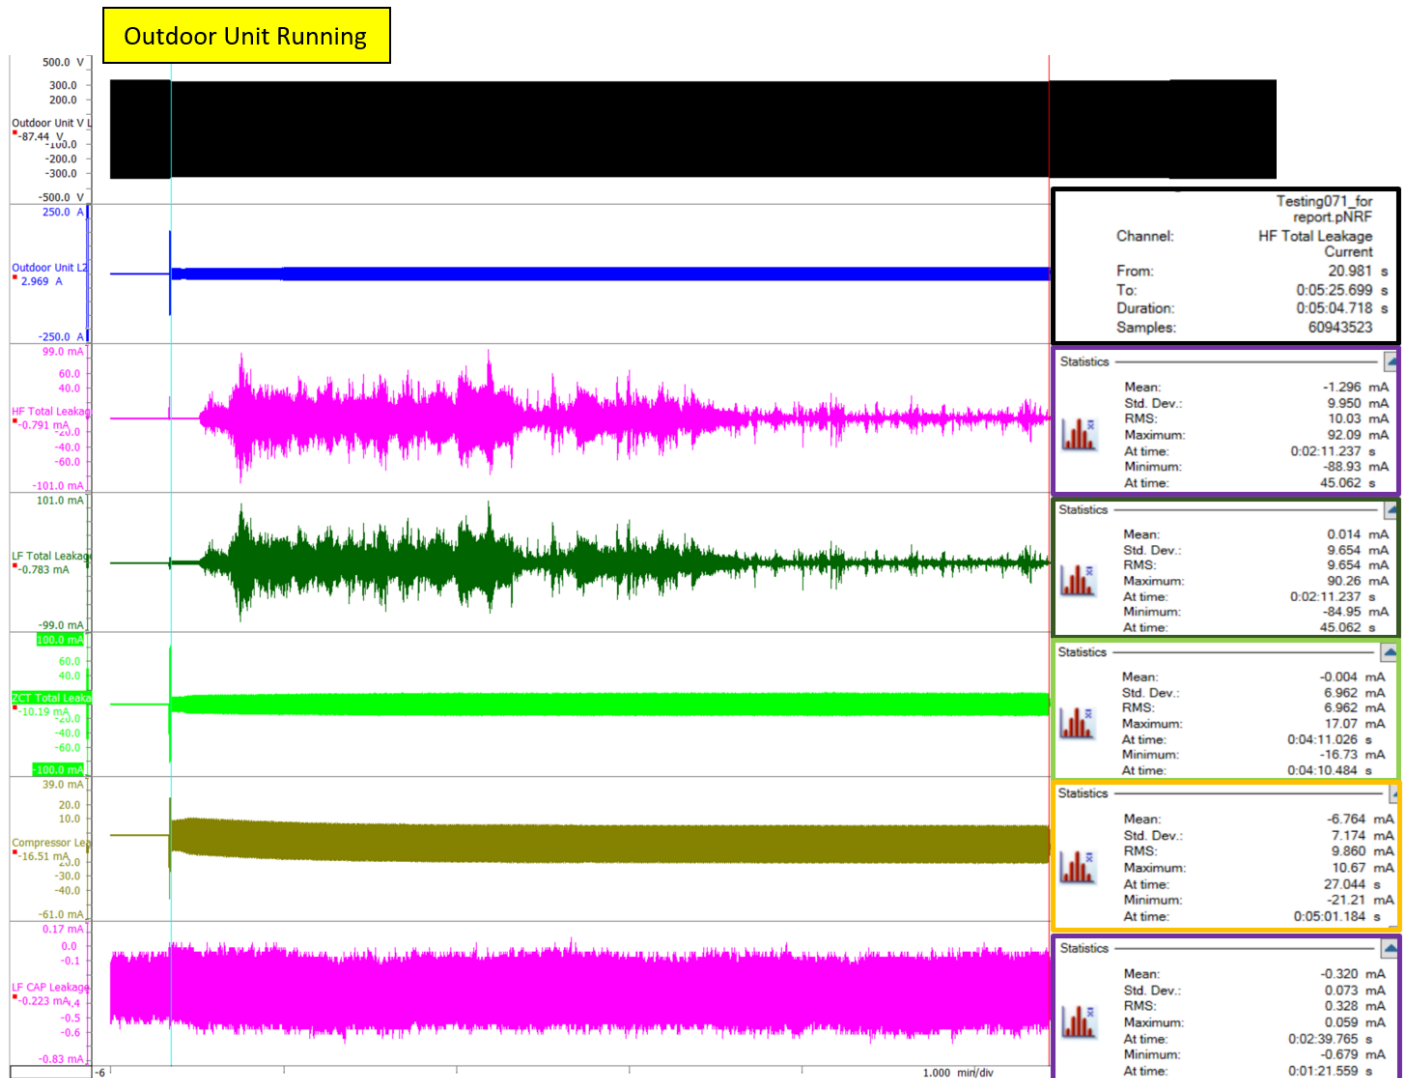
Figure 6-46  
Outdoor Unit Running Leakage Current, First 20-Minutes

Figure 6-46 shows the waveforms during the 5-minute period after the compressor started and the outdoor unit was running. The statistics for each of the leakage current measurements may be seen in the statistic boxes to the right of each waveform.

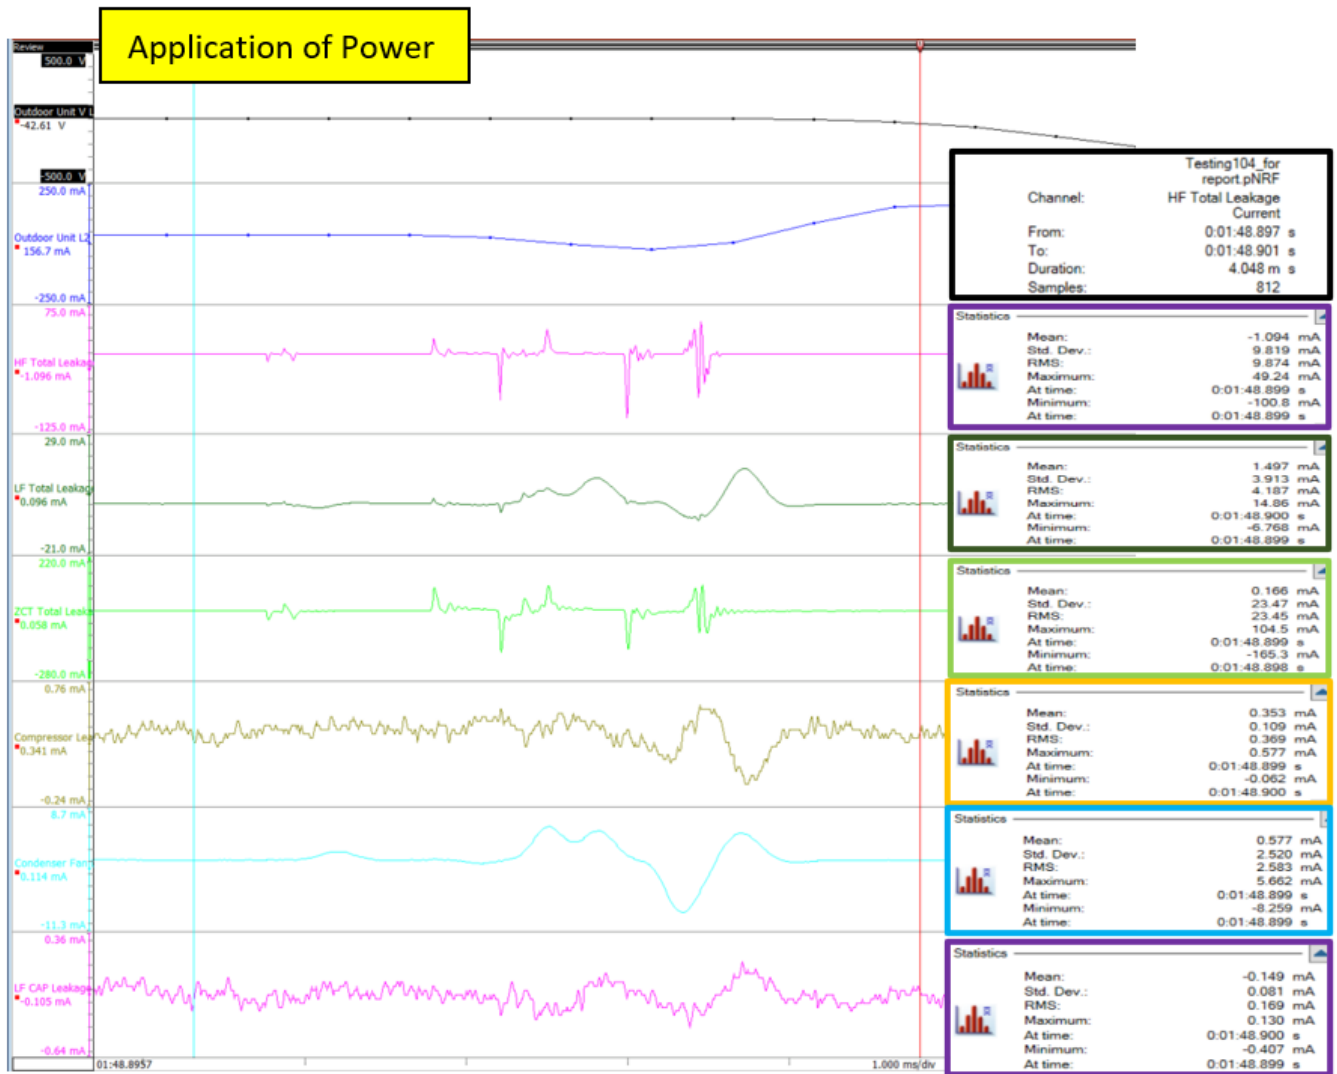
Figure 6-52 Application of Power Leakage Current Waveforms

Figure 6-52 shows the voltage, current, and leakage current at strategic locations throughout the outdoor unit when power was applied. The statistics for all the leakage currents are shown to the right of the waveforms. A table of all the leakage current measurements for the first defrost cycle may be seen in **Error! Reference source not found.**

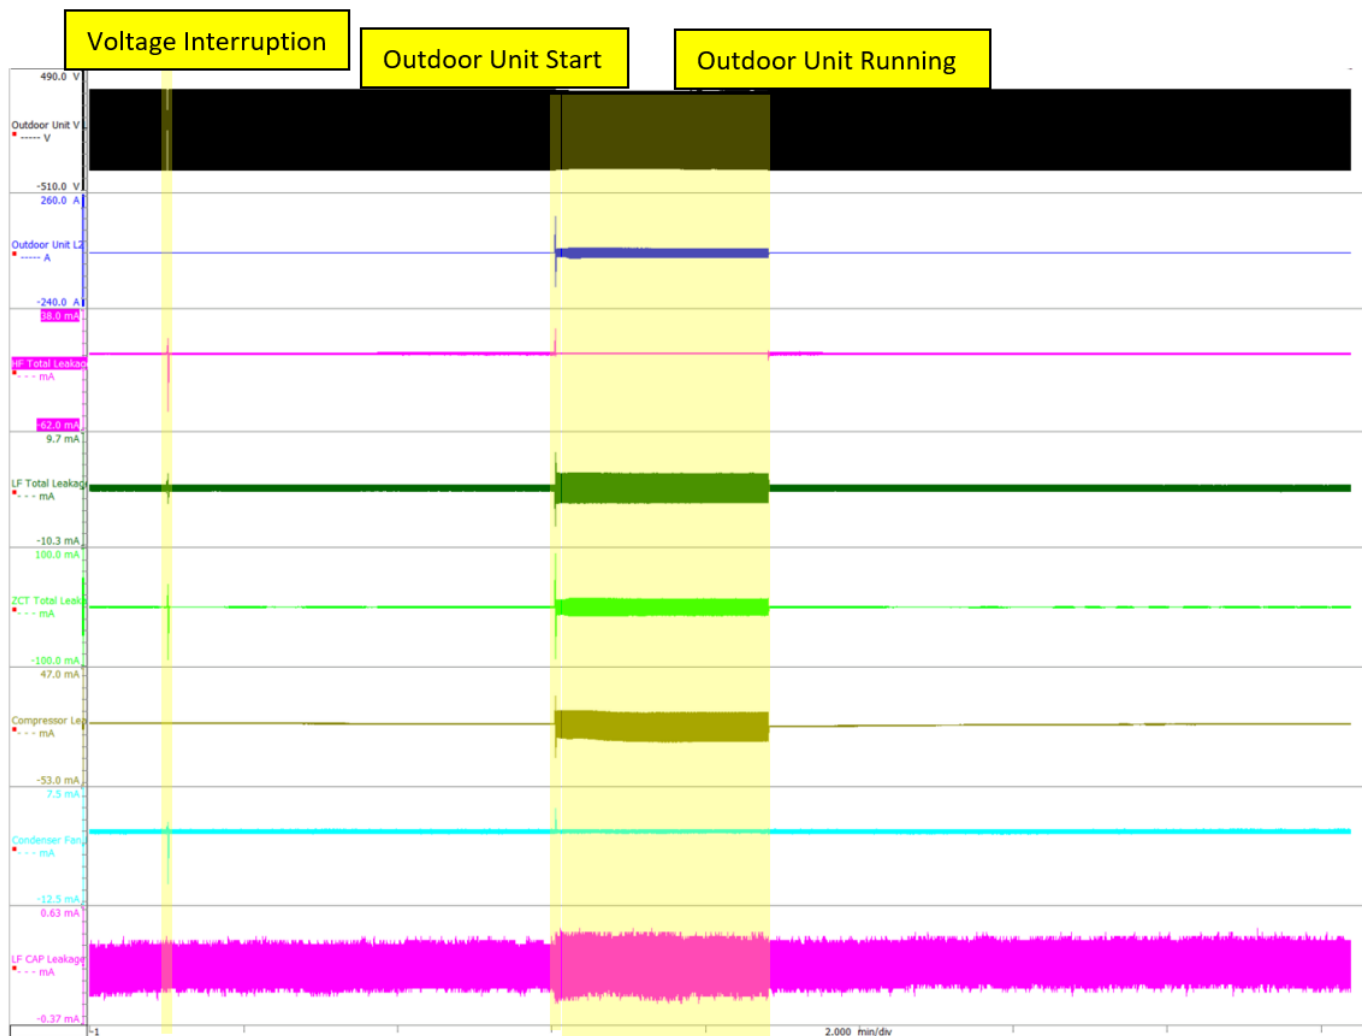
Figure 6-59  
Chamber Condition 2, High-impedance Interruption, File 97

REF\_Ref149288627 \h Figure 6-59 shows where the voltage interruption was executed, the outdoor unit started (compressor energized), and the period of time where the outdoor unit was permitted to run. The leakage current during these time periods were analyzed and discussed in this section of the report.

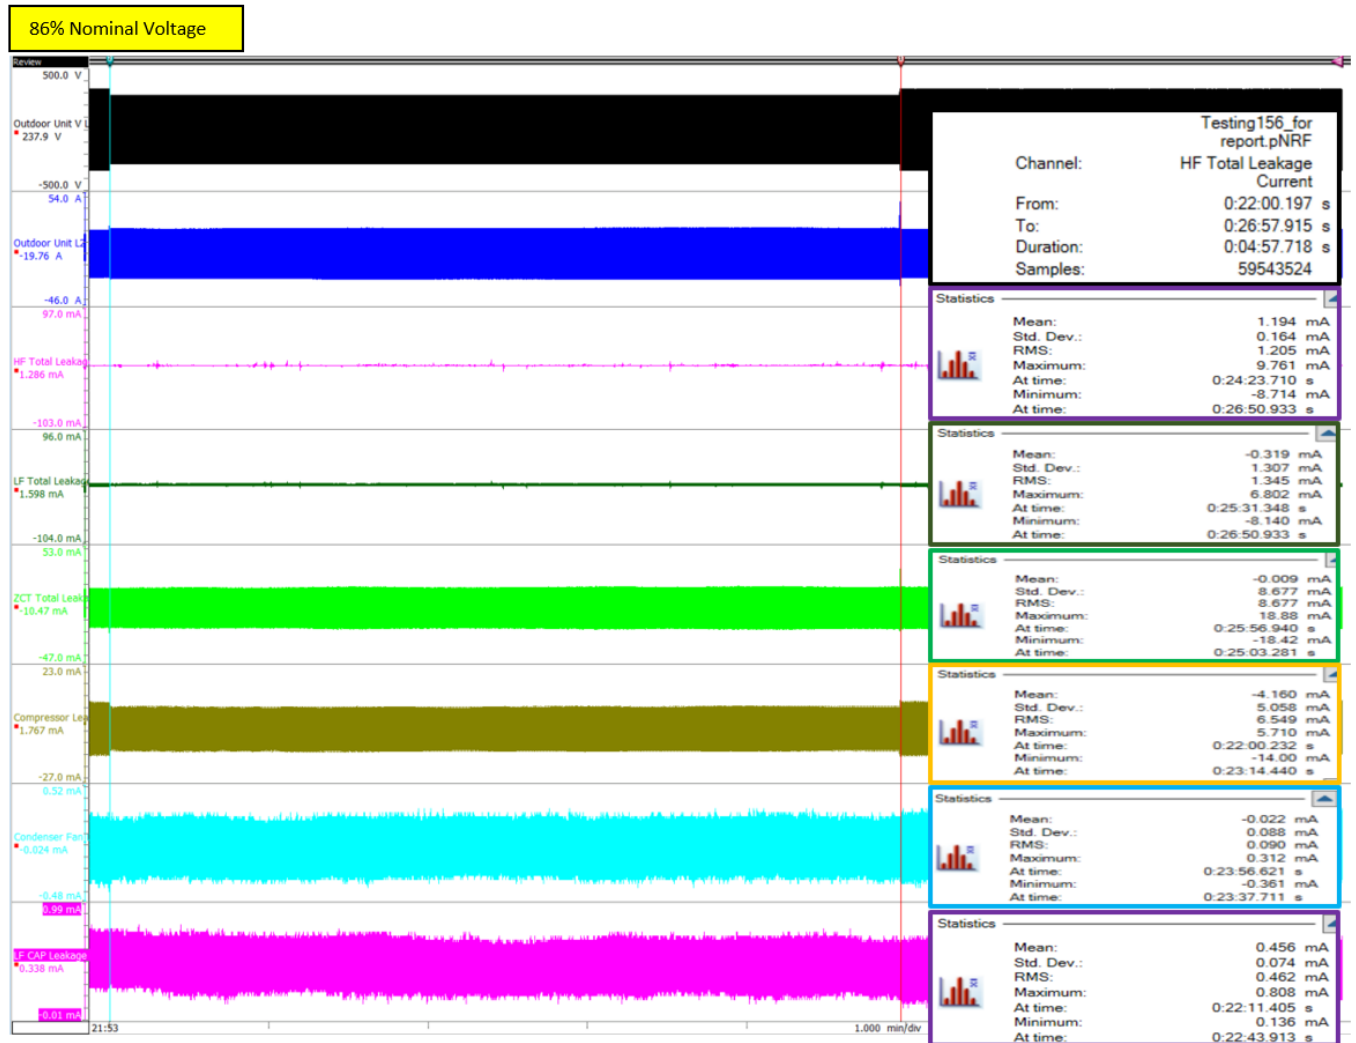
Figure 6-76  
86% Step Voltage

Figure 6-76 shows the waveforms when the nominal voltage was decreased to 86%. This was the minimum voltage level for this regime of testing. The leakage current measured by the Z-CT was above the allowable limits of UL 943; however, the GFCI did not trip. A tabular analysis of the RMS leakage current measurements may be seen in **Error! Reference source not found.**

Figure 6-76 shows the current waveform is no longer sinusoidal and has high 3rd and 5th harmonic content, indicating the power factor correction turned off. The unfiltered condition remained for 2.5 seconds before the compressor turned off the output. The output remained off for approximately 1.5 minutes before automatically restarting.

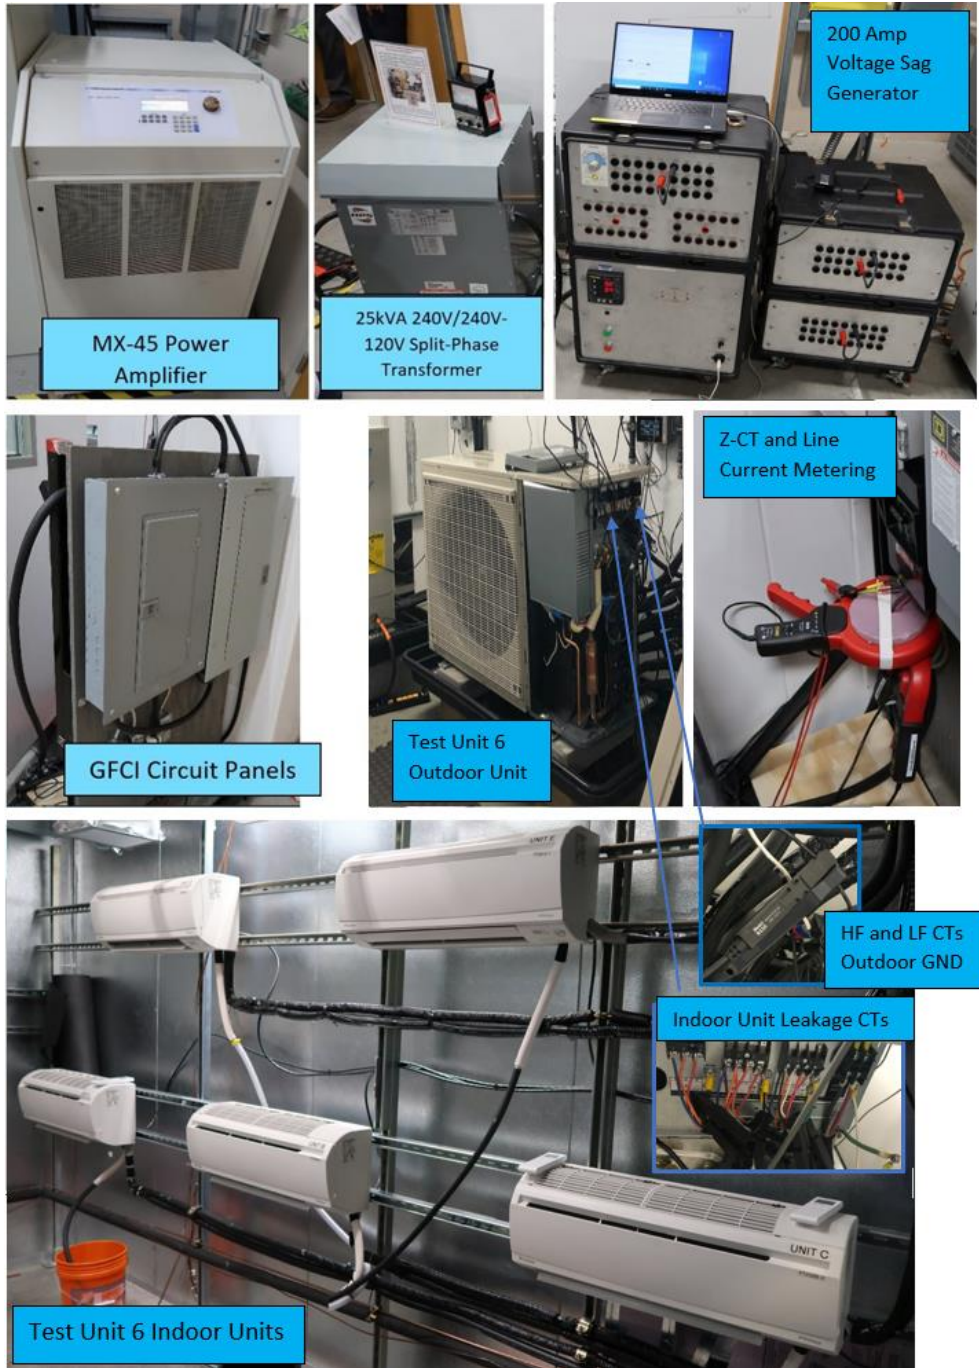
Figure 7-1  
AHRI Test Unit 6 Setup

This section will describe the test setup for the Unit 6 testing. **Error! Reference source not found.** is a collage of photos from the Unit 6 test setup.

The test setup contained HVAC test unit 6, a 45-kVA power amplifier, the 200-amp voltage sag generator, and metering and measurement CTs. A block diagram of the test setup may be seen in Figure 7-2.

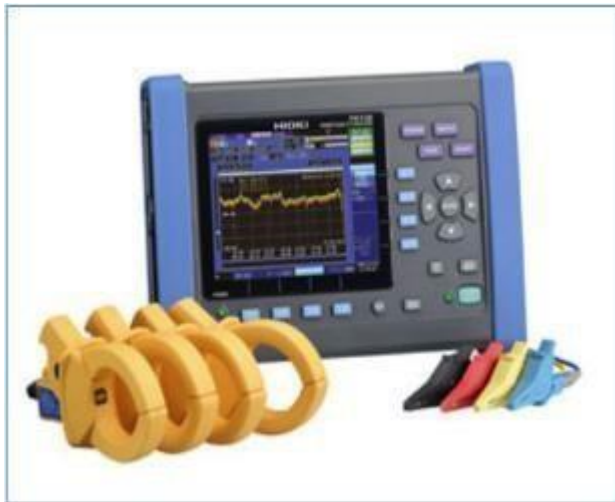
Figure B-1  
Hioki Power Analyzer

The power and energy of the equipment will be measured using a Hioki 3198 power analyzer shown in Figure B-1.

The Hioki has the capability to measure many parameters. The meter will be configured to record all available measurement parameters. Figure B-2 is a list of all the recorded parameters.
