**Effect of Selected Contaminants in Air Conditioning
and Refrigeration Equipment**

Final Report

December 2000

Prepared for:
The Air Conditioning and Refrigeration Technology Institute
under
ARTI MCLR Project Number 665-53000

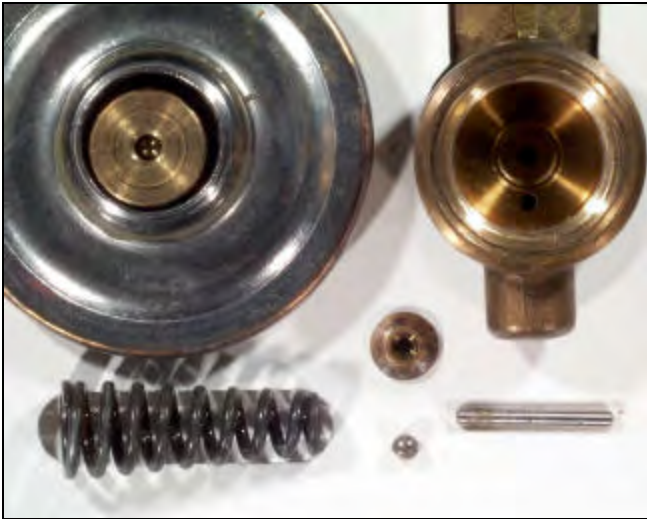
**Photographic Documentation of R-507A Control Compressor
355 psig/14 psig**

Condition good
Appearance corrosion/blued/carbon
Trepan slight
Varnish ring medium

Constant Pressure Expansion Valve (macro)

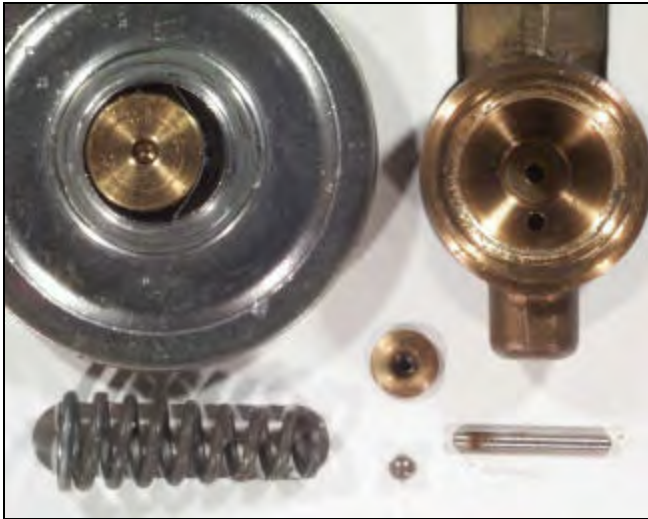
**Photographic Documentation of R-507A Control Compressor
355 psig/14 psig**

Discharge reed
Condition good
Appearance corrosion/v. light carbon
Trepan very slight
Varnish ring none

Constant Pressure Expansion Valve (macro)

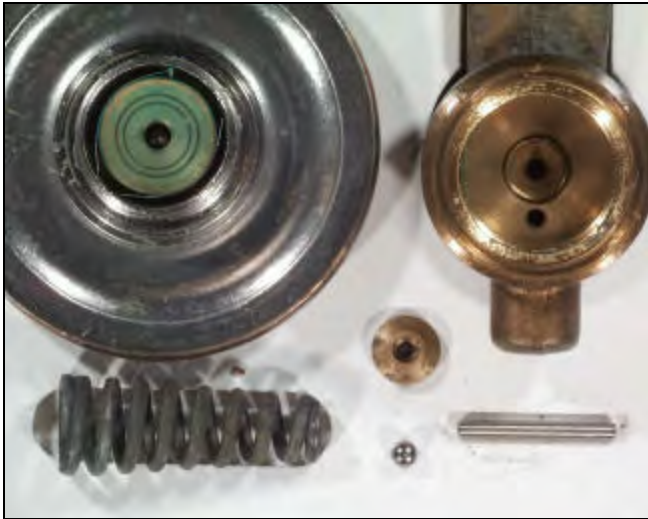
**Photographic Documentation of R-507A Compressor with Contaminant Air
355 psig/14 psig**

Condition good
 Appearance corrosion/blued/carbon
 Trepan medium
 Varnish ring heavy

Constant Pressure Expansion Valve (macro)

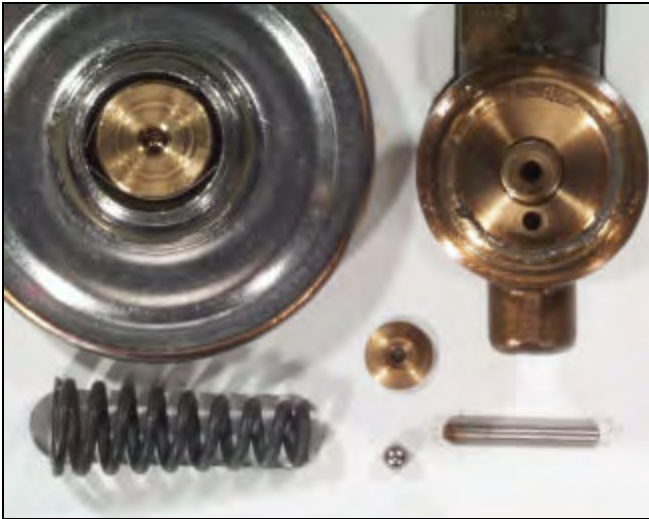
**Photographic Documentation of R-507A Compressor with Contaminant Acid, Water, and R-502
185 psig/30 psig**

Condition good
Appearance corrosion
Trepan very slight
Varnish ring very slight

Constant Pressure Expansion Valve (macro)

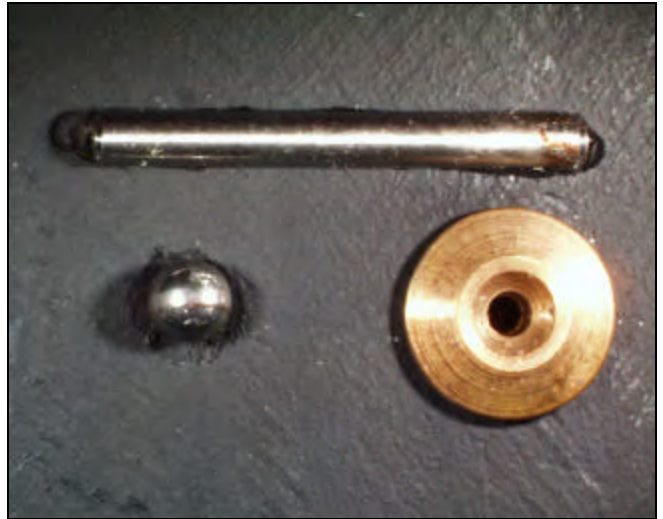
Ball, Pin, Seat of CPEV (micro)
