**Air-Conditioning, Heating and
Refrigeration Technology Institute**

AHRTI Report No. 9007-2

Benchmarking Risk by Whole Room Scale Leaks and Ignitions Testing of A3 Refrigerants

July 2019

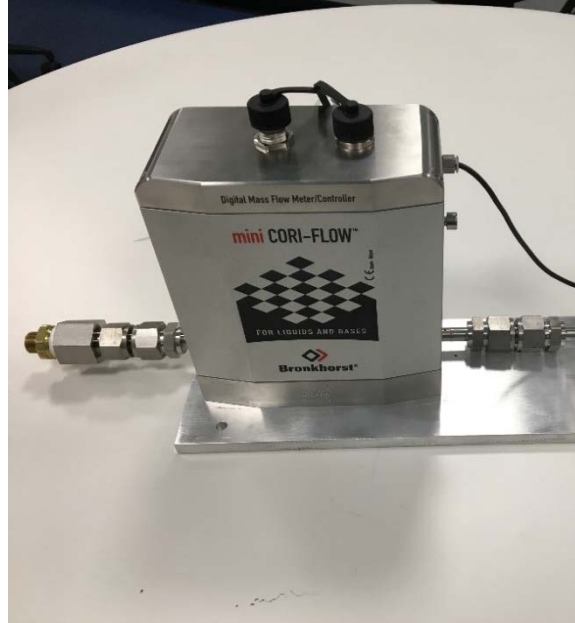
Figure 6 – Mass Flow Meter

The mass flow meter as delivered for this project was calibrated by the manufacturer from 0 to 300 kg/hr (83.3 g/s) as shown in Figure 7. In order to improve resolution at the data acquisition system the full scale output signal was set to 150 kg/hr. This setting was made in software and did not affect the calibration. The mass flow meter is shown in Figure 6.

The needed flow rates were determined based on the relative liquid mass flow rates of R-32 and propane (See 11.1.1 Comparison of R-32 and Propane Release Rates). These rates were determined to be 6.8 g/s and 40 g/s (24.6 kg/hr. and 144 kg/hr., respectively). The manufacturer’s calibration certificate shows a specification of $\pm 0.4\%$ of reading at the lowest flow rate of 25 kg/hr.

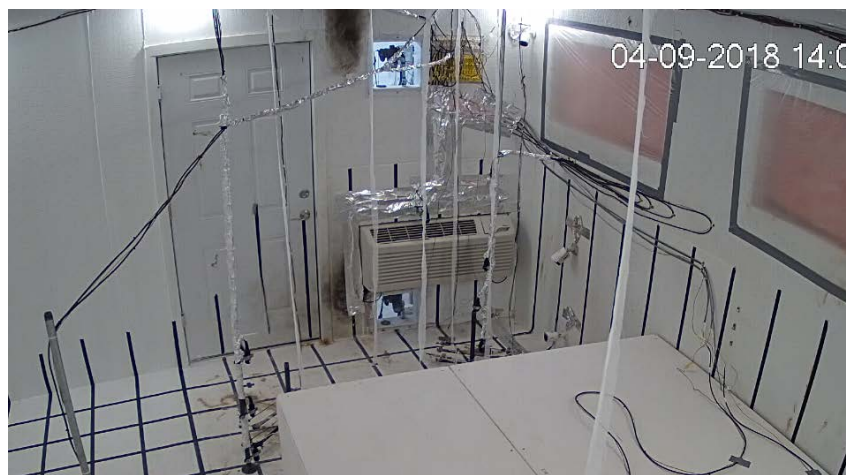
Figure 30 – PTAC shown in location prior to a test

The motel room scenario involved the use of a Package Terminal Air Conditioner (PTAC) in a motel room layout. The test setup for the motel room is shown in Figure 29 and Figure 30. This arrangement is directly comparable to the PTAC series of tests in the A2L project (9007-1). An object representing a bed was located in the test area.

The PTAC was mounted such that the base of the unit was 0.4 m (16 inches) above the floor at the minimum distance from the side wall. For the first three tests (concentration tests), the discharge tube was placed at a return bend on the evaporator coil as shown in Figure 31.

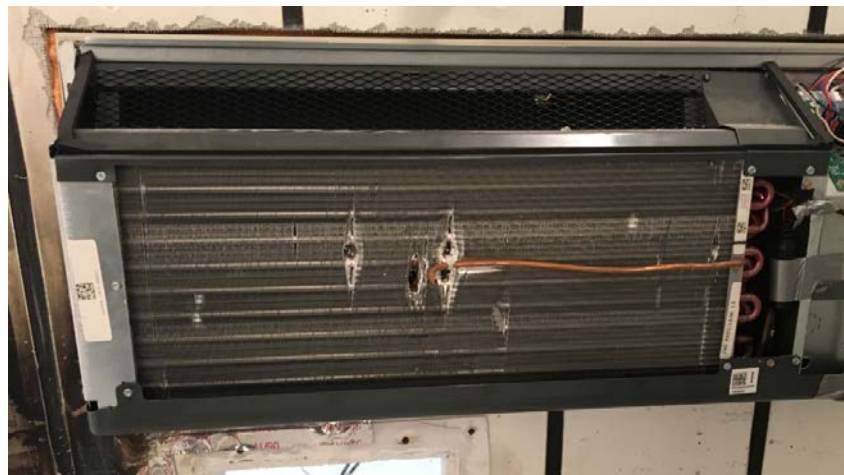
Figure 32 – ¼ inch discharge tube in the center of the PTAC evaporator coil

For the remaining tests, an 8 mm (¼ inch) O.D. copper tube was placed in the center of the evaporator coil at 0.6 (24 inches) above the floor. The tube was angled directly out from the face of the evaporator towards the grill as shown in Figure 32.

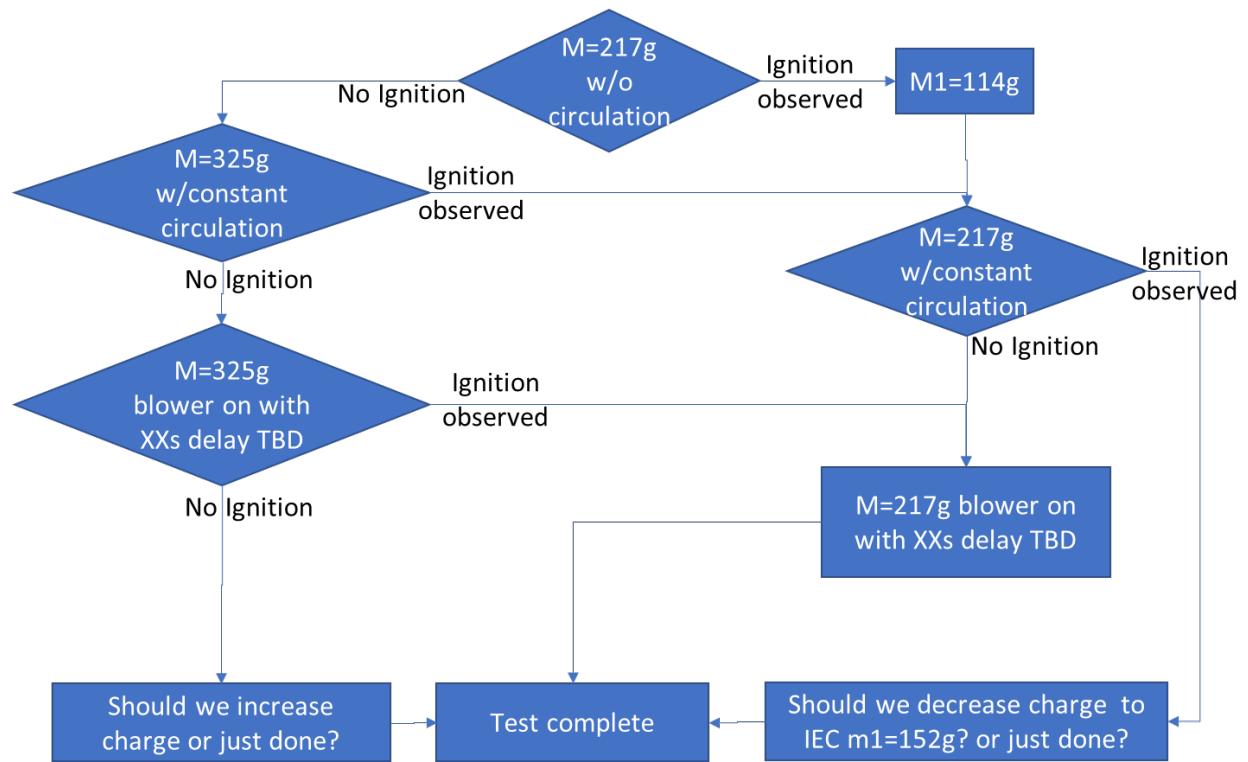
Figure 33 – PTAC Test Plan

A total of four tests were planned for the PTAC testing using electric arc ignition sources. In order to optimize the planned tests, a flow chart was developed to guide test parameters used on subsequent tests. The plan included using the unit fan to disperse leaked refrigerant in the test room as a mitigation method. The test series started with an initial planned discharge quantity of 217g and with the circulation fan in OFF position. The discharge quantity and circulating fan operation were changed in subsequent tests based upon test results as shown in Figure 33.

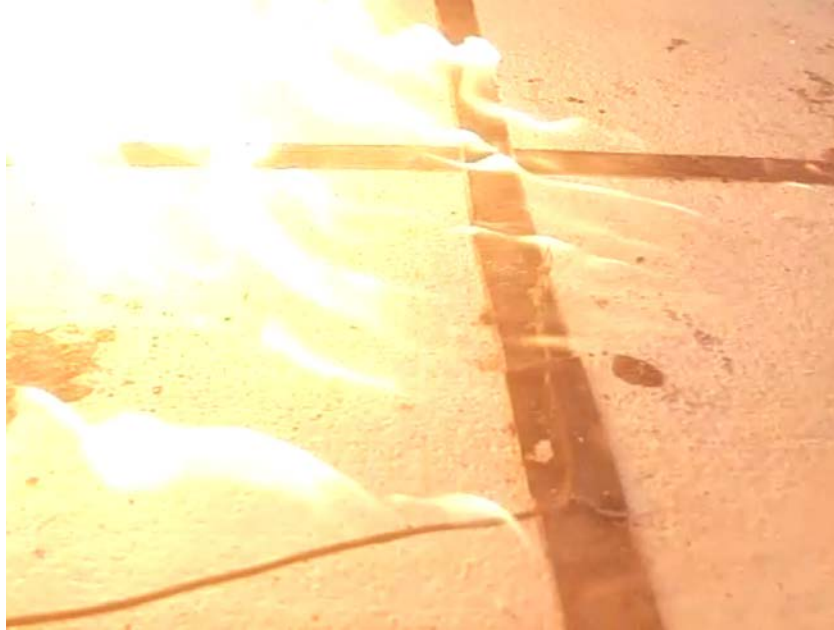
Figure 42 - PTAC_17 (217 g; Fan On). Flames attached to a pool of liquid propane

Pooling of liquid propane on the floor of the test room was evident in the high speed videos. Figure 42 shows one video frame from PTAC_17 test. Frames prior to ignition show liquid drops falling and splashing into the pool at floor level. These flames persisted for 15 s after the flammable mixture of gases in the room volume had been consumed.

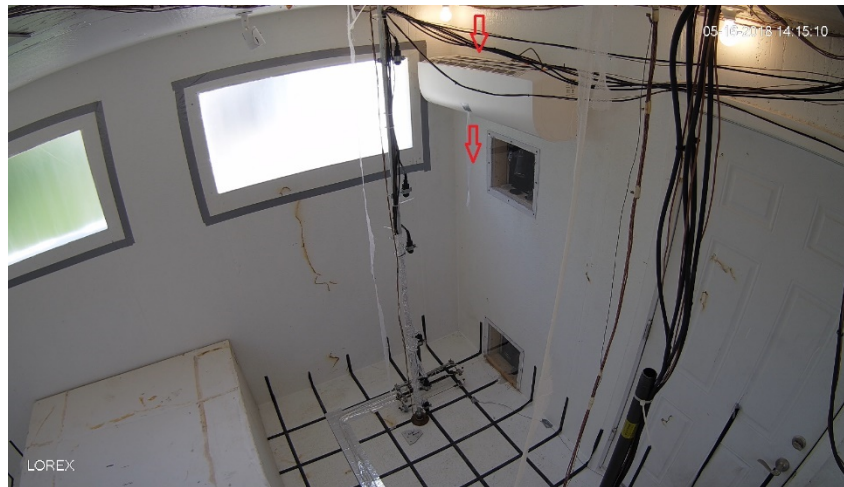
Figure 44 – Mini-split shown in location prior to a test. Red arrows showing the air flow path

The motel room scenario involved the use of a mini-split indoor unit in a motel room layout. The test setup for the motel room is shown in Figure 43 and Figure 44. An object representing a bed was located in the test area.

The mini-split was mounted such that the base of the unit was 1.8 m (71 inches) above the floor at the minimum distance from the side wall. A small piece of cheesecloth was attached to the front panel to give visual indicate of fan flow. The ¼ inch discharge tube was placed in the center of the evaporator coil as shown in Figure 45.

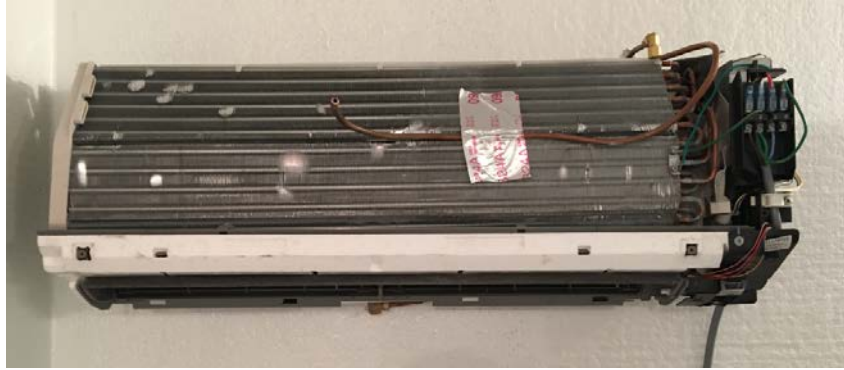
Figure 45 – Mini-split discharge tube location

The tube was angled directly out from the face of the evaporator towards the front panel as shown in Figure 45. The condensate pan drain was plugged during these tests.

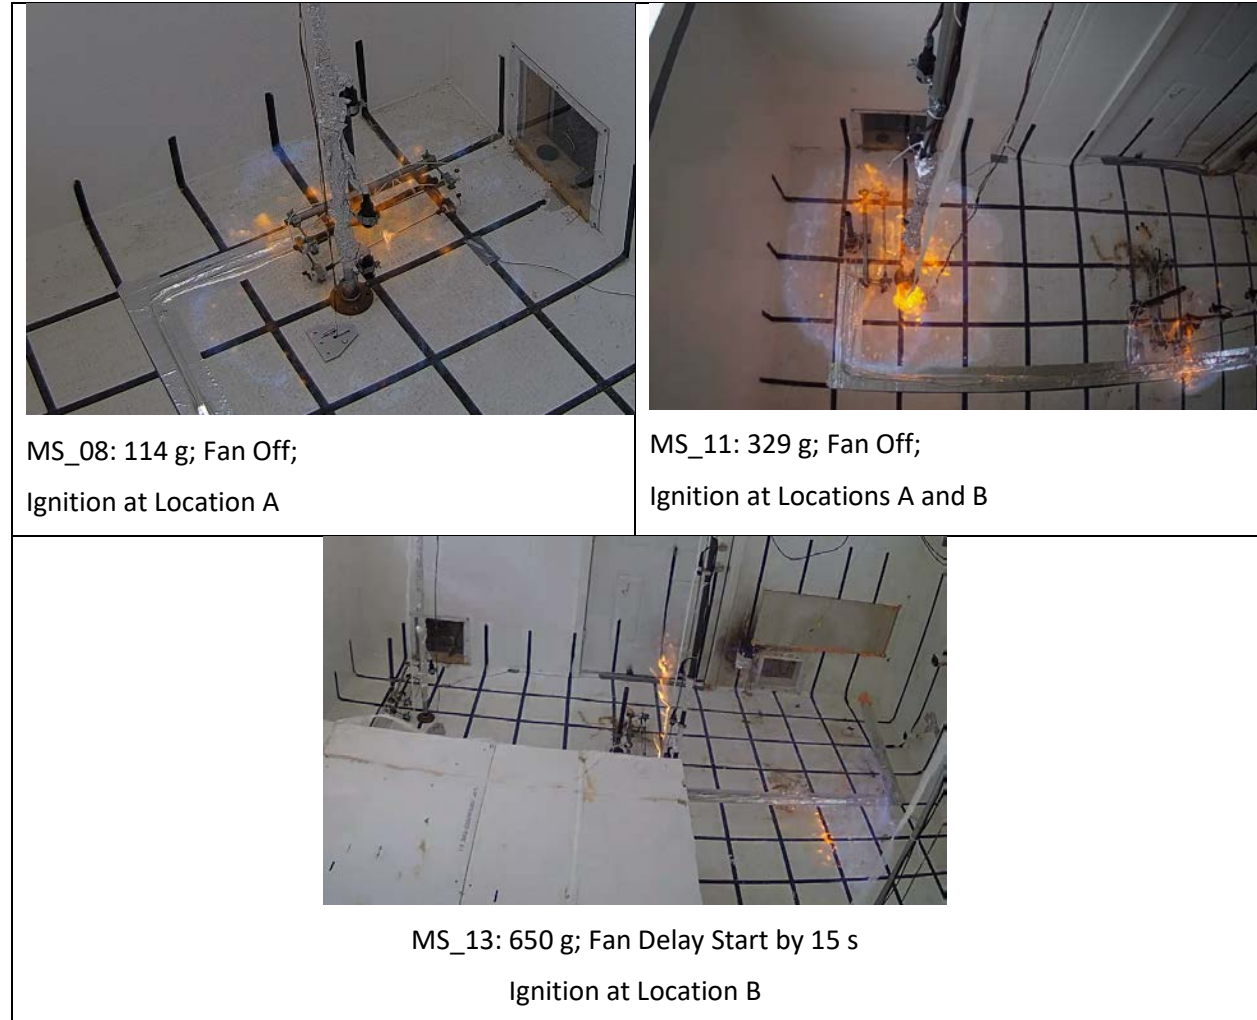
Figure 51 – Mini-split Ignitions

Figure 51 includes video frames at the moment of ignition. The photos show the difference in concentrations near the electric arcs. All three show the blue colored flame front of a pre-mixed propane/air mixture. Ignition in test MS_08 (114 g) occurred only at the location A electric arc. Ignitions occurred simultaneously in test MS_11 (329 g) at locations A and B.

The initial ignition event in MS_13 (650 g; Fan delay) was visible only in the infrared camera. Ignition occurred at location B only. The frame shown is approximately 0.5 seconds after ignition. This data shows that the fan had begun to sweep away flammable concentrations at location A. A higher fan flow rate, earlier activation, or faster spin-up time are indicated to prevent ignition at this charge level.

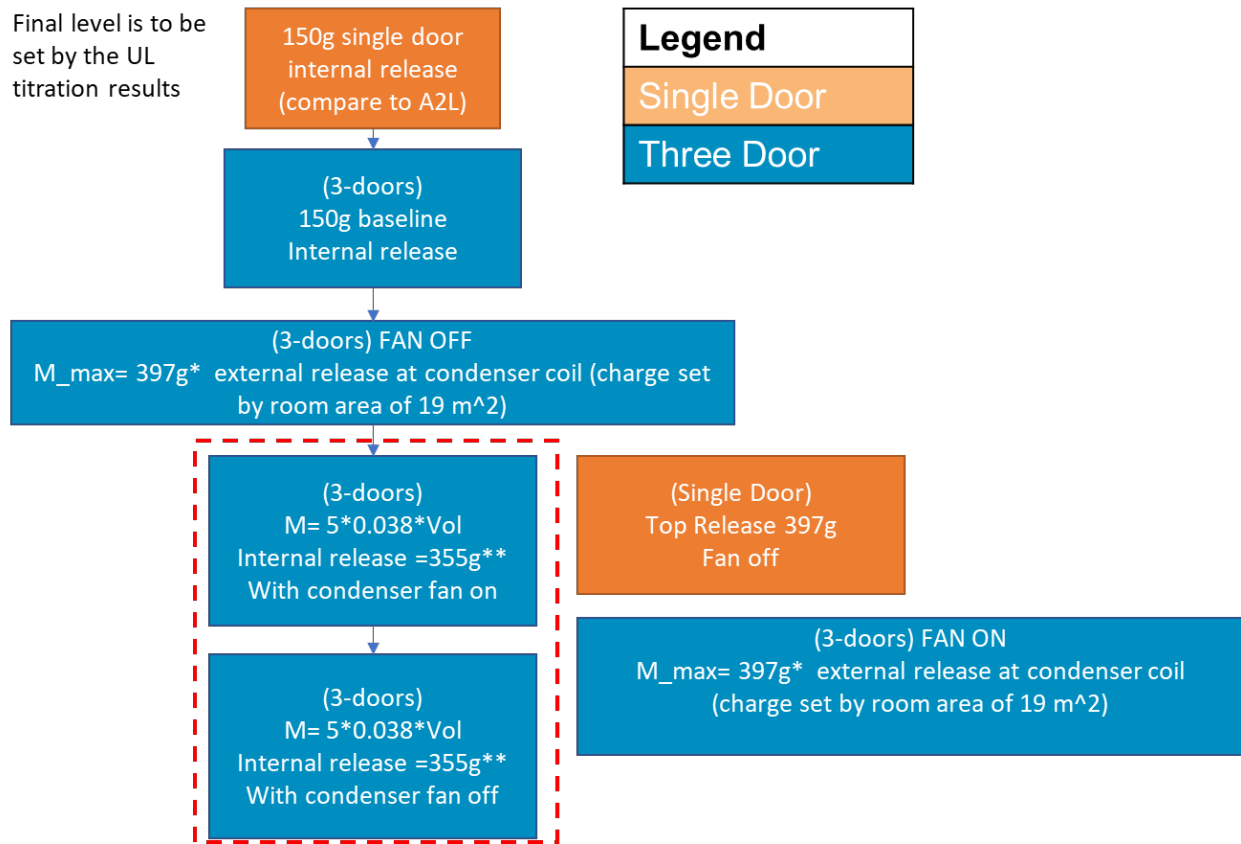
Figure 58 – Reach-in Cooler Test Series

A sixth test was added to the series when it was determined to be unsafe to continue toward the 355 g internal release in the three door cooler. Figure 58 shows the test plan including single and three door coolers.

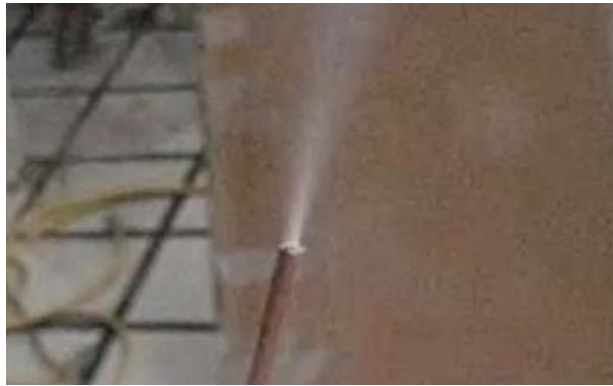
Figure 59 – Capillary Tube showing liquid mist at the exit

The discharge tube was also changed from ¼ inch O.D. tubing to a capillary tube such that the leak flow would be primarily liquid propane. Figure 59 shows a video frame of a capillary tube with a propane mist leaving the end of the tube.

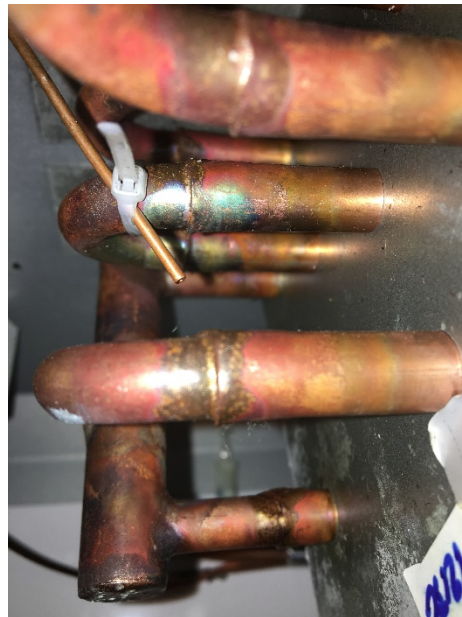
Figure 60 – Capillary tube as installed on the three door cooler evaporator

Figure 60 shows a capillary tube as installed on a return bend of the three door cooler evaporator. Similar installations were made on a condenser coil return bend for the external leak tests. The same method was used on the single door refrigerator evaporator and condensers as required for either internal or external leaks.

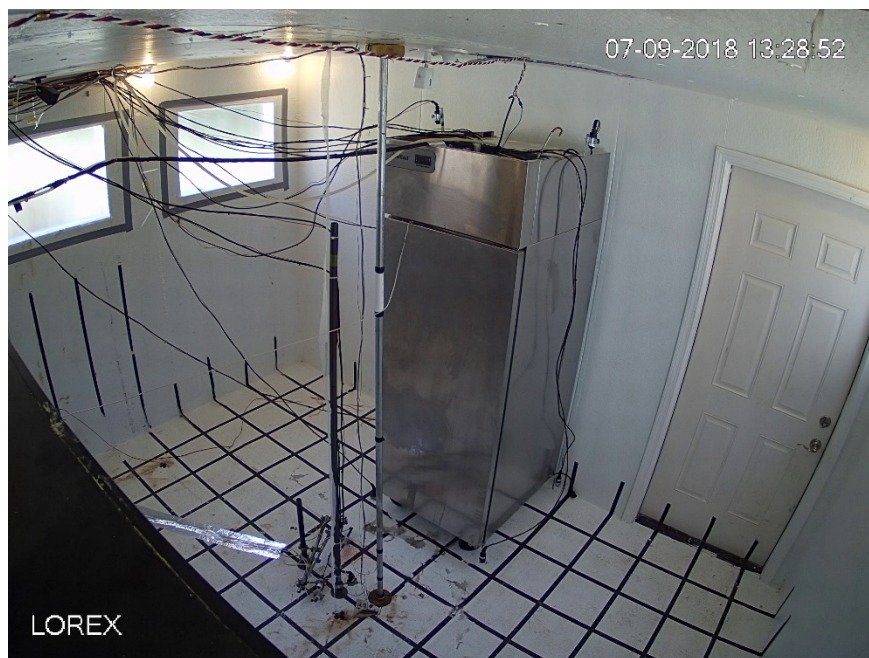
Figure 63 – Single door refrigerator installation

Figure 63 shows the installation for the single door refrigerator.

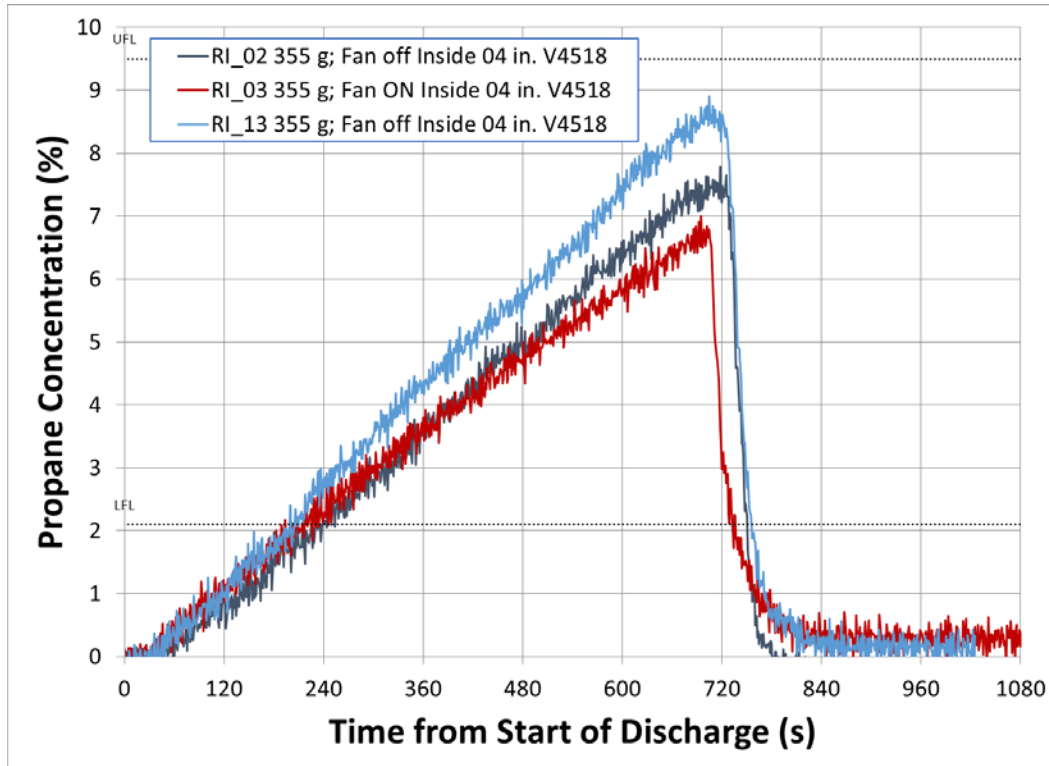
Figure 65 – Three door cooler 355 Internal Release Tests (no igniters)

There were no corresponding igniter tests matching the 355 g release because of the unsafe conditions observed in the case of the 200 g ignition.

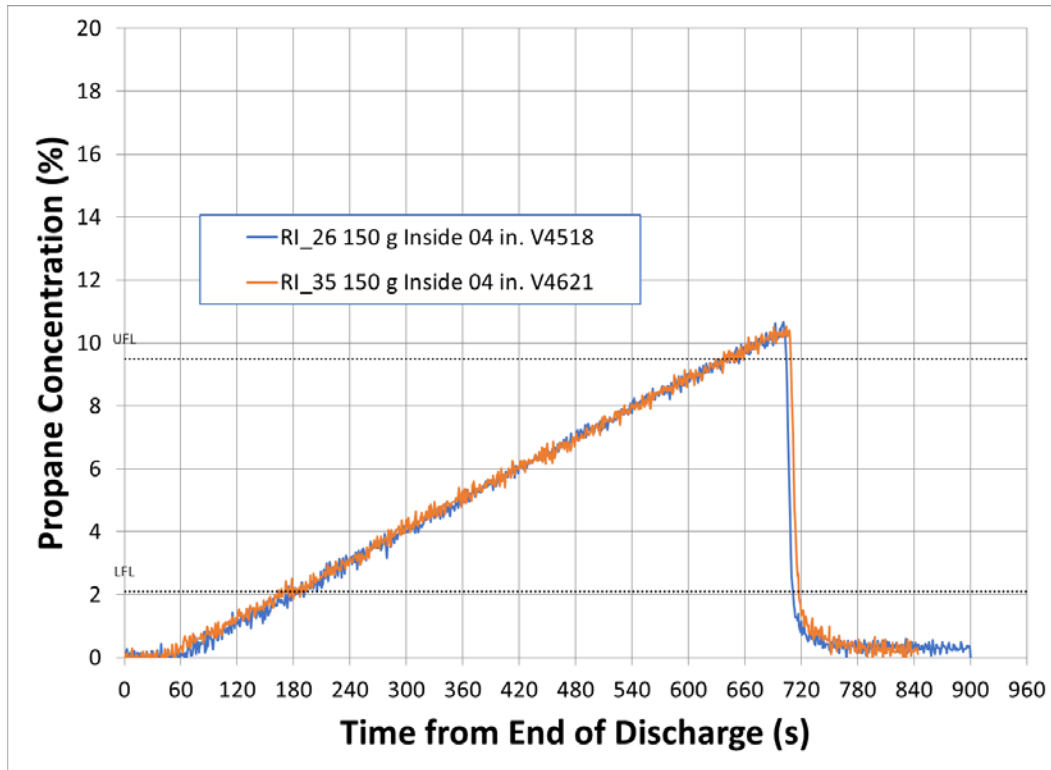
Figure 66 – Single door refrigerator: 150 g internal release (no igniters)

Figure 66 plots the internal concentration data for the single door refrigerator resulting from a 150 g discharge. RI_26 was the baseline data and is overlaid by the data from RI_35 indicating minimal or zero damage to the door gaskets from the intervening igniter tests.

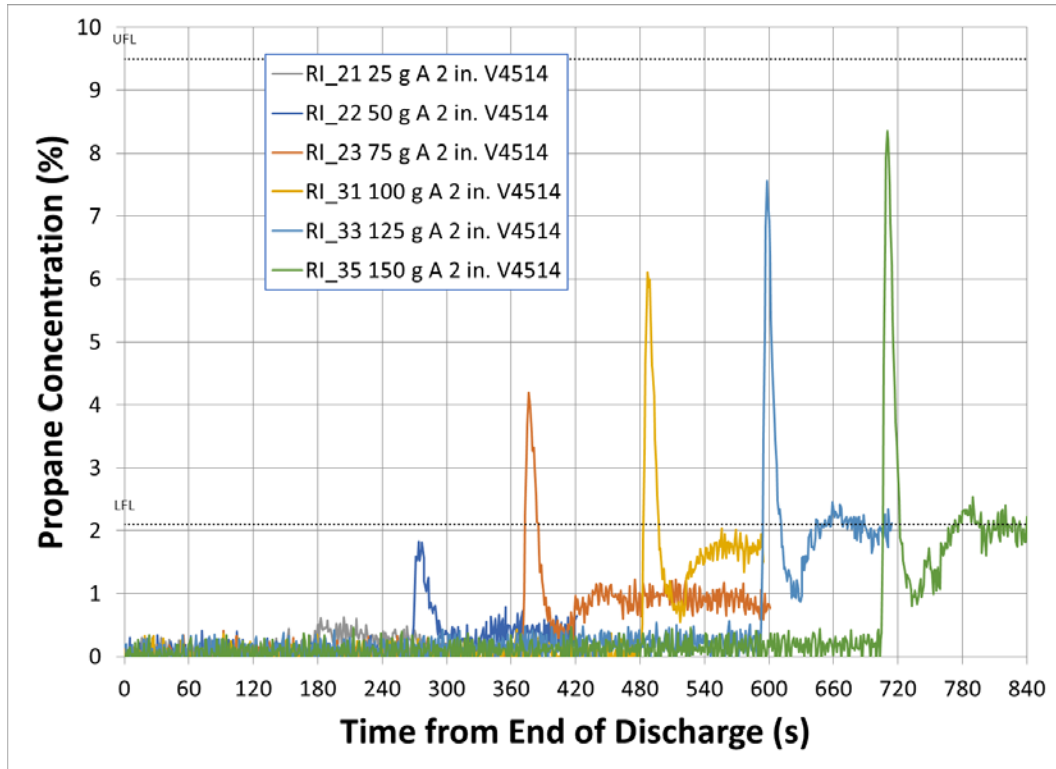
Figure 71 – Single door refrigerator step-wise progression at Location A, 2-inch level

Figure 71 plots single door refrigerator concentrations at location A 2-inch level from the step-wise progression from 25 g to 150 g releases. The peaks are larger than the three-door tests because the smaller volume of the single door refrigerator resulted in higher concentrations within the compartment from the same release amounts. The 25 g release did not rise above the LFL, while the other five had peaks well above the LFL. The 125 g and 150g releases settled at values close to LFL at the 2-inch level.

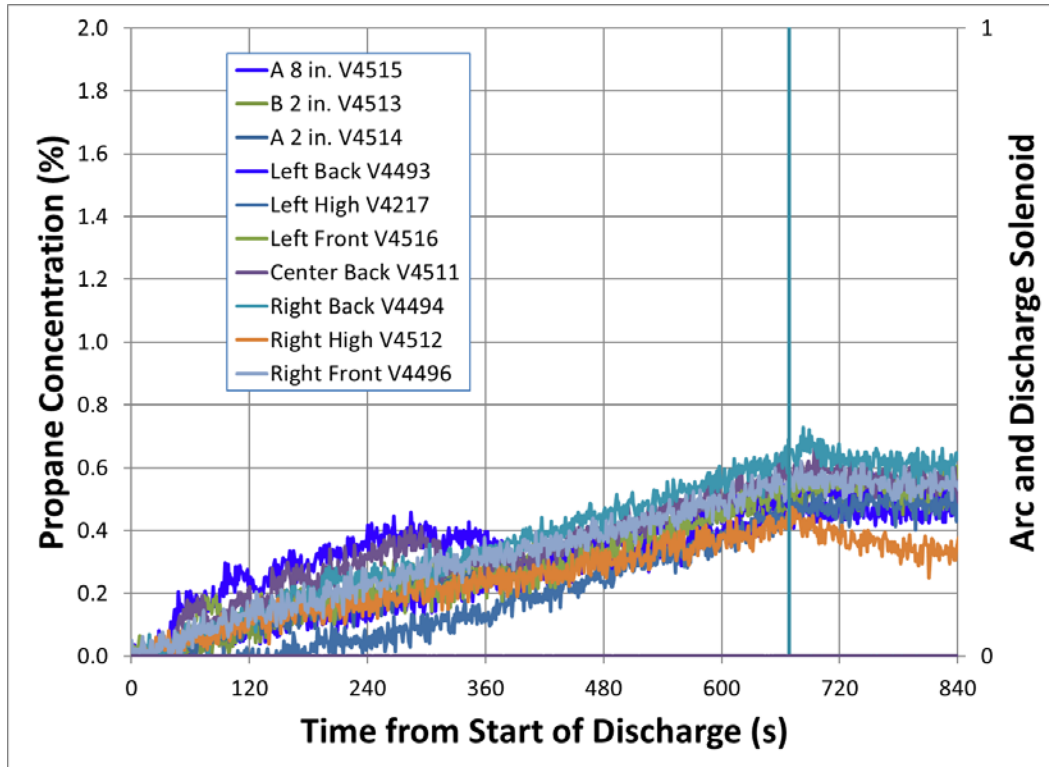
Figure 73 – Single door refrigerator test RI_28: 397 g, condenser fan operating

Figure 73 shows the non-deconvoluted concentration from throughout the test room (Test RI_28). Most sensors settled to concentrations between 0.4 and 0.6% at the end of data recording. The exception was the sensor located high on the right side of the single door refrigerator (Right High V4512). The exact reason for this behavior is unknown, but possibilities include air leakage from the test room exit door or air leakage from the attic through the video camera support.

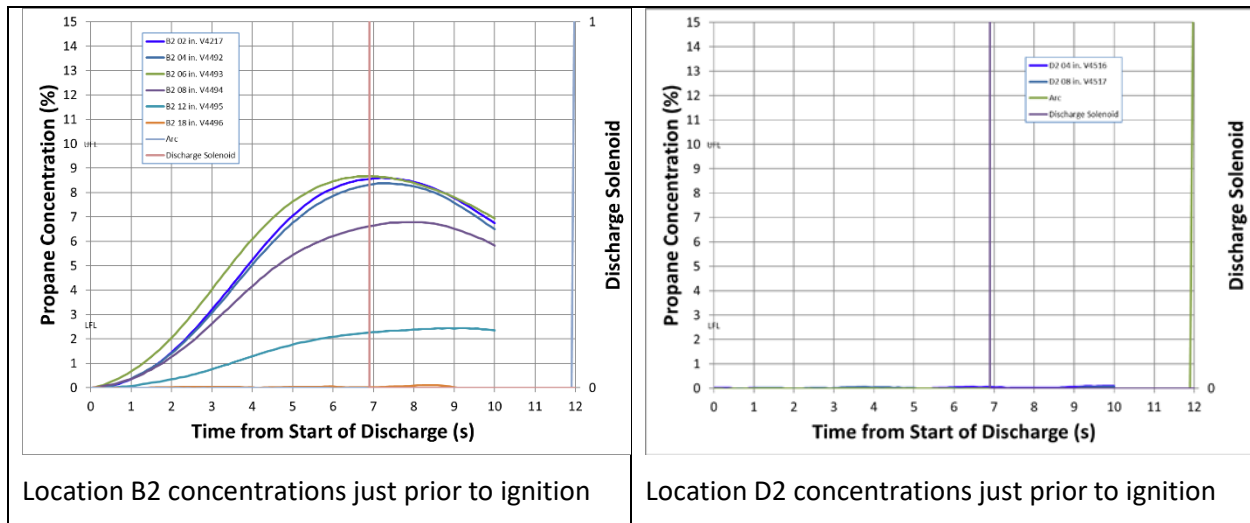
Figure 88 – CP_03 Concentrations

Figure 88 shows the deconvoluted concentrations measured up to the point that combustion products caused a false measure of propane concentration. Deconvolution looks back 2 seconds from the ignition time so the data has been chopped 2 seconds before the electric arc time to delete the combustion gases effect on the oxygen sensors.

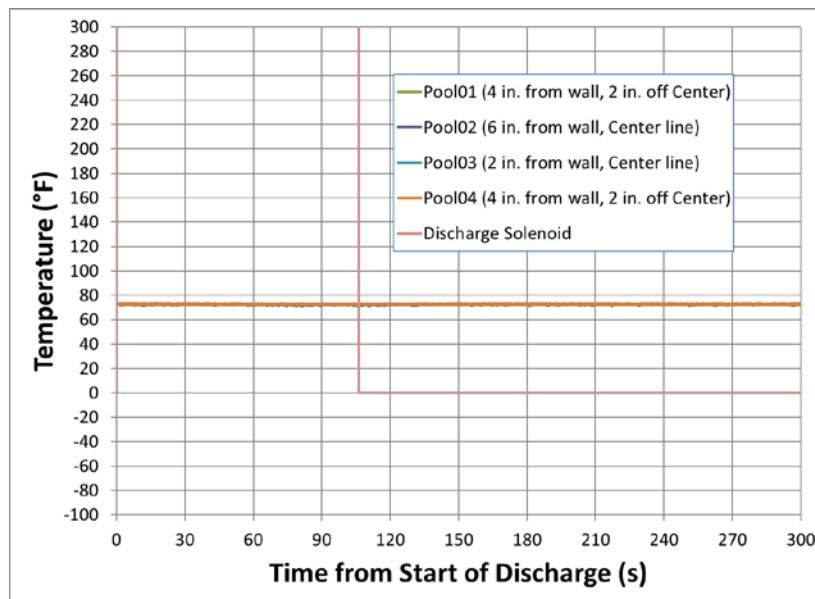
Figure 100 – CP_04 Liquid pooling at the floor

Figure 100 shows the thermocouple response to potential liquid propane pooling on the floor in front of the discharge tube. There was no evidence of cooling at these thermocouples.

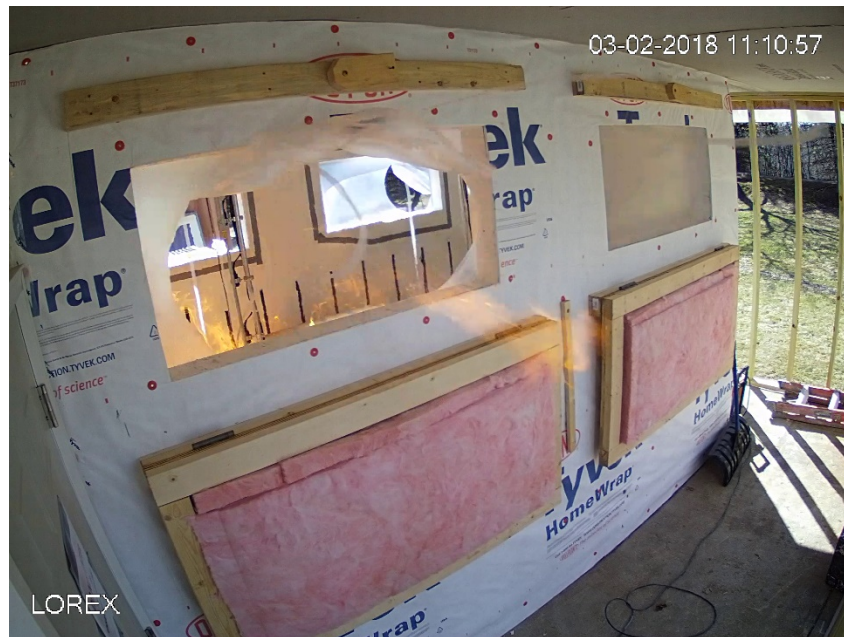
Figure 126 – CP_08 Flame extension through the west side vent

At the time of ignition, three deflagration vents burst with some flames extending out from the west side vents as shown in Figure 126. The last vent was melted open by the hot gases.

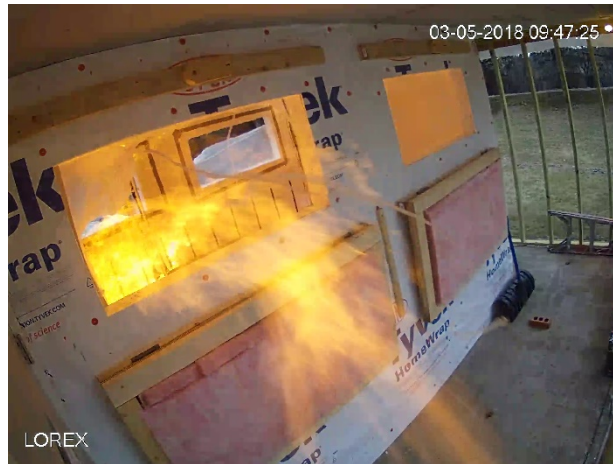
Figure 152 – CP_12 Flame extension through the west side vent

At the time of ignition, all three deflagration vents burst with some flames extending out from the west side vents as shown in Figure 152. The last vent melted open due to hot gases.

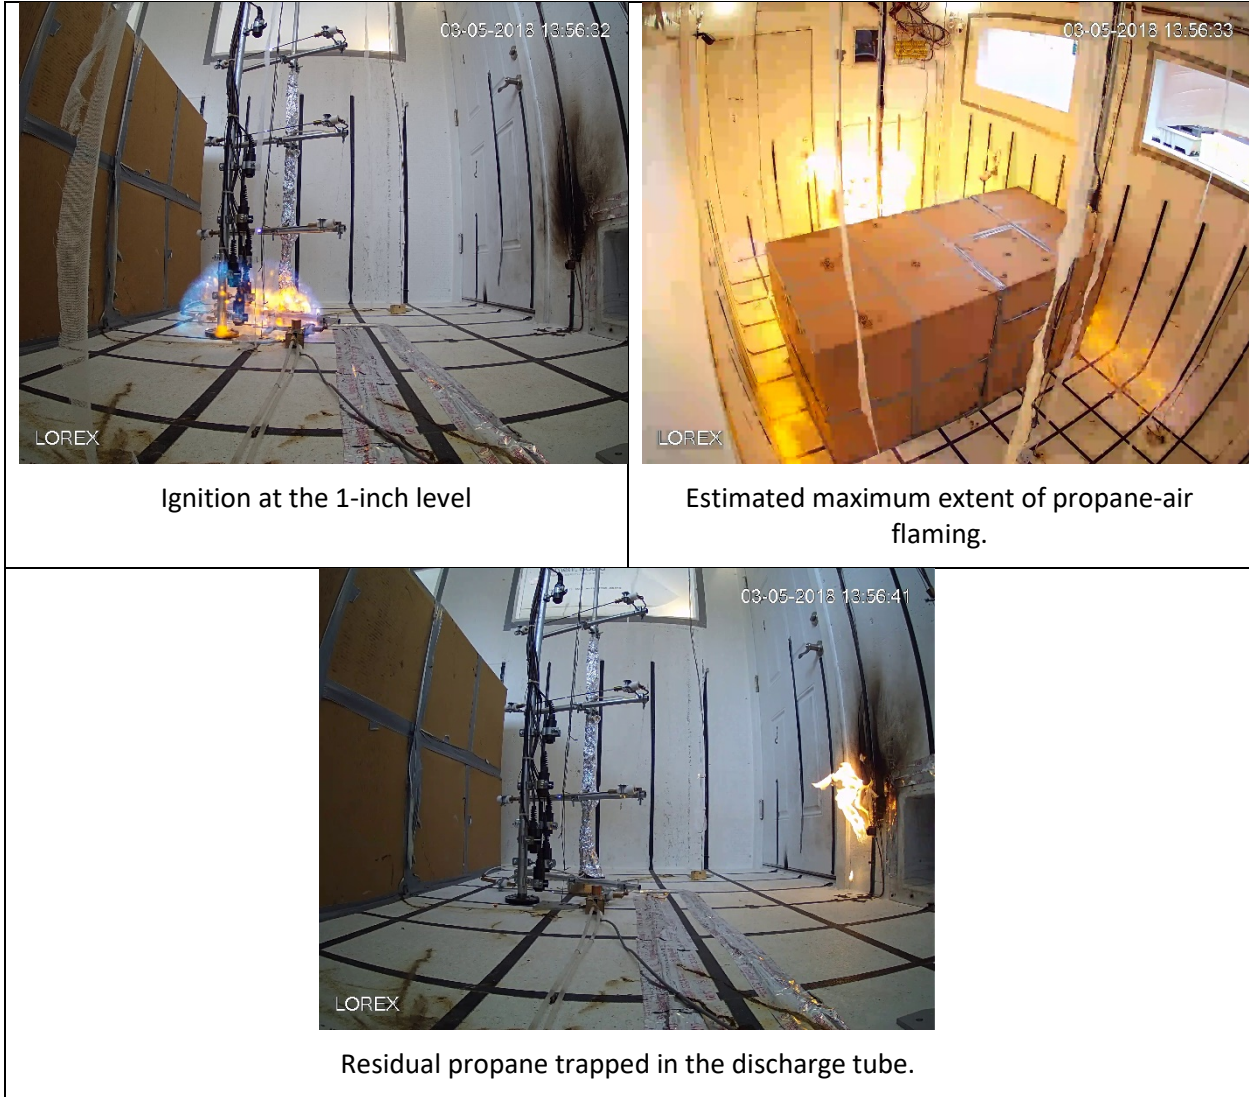
Figure 173 – CP_15: Frames of flaming from videos

Selected frames from the videos are shown in Figure 173. The ignition initially had the appearance of a pre-mixed flame, but quickly transitioned into a diffusion flame. Three deflagration vents burst at ignition time. The propane-air mixture flamed for 2 seconds. Remaining propane in the discharge tube continued to expand out of the tube and ignited for an additional 2 minutes.

Ignition at the 1-inch level

Estimated maximum extent of propane-air flaming.

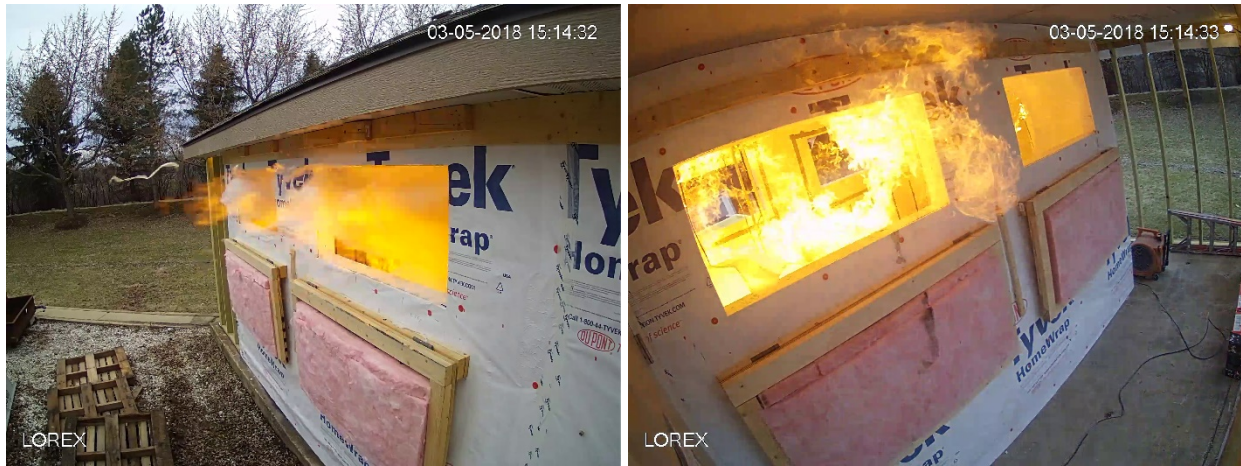
Figure 186 – CP_17 Flame extension through the west and east side vents

At the time of ignition, all three deflagration vents burst with some flames extending out from the east and west side vents as shown in Figure 186. The last vent melted open due to hot gases.

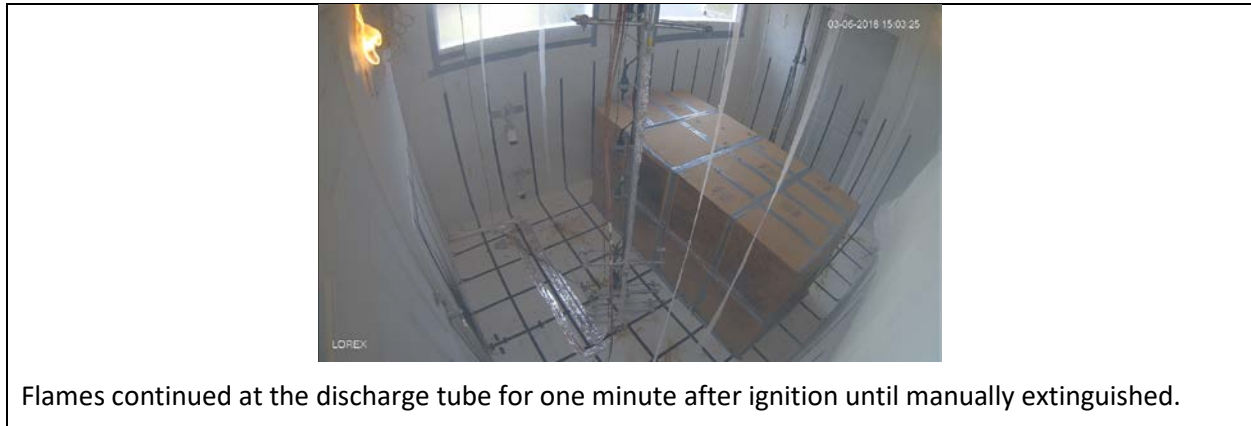
Figure 211 – CP_21: Continued flaming from expanding propane in the discharge tube

Figure 211 shows that some propane remained in the discharge tube after the closure of the discharge solenoid. This gas slowly expanded and continued to flame for 50 seconds after ignition. The flames were manually suppressed after 1 minute to protect sensor wiring.

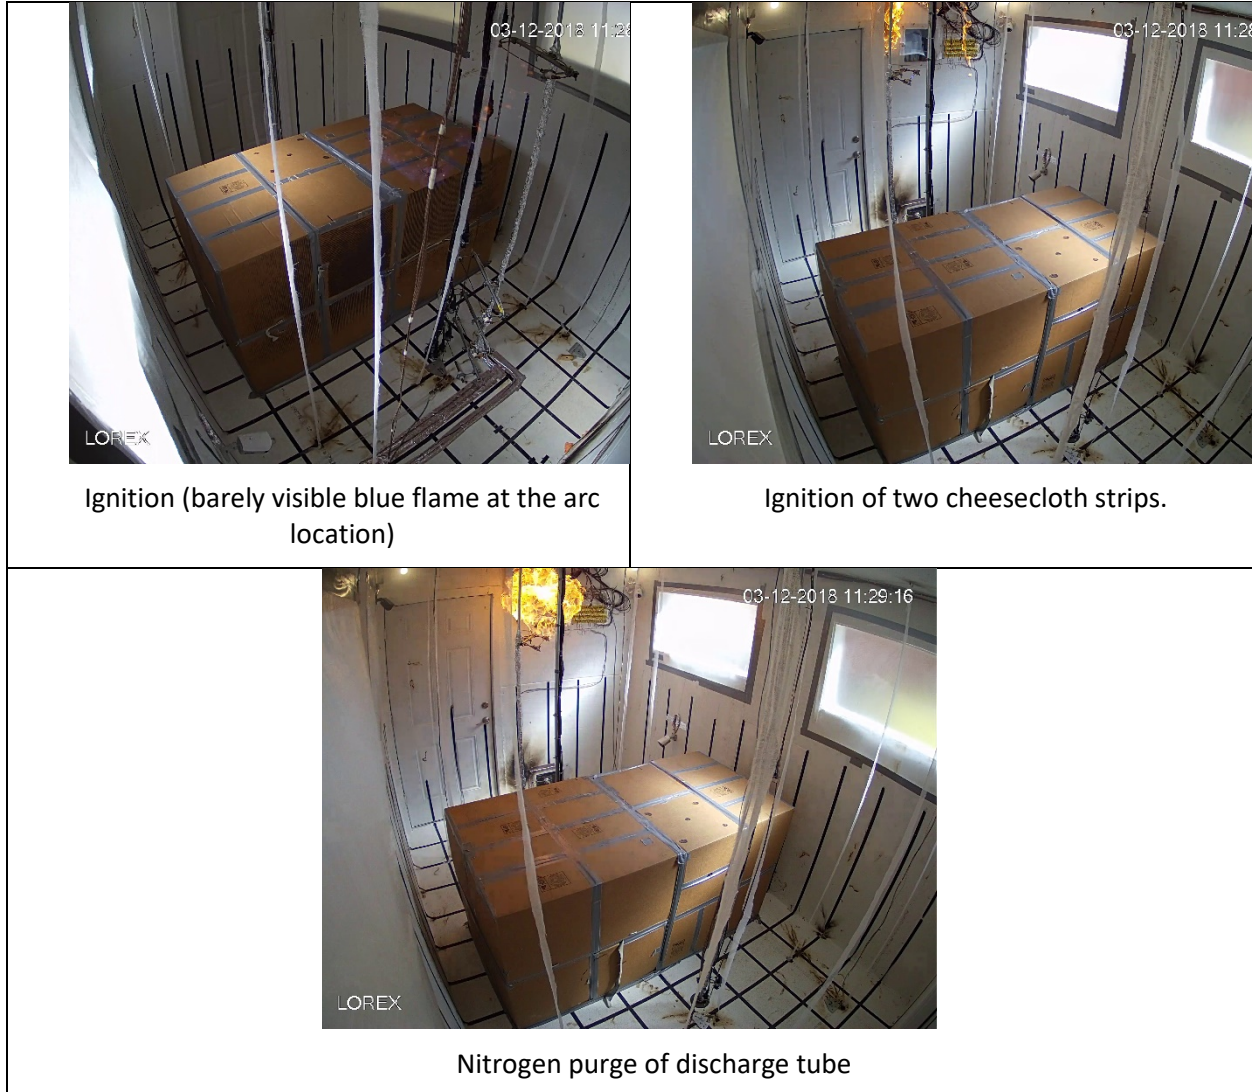
Figure 221 – CP_23: Frames of flaming from videos

Selected frames from the videos are shown in Figure 221. Ignition was barely visible in the camera view, but resulted in ignition of two cheesecloth strips and ignited the remaining propane expanding from the discharge tube. The tube was purged with nitrogen resulting in a brief flare at 55 seconds after the arcs were energized. There was no bursting or melting of the deflagration vents in this test.

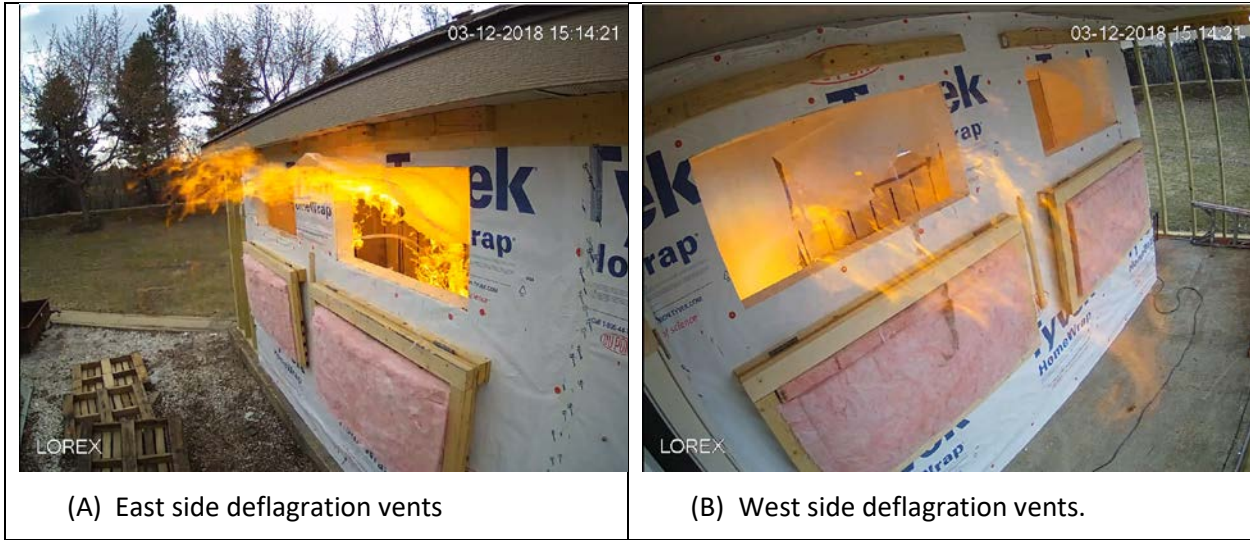
Figure 234 – CP_25 Deflagration Vents Bursting with Flame Extension

At the time of ignition, all four deflagration vents burst with some flames extending out from the vents as shown in Figure 234.

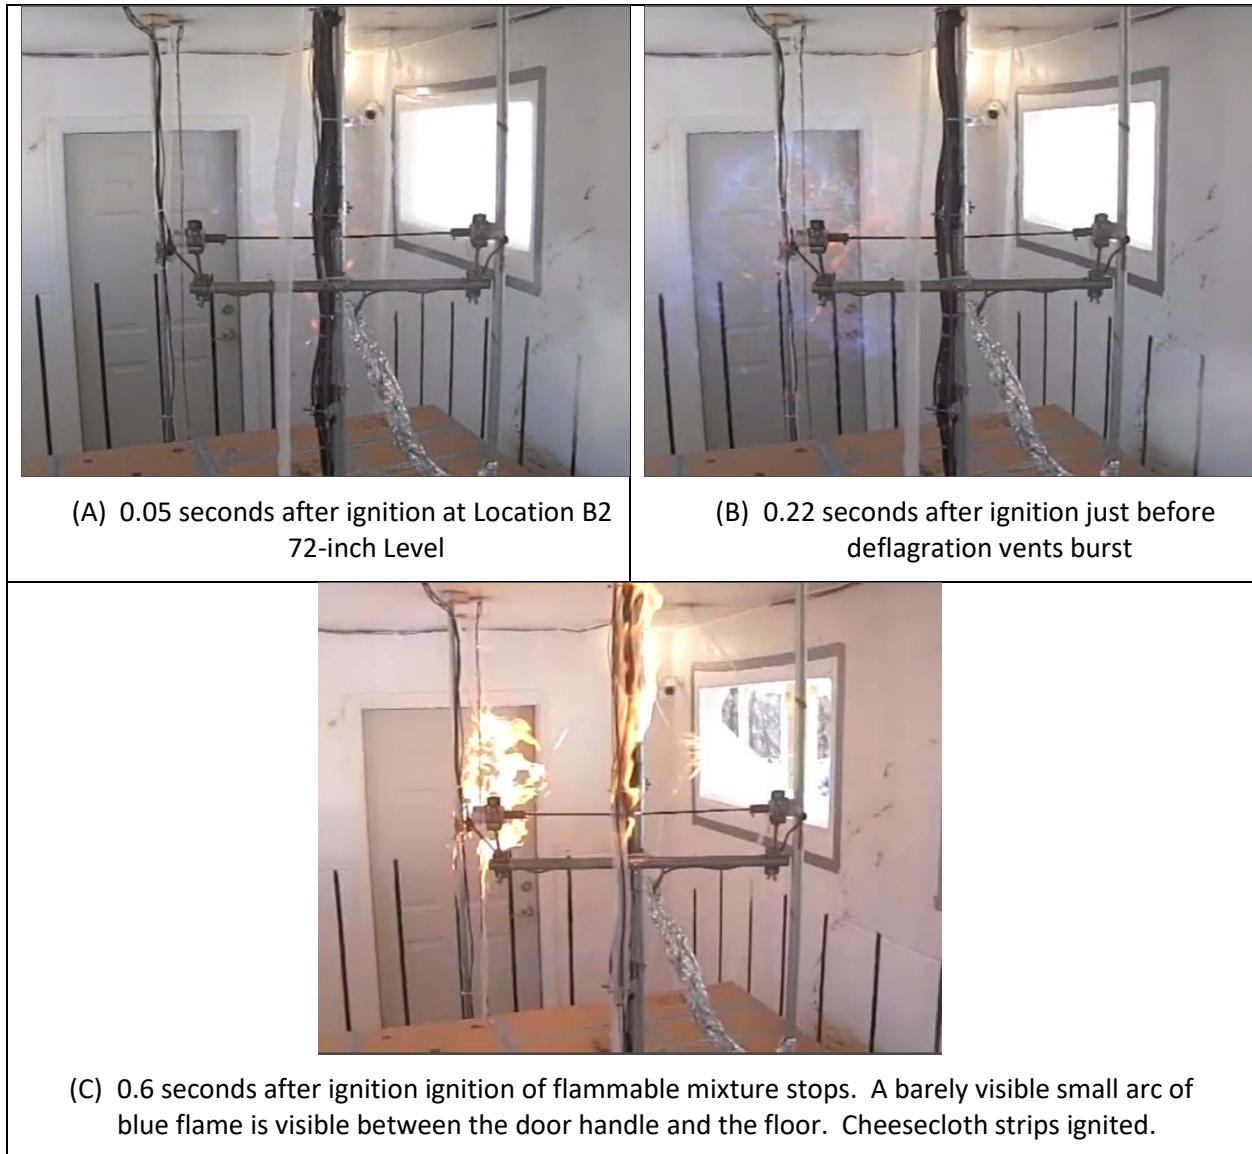
Figure 241 – CP_26: Frames of flaming from videos

Selected frames from the videos are shown in Figure 241. Burning of these air mixtures stopped after 0.6 seconds. Three deflagration vents burst and the other melted 2 seconds later due to the hot gases.

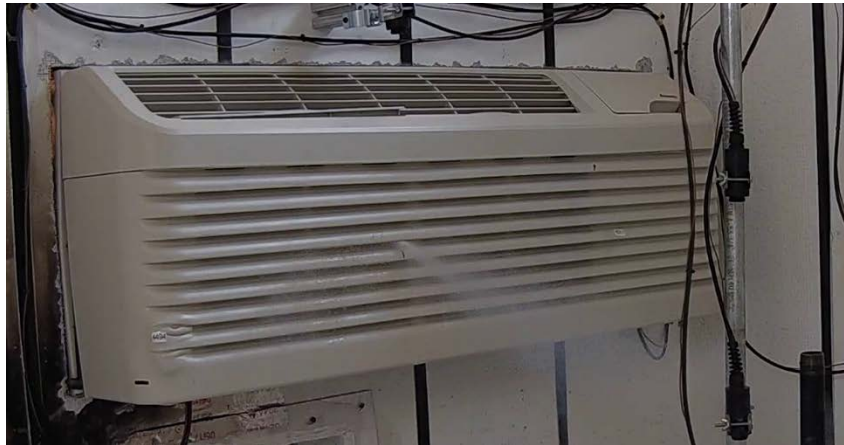
Figure 289 – PTAC_13 Discharge showing accumulation of liquid propane on the PTAC grill

Figure 289 shows liquid propane dripping from the front of the PTAC grill. It is suspected that splash back into the unit resulted in some accumulation of liquid propane in the drip pan at the left side of the unit.

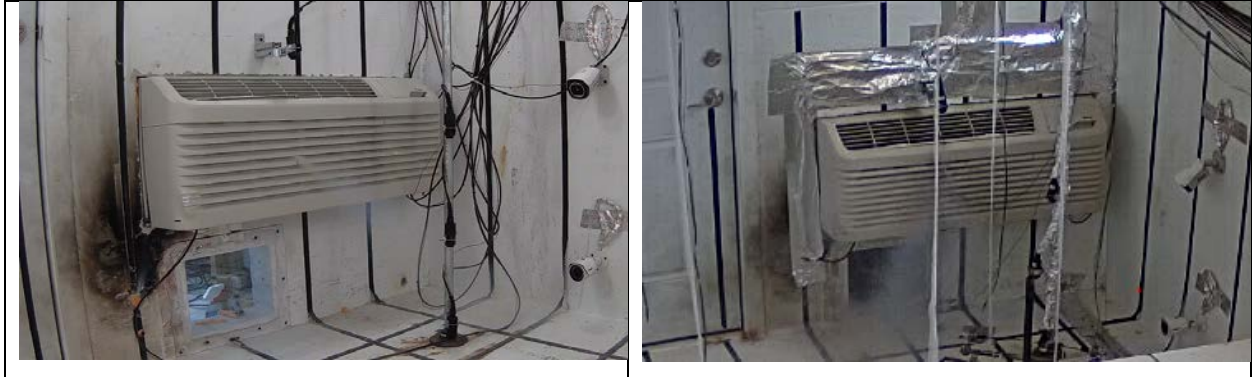
Figure 305 – PTAC_09 (left) to PTAC_16 (right) Stream Comparison

Figure 305 compares the visual of the propane mist between PTAC_09 (left) and PTAC_16 (right). The comparison shows that the streams exited the grill of the PTAC at different angles which is a factor in the distribution of measured propane concentrations. The PTAC_16 stream is angled away from the corner which reduced the accumulation at location A and increases the concentration at location B. The stream from PTAC_09 is nearly perpendicular to the mounting wall except for the down angle. This behavior increased concentration at location A and decreased concentration at location B.

It was noted that the PTAC grill assembly had slightly warped from the exposure to fire in PTAC_14 and PTAC15 tests. The result was that the discharge impacted the grill face at slightly different conditions.

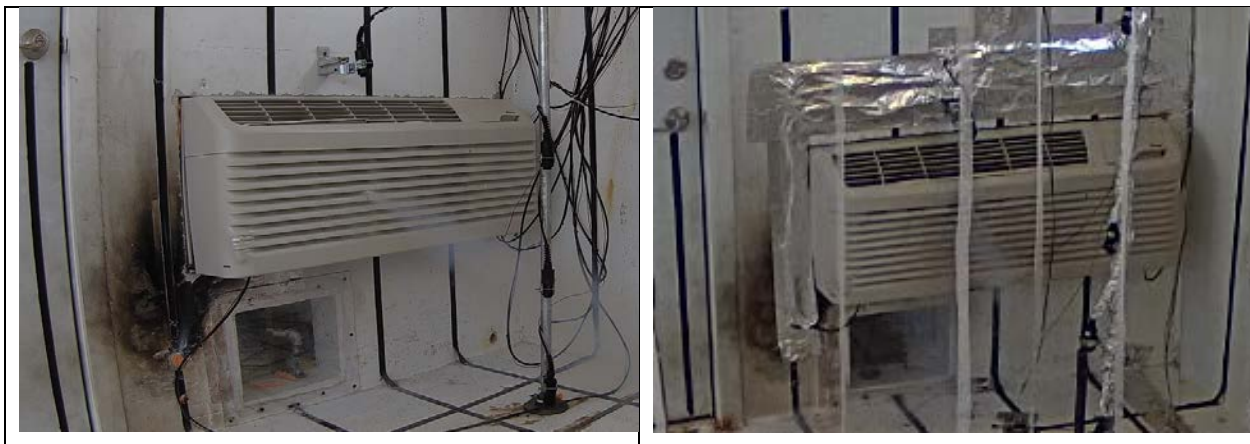
Figure 312 – PTAC_06 (left) to PTAC_17 (right) Stream Comparison

Figure 312 compares the visual of the propane mist between PTAC_06 (left) and PTAC_17 (right). The comparison shows that the streams exited the grill of the PTAC at different angles which is a factor in the distribution of measured propane concentrations. The video shows the PTAC_06 with a smaller amount of liquid propane droplets while the PTAC_17 video shows a much larger flow of liquid propane.

The lesser amount of liquid propane in PTAC_06 contributed to higher gaseous propane concentrations shown in Figure 311. It was noted that the PTAC grill assembly had warped from the exposure to fires in PTAC_14, PTAC_15, and PTAC_16 tests. The result was that the discharge impacted the grill face at different conditions.
