**Air-Conditioning, Heating and
Refrigeration Technology Institute**

AHRTI Report No. 9007-2

Benchmarking Risk by Whole Room Scale Leaks and Ignitions Testing of A3 Refrigerants

July 2019

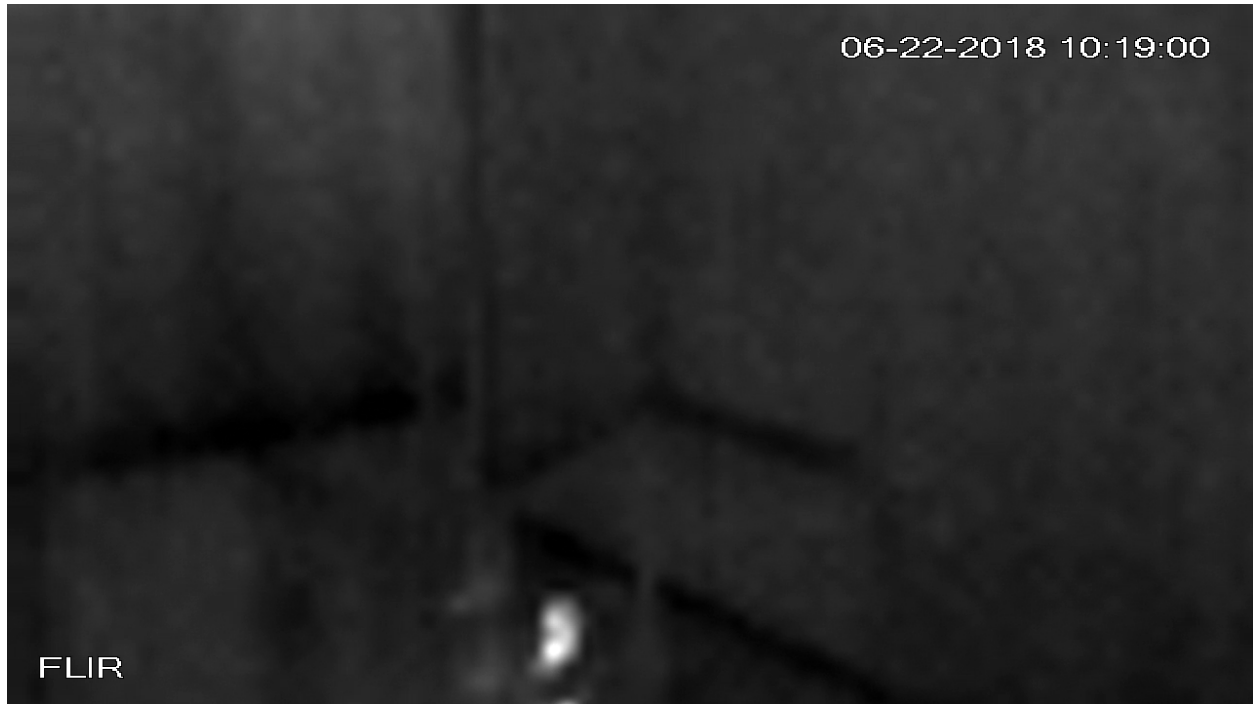
Figure 398 – RI_05 Small flaring at the location A electric arc.

The infrared camera captured flaring at the electric arc as shown in Figure 398. This effect was not visible in the other cameras except as a disturbance in the shape of the electric arc.

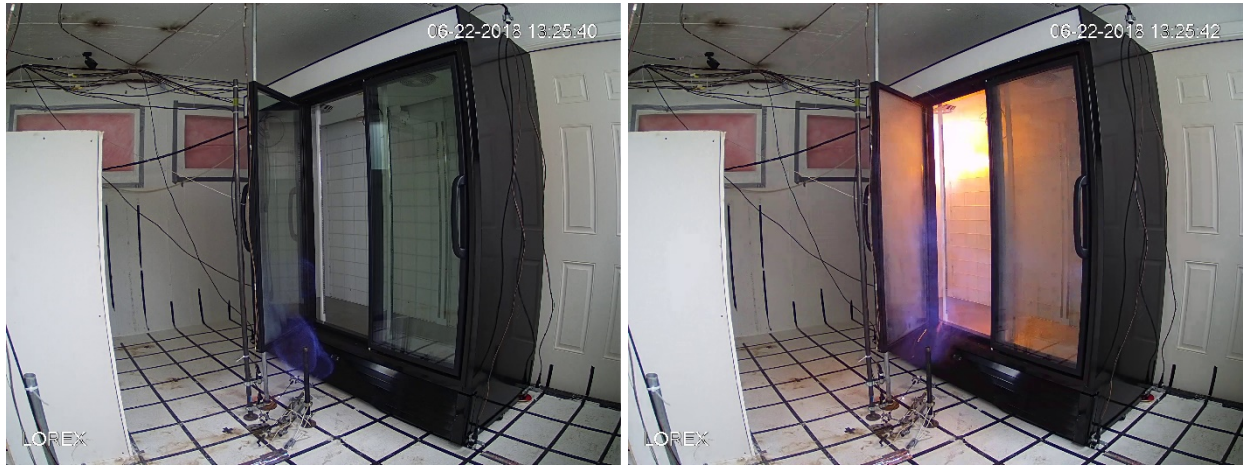
Figure 415 – RI_08 Ignition (left) and small fireball (right).

The videos show that the propane flaming endured for 4 seconds. The pressure was sufficient to cause 1 of 6 deflagration vents to open another vent melted from the hot gas layer. The east side vents were shuttered during this test since a large deflagration was not expected.

The flames were almost entirely pre-mixed and blue in color. Figure 415 left-side shows the faint blue flame. The right side frame shows the fireball inside the cooler when the flames reached up to the level of the drip tray, just below the location (hidden) of the discharge capillary tube. After the fireball, pre-mixed flaming continued for another 2 seconds.

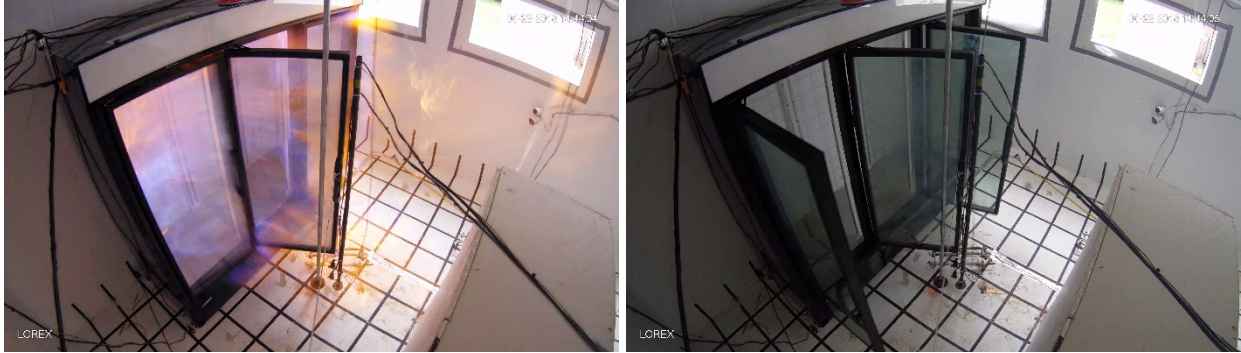
Figure 428 – RI_10 Deflagration showing doors forced open due to developed pressure.

The videos show that the propane flaming endured for 2 seconds. The deflagration pressure was sufficient to cause 3 of 6 deflagration vents to open. The deflagration also forced open the other two doors of the cooler as shown in Figure 461. The doors were thrown completely open. The left-hand door latched open and the right-hand door bounced and closed.

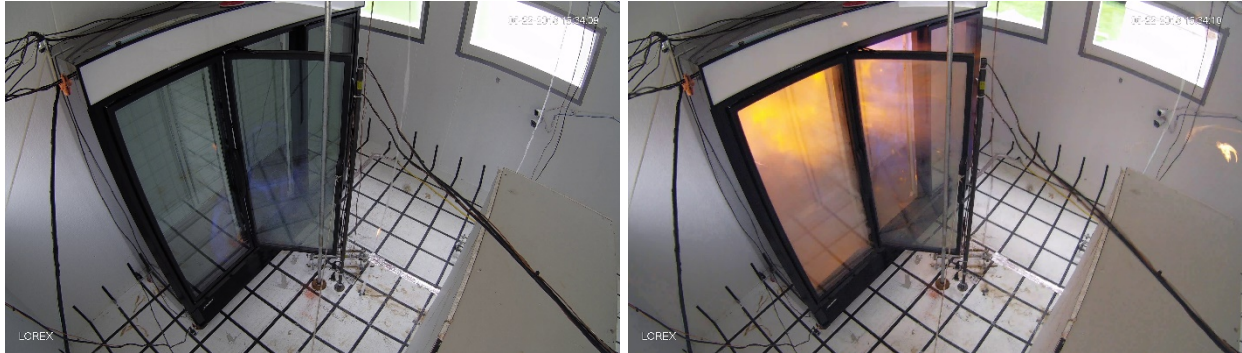
Figure 435 – RI_11 Deflagration showing initial pre-mixed flame (left) and small deflagration (right)

The videos show that the propane flaming endured for 2 seconds. The deflagration pressure was sufficient to cause 3 of 6 deflagration vents to open. One additional vent melted open due to the hot gases. The deflagration also forced open the other two doors of the cooler as shown in Figure 435. Both doors were popped open about 2 inches by the fast, but small, deflagration shown in the right-hand image.

The high-speed camera showed the yellow fireball expanding from initiation to its largest size in 0.05 seconds.

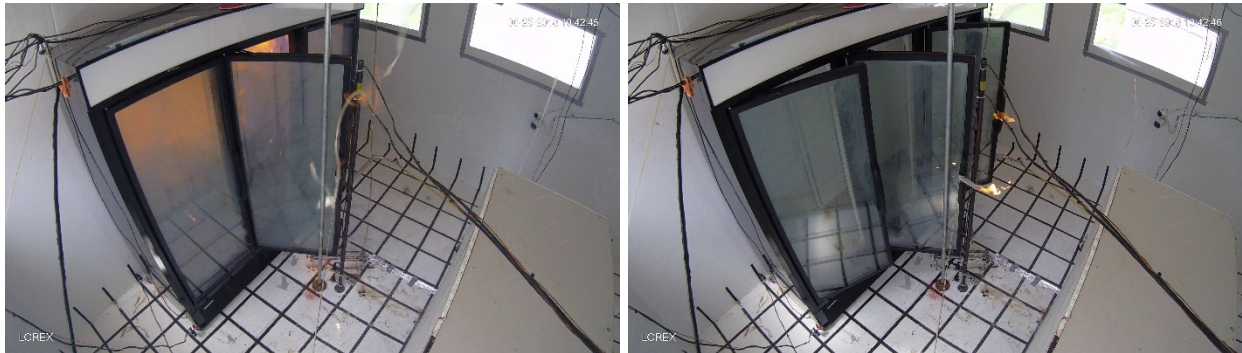
Figure 442 – RI_12 Deflagration showing doors forced open due to developed pressure.

The videos show that the propane flaming endured for 2 seconds. The deflagration pressure was sufficient to cause 5 of 6 deflagration vents to open. The deflagration also forced open the other two doors of the cooler as shown in Figure 442.

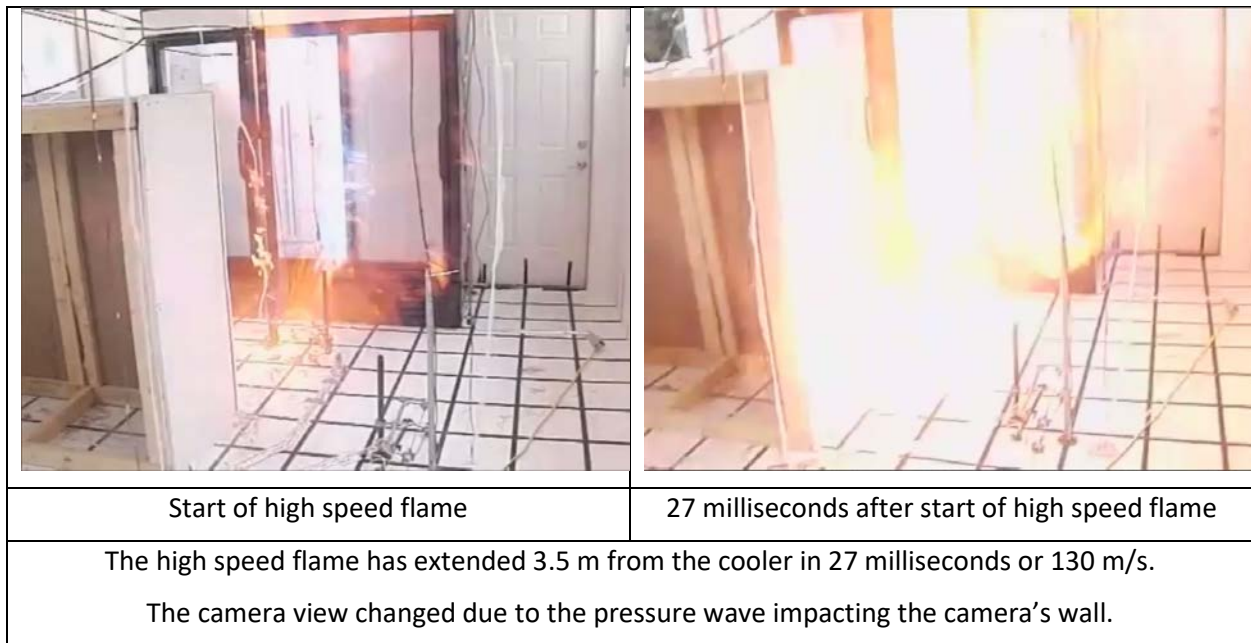
Figure 478 – RI_18 Deflagration Overpressure Effects

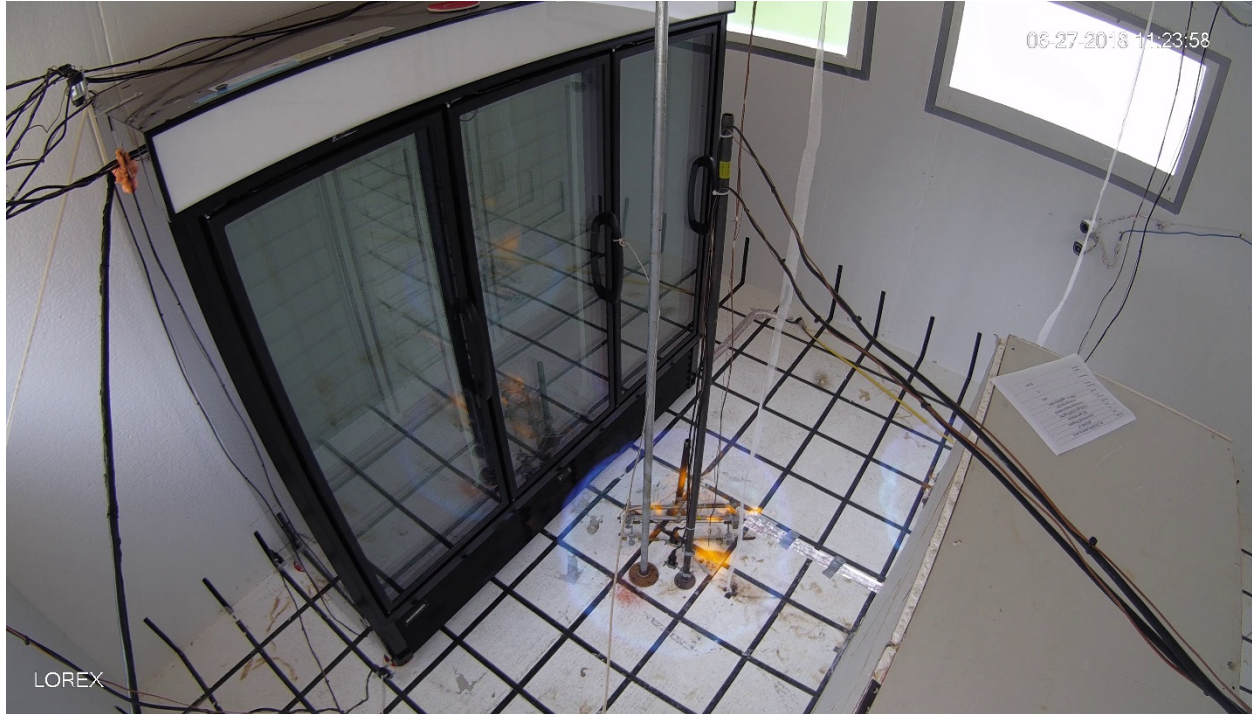
Figure 488 – RI_20 Simultaneous Ignition at Locations A and B

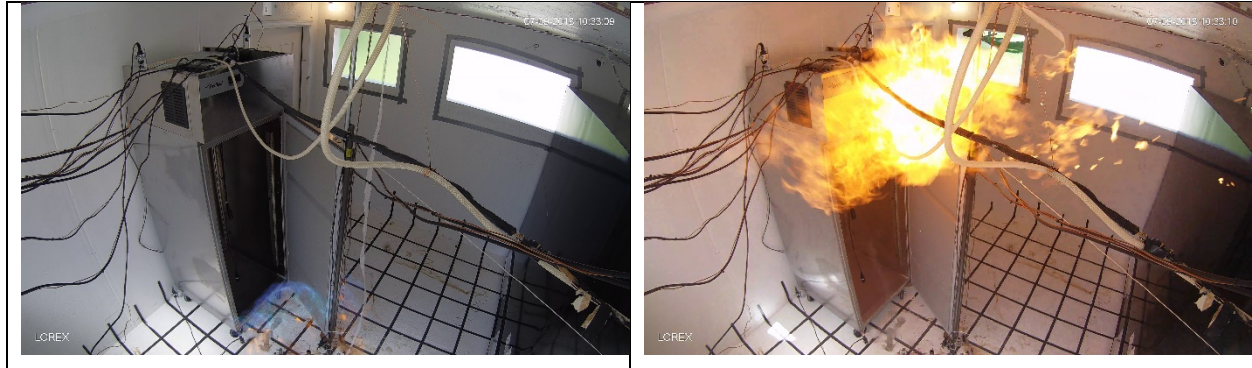
Figure 539 – RI_30 Ignition event

The videos show that the propane flaming endured for 3 seconds. Figure 539 shows the ignition at the 6-inch arc in front of the door. There is an initial blue flame (premixed), while the dominant yellow color signifies a diffusion flame. The second frame shows that the gases were pushed out of the cooler to mix with room air. Four deflagration vents burst due to the ignition event.

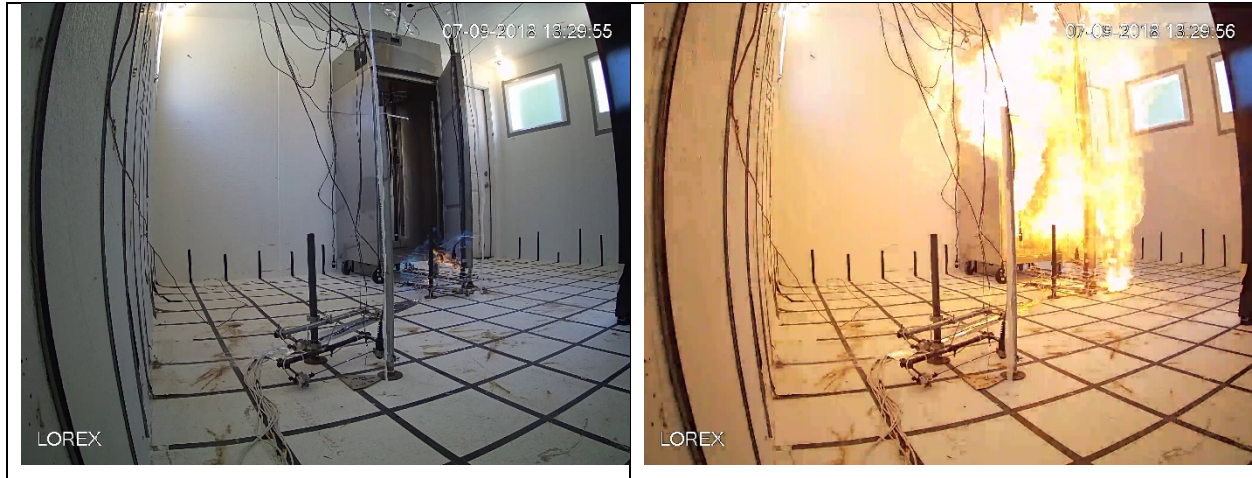
Figure 552 – RI_32 Ignition event

The videos show that the propane flaming endured for 4 seconds. Figure 552 shows the ignition at the 6-inch arc in front of the door. There is an initial blue flame (premixed), while the dominant yellow color signifies a diffusion flame. The second frame shows that the gases were pushed out of the cooler to mix with room air. Two deflagration vents burst due to the ignition event and two others melted from the heat.

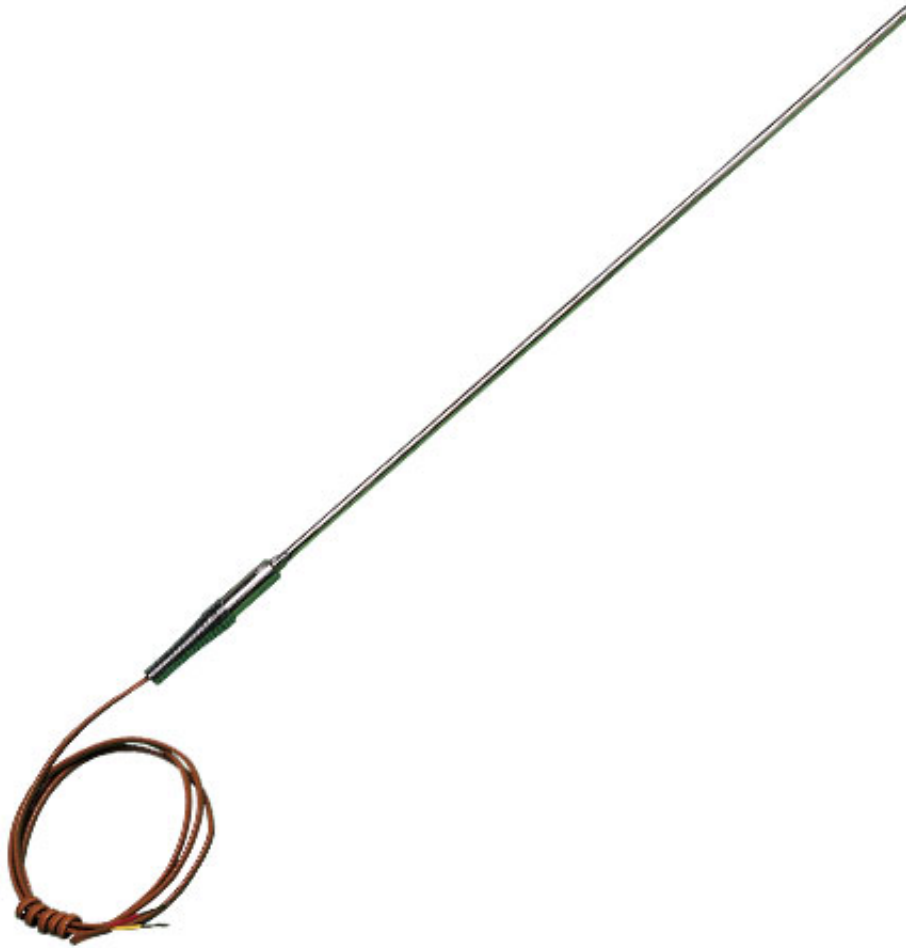
Figure 590 - TJ36-CAXL-18U-48

Thermocouple, shielded probe

Ungrounded 1/8 inch diameter type K thermocouples were used to measure temperatures in the release and pressure tanks as well as the surrounding water baths.

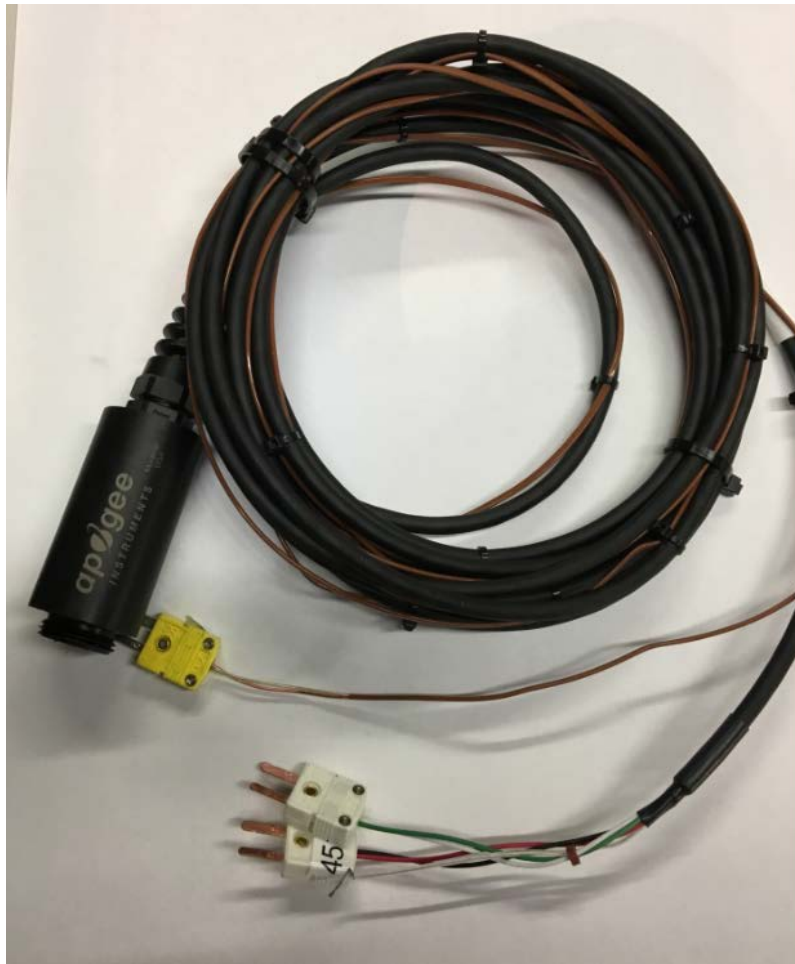
Figure 591 – Apogee Model 220 Oxygen Sensor

The oxygen sensor was used to measure propane concentration because of the displacement of oxygen by propane (prior to any combustion gases that can skew the results).

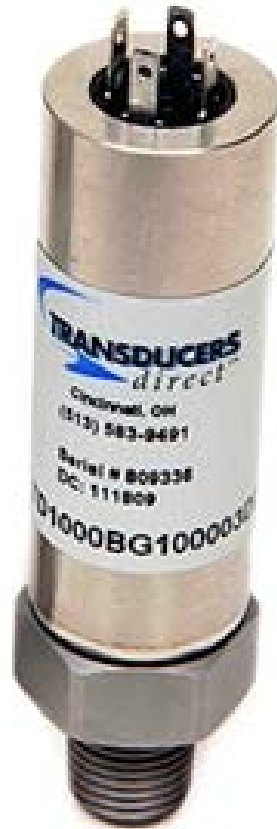
Figure 593 - TD1000

Pressure Transducer, 0-500 psig

Pressure transducers were used on the Release and Pressurizer tanks.

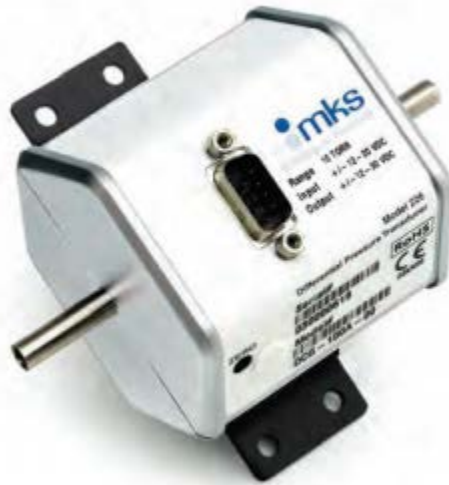
Figure 594 – MKS Model 226A; 100 Torr

The 100 Torr pressure transducer was used to monitor the pressure difference between the test room and equipment room.

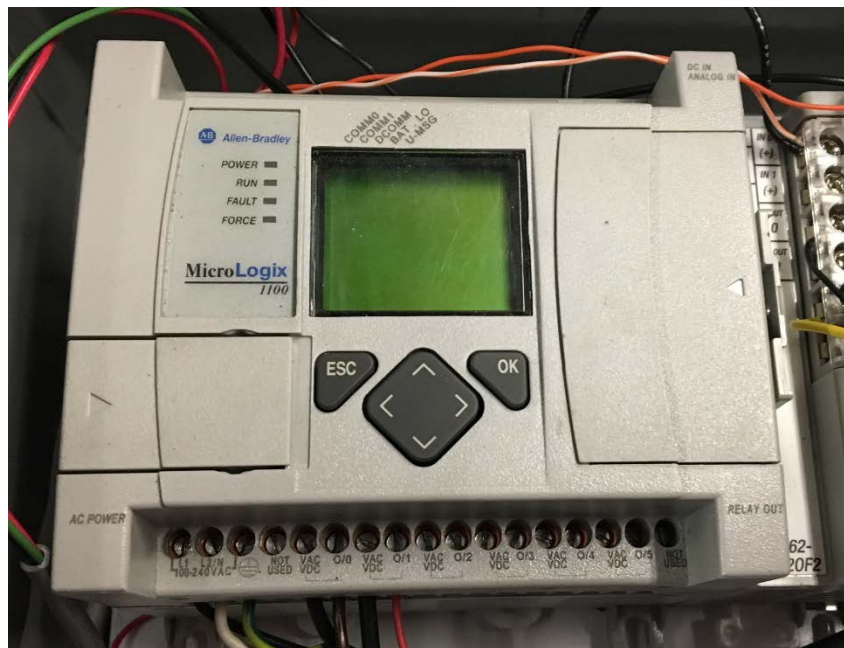
Figure 596 – Mass Flow System Programmable Logic Controller (PLC)

The PLC was programmed with controls to start, stop, measure, totalize the propane flow. The PLC output a calibrated flow signal to the data acquisition system.

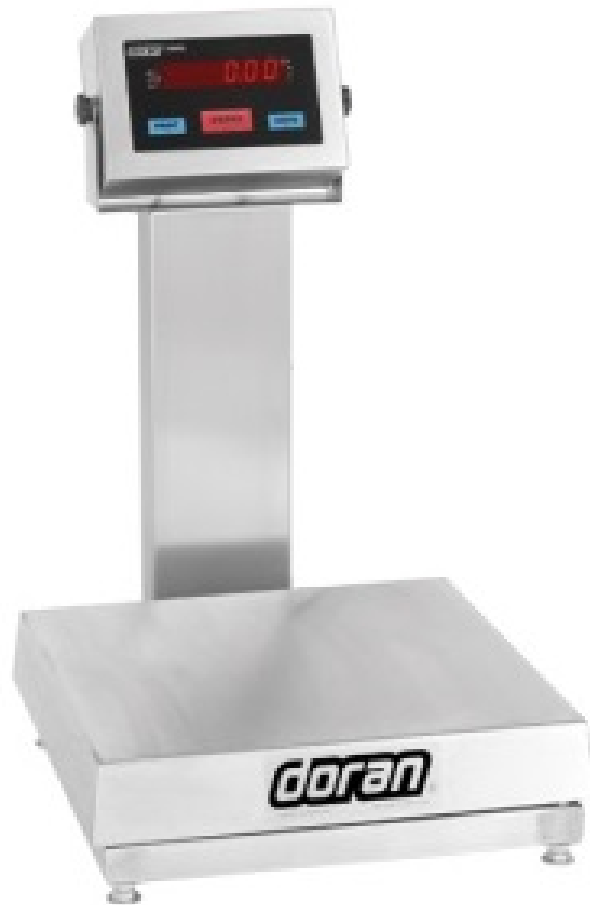
Figure 597 - SCL\7000xl

Scale, 0-500 lbs

The 7000xl scale was used to record release and pressurizer tank weights before and after filling and also after release weight.

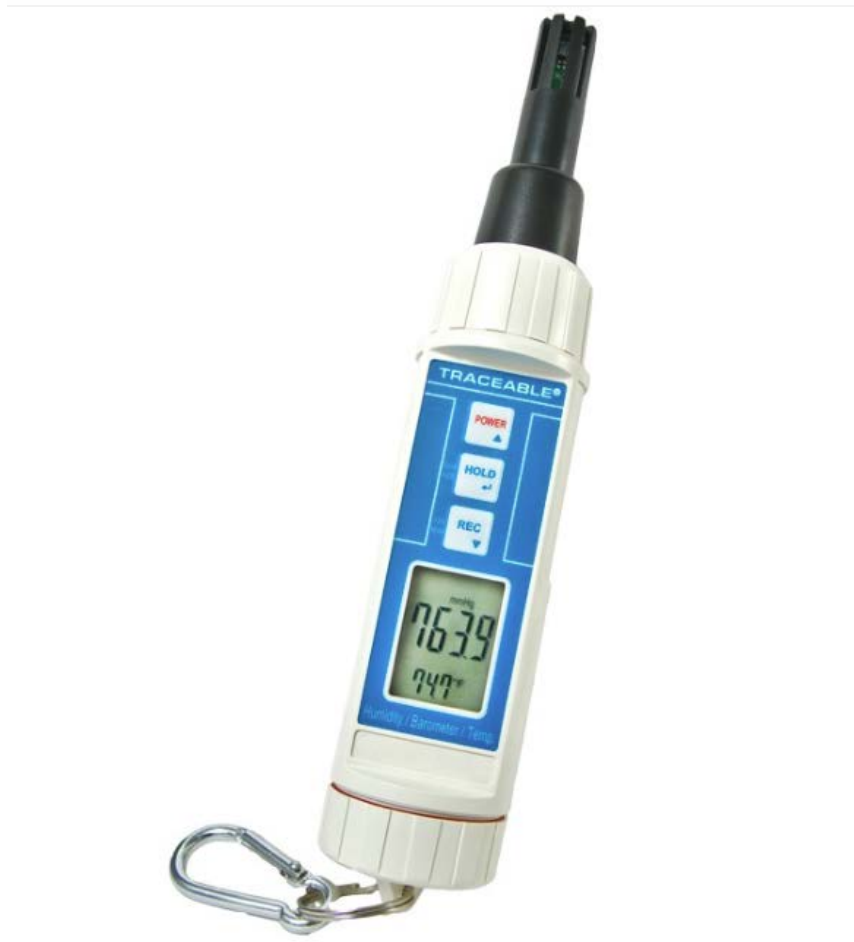
Figure 598 – Traceable Model 4247

Temp/Hum/Pres probe

Handheld temperature humidity probe used to determine humidity and barometric pressure at the beginning of each test.
