AHRI Report No. 8014

EFFECTS OF LOW RETURN AIR TEMPERATURE ON GAS FIRED FORCED AIR FURNACES

April 2017

GAS CONSULTANTS, INC.
Walton Hills, Ohio

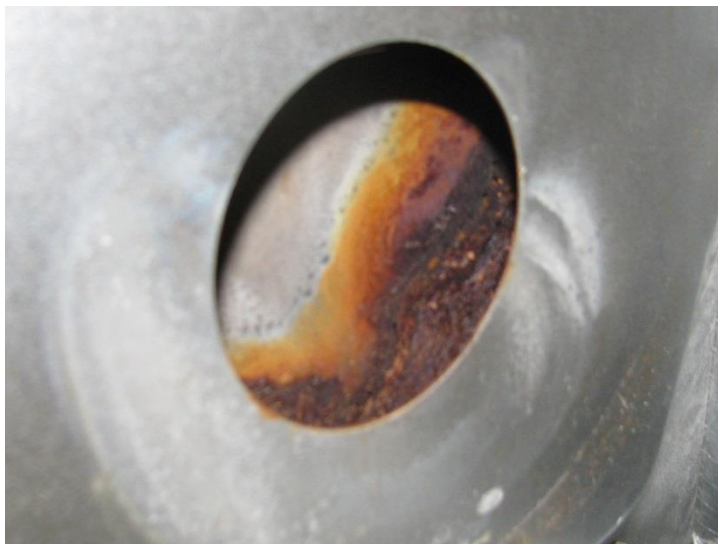
Photo A33

**View Through Collector
Box Cover Into Collector
Box**
