**COMPATIBILITY OF REFRIGERANTS AND LUBRICANTS WITH  
MOTOR MATERIALS**

Photographs of Motor Materials after Exposure to Refrigerants  
and Refrigerant-Lubricants  
Volume IV

Robert Doerr and Stephen Kujak

Prepared for  
The Air-Conditioning and Refrigeration Technology Institute  
Under  
ARTI MCLR Project Number 650-50400

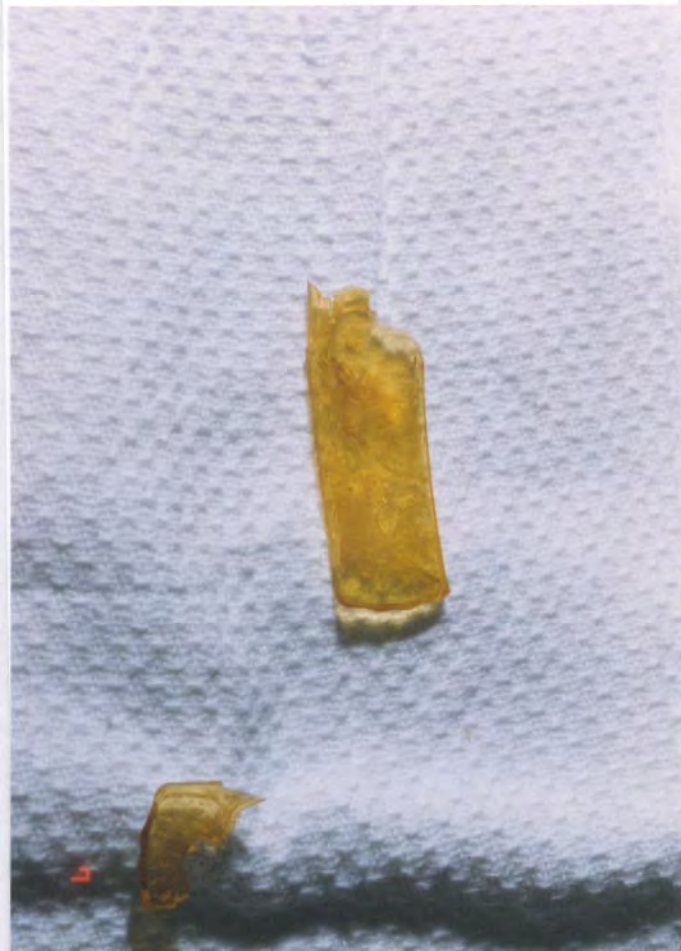
**Photograph #1 (above)**  
**Photograph #2 (below)**

<b><u>Photo #</u></b>	<b><u>Description</u></b>
1	Y-833 varnish disks after exposure 500 hour exposure to R-22. The Y-883 varnish is crazed.
2	Sheet insulations(top to bottom) Mylar, Dacron/Mylar/Dacron and Nomex/Mylar/Nomex after 500 hour exposure to R-22.
3	Helical Coils after exposure to R-22 and after bond strength testing.
4	Sheet insulations(top to bottom) Melinex, Nomex Mica and Nomex after 500 hour exposure to R-22.
5	Tie Cord after 500 hour exposure to R-22 and after break load testing.
6	Lead Wires after 500 hour exposure to R-22 and after dielectric testing.
7	Tapes(top to bottom) Glass, Polyester and Permacel after 500 hour exposure to R-22
8	Sleeving(top to bottom) Nomex/Mylar, Mylar and Nomex after 500 hour exposure to R-22.
9	Varnish Disks(top to bottom) Iso-800, 923, Y-833, ER-610, Y-390 and U-475 after 500 hour exposure to R-22.
10	Sheet Insulation(top to bottom)Melinex, Nomex-Mica, Nomex, Mylar, Dacron/Mylar/Dacron and Nomex/Mylar/Nomex after 500 hour exposure to R-22 plus the 24 hour air bake at 302°F.

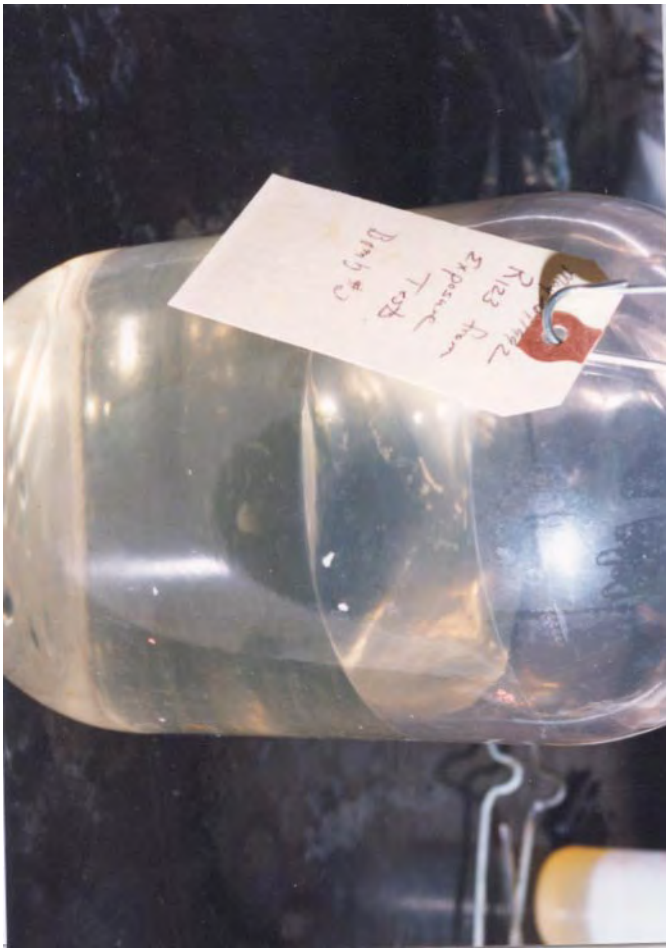
Photograph #1(above)  
Photograph #2(below)

<b><u>Photo #</u></b>	<b><u>Description</u></b>
1	R-123 liquid after exposure to the motor materials.
2	Sheet Insulations, tapes and tie cord after 500 hour exposure to the R-123.
3	Varnish disks, lead wires and sleeving after 500 hour exposure to the R-123.
4	Varnish disks after 500 hour exposure plus the 24 hour air bake.
5	Nomex/Mylar/Nomex and Dacron/Mylar/Dacron sheet insulation after 500 hour exposure plus the 24 hour air bake.
6	Sheet Insulation(top to bottom)Melinex, Nomex-Mica, Nomex, Mylar, Dacron/Mylar/Dacron and Nomex/Mylar/Nomex after 500 hour exposure to R-123 plus the 24 hour air bake at 302°F.
7	Sleeving(top to bottom) Nomex/Mylar, Mylar and Nomex after 500 hour exposure to R-123 plus a 24 hour air at 302°F
8	Tapes(top to bottom) Glass, Polyester and Permacel after 500 hour exposure to R-123 plus the 24 hour air bake.
9	Lead Wires after 500 hour exposure to R-123 plus the 24 hour air bake at 302°F and after dielectric testing.

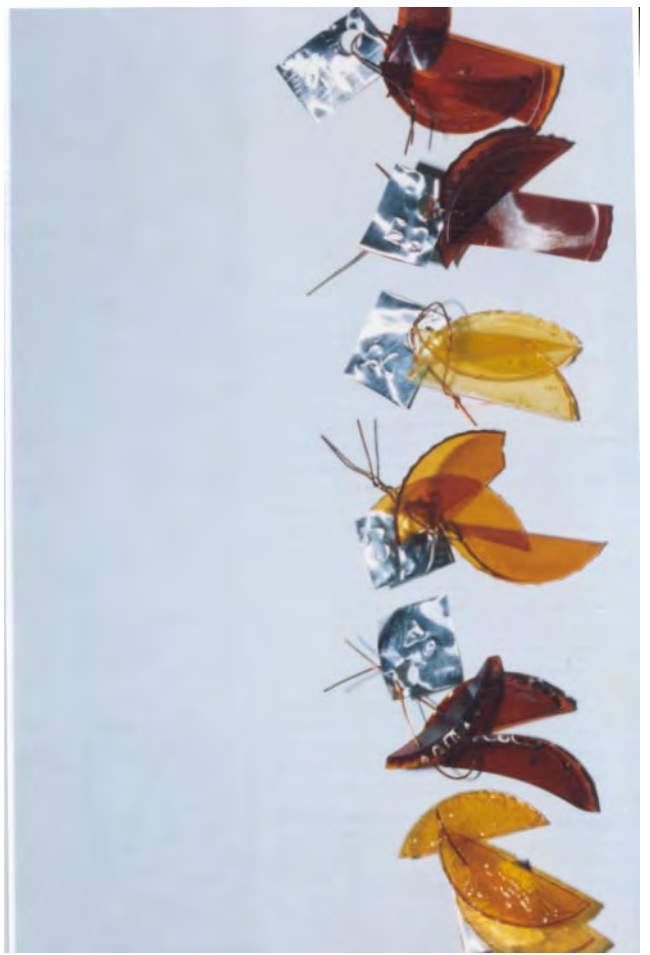
Photograph #11(above)  
Photograph #12(below)

11	Varnish Disks(top to bottom) Iso-800, 923, Y-833, ER-610, Y-390 and U-475 after 500 hour exposure to R-124 plus the 24 hour air bake.
12	Sleeving(top to bottom) Nomex/Mylar, Mylar and Nomex after 500 hour exposure to R-124 plus the 24 hour air bake.
13	Tapes(top to bottom) Glass, Polyester and Permacel after 500 hour exposure to R-124 plus the 24 hour air bake.
14	Lead Wires after 500 hour exposure to R-124 plus the 24 hour air bake.

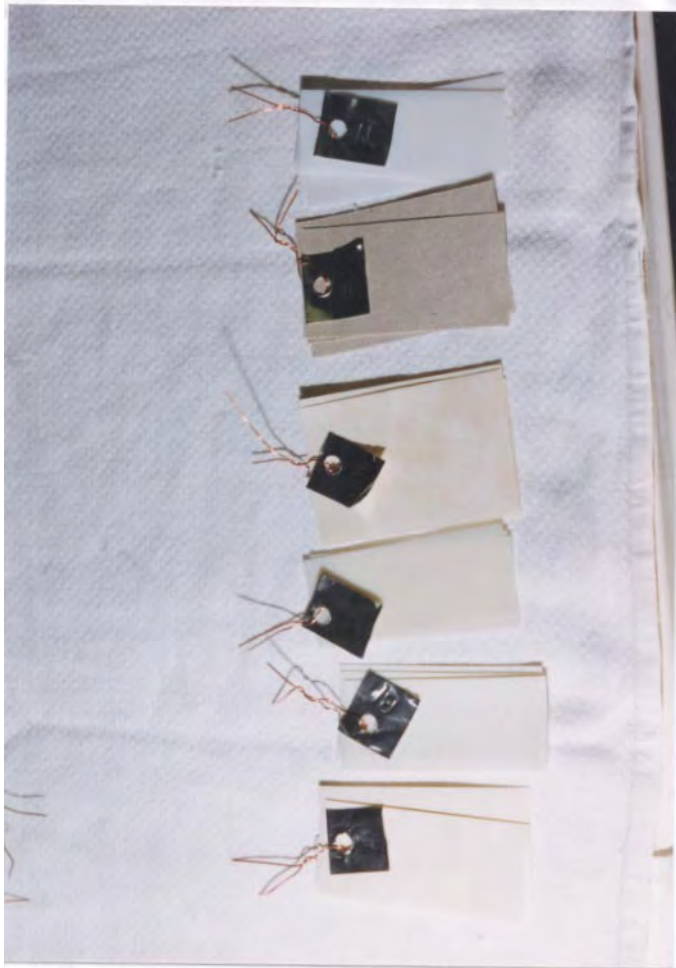
**Photograph #1 (above)**  
**Photograph #2 (below)**

<u>Photo #</u>	<u>Description</u>
1	Sheet Insulation(top to bottom)Melinex, Nomex-Mica, Nomex, Mylar, Dacron/Mylar/Dacron and Nomex/Mylar/Nomex after 500 hour exposure to R-152a.
2	Tie cords after 500 hour exposure to R-152a.
3	Sleeving(top to bottom) Nomex/Mylar, Mylar and Nomex after 500 hour exposure to R-152a.
4	Tapes(top to bottom) Glass, Polyester and Permacel after 500 hour exposure to R-152a.
5	Lead Wires after 500 hour exposure to R-152a.
6	Sheet Insulation(top to bottom)Melinex, Nomex-Mica, Nomex, Dacron/Mylar/Dacron, Nomex/Mylar/Nomex after 500 hour exposure to R-152a plus a 24 hour air bake.
7	Varnish Disks(top to bottom) Iso-800, 923, Y-833, ER-610, Y-390 and U-475 after 500 hour exposure to R-152a.
8	Varnish Disks(top to bottom) Iso-800, 923, Y-833, ER-610, Y-390 and U-475 after 500 hour exposure to R-152a plus the 24 hour air bake.
9	Tested Tie cords after 500 hour exposure to R-152a plus the 24 hour air bake.

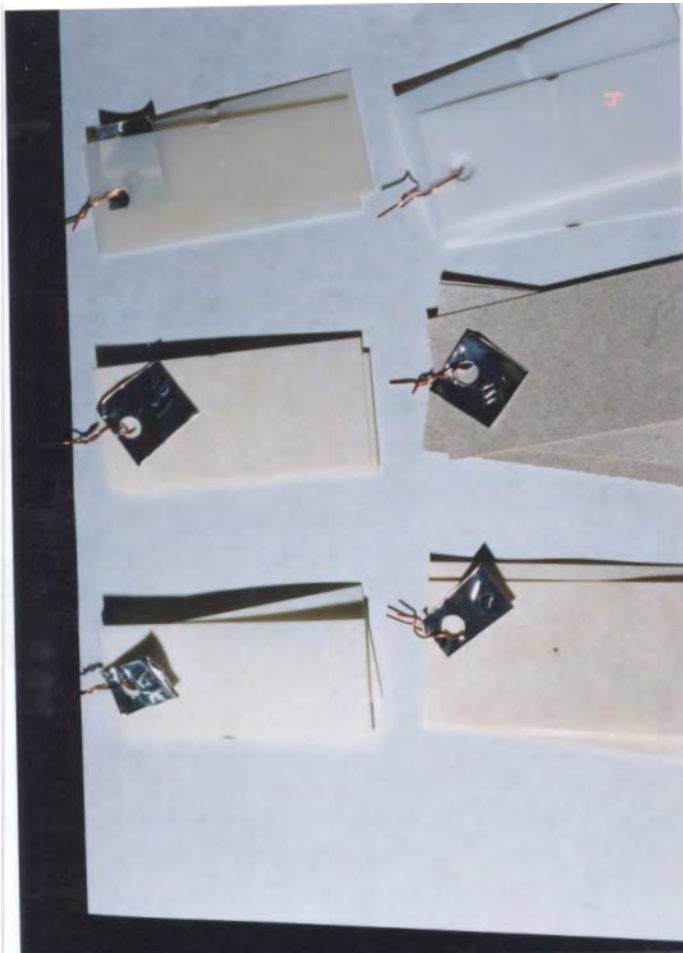
**Photograph #1(above)**  
**Photograph #2(below)**

<u>Photo #</u>	<u>Description</u>
1	Sheet Insulation(top to bottom-Right) Melinex, Nomex-Mica, Nomex,(top to bottom-left) Mylar, Dacron/Mylar/Dacron and Nomex/Mylar/Nomex after 500 hour exposure to R-134a.
2	Tie cords after 500 hour exposure to R-134a.
3	Sleeving(top to bottom) Nomex/Mylar, Mylar and Nomex after 500 hour exposure to R-134a.
4	Tapes(top to bottom) Glass, Polyester and Permacel after 500 hour exposure to R-134a.
5	Lead Wires after 500 hour exposure to R-134a.
6	Sheet Insulation(top to bottom)Melinex, Nomex-Mica, Nomex, Dacron/Mylar/Dacron, Nomex/Mylar/Nomex after 500 hour exposure to R-134a plus a 24 hour air bake.
7	Varnish Disks(top to bottom-right) Iso-800, 923, Y-833,(top to bottom-left) ER-610, Y-390 and U-475 after 500 hour exposure to R-134a.
8	Varnish Disks(top to bottom-right) Iso-800, 923, Y-833,(top to bottom-left)ER-610, Y-390 and U-475 after 500 hour exposure to R-134a plus the 24 hour air bake.

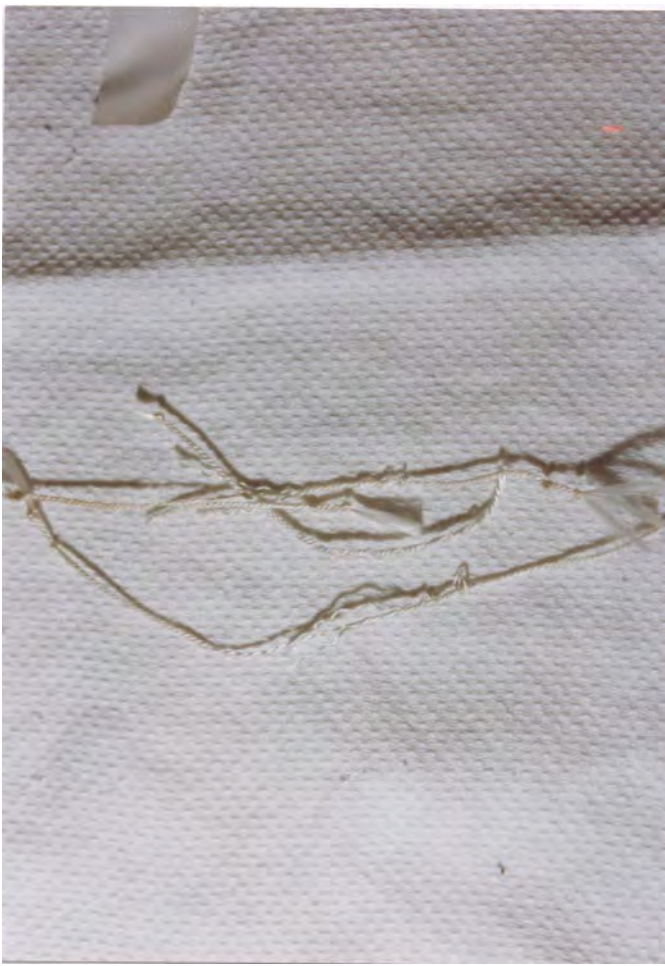
**Photograph #9(above)**  
**Photograph #10(below)**

9	Tested Tie cords after 500 hour exposure to R-134a plus the 24 hour air bake.
10	Sleeving(top to bottom) Nomex/Mylar, Mylar and Nomex after 500 hour exposure to R-134a plus the 24 hour air bake.
11	Tapes(top to bottom) Glass, Polyester and Permacel after 500 hour exposure to R-134a plus the 24 hour air bake.
12	Lead Wires after 500 hour exposure to R-134a plus the 24 hour air bake.

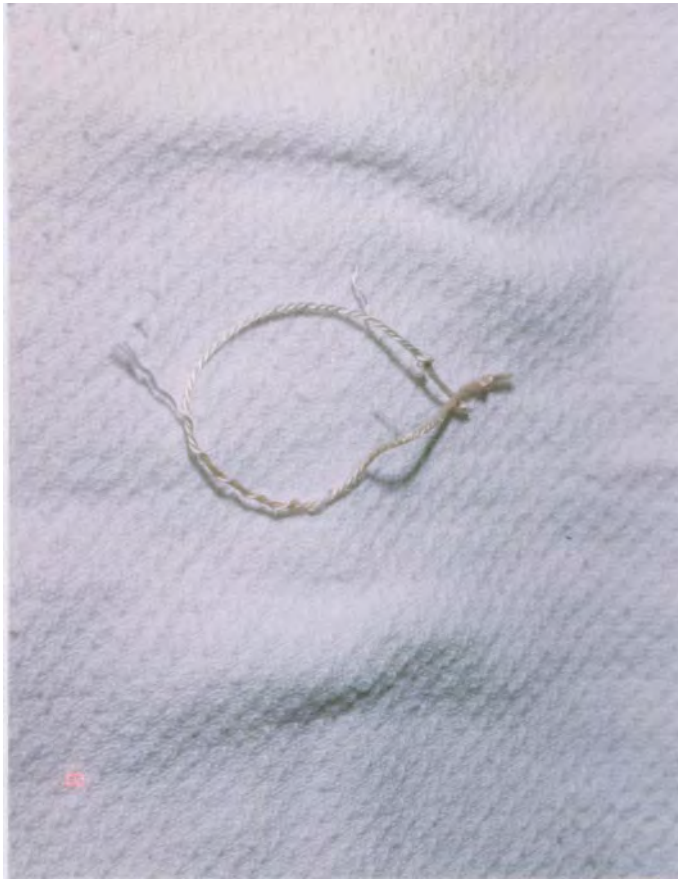
**Photograph #9(above)**  
**Photograph #10(below)**

<b><u>Photo #</u></b>	<b><u>Description</u></b>
1	Sheet Insulation(top to bottom)Melinex, Nomex-Mica, Nomex, Mylar, Dacron/Mylar/Dacron and Nomex/Mylar/Nomex after 500 hour exposure to R-134.
2	Tie cords after 500 hour exposure to R-134.
3	Sleeving(top to bottom) Nomex/Mylar, Mylar and Nomex after 500 hour exposure to R-134.
4	Tapes(top to bottom) Glass, Polyester and Permacel after 500 hour exposure to R-134.
5	Lead Wires after 500 hour exposure to R-134.
6	Sheet Insulation(top to bottom)Melinex, Nomex-Mica, Nomex, Dacron/Mylar/Dacron, Nomex/Mylar/Nomex after 500 hour exposure to R-134 plus the 24 hour air bake.
7	Varnish Disks(top to bottom) Iso-800, 923, Y-833, ER-610, Y-390 and U-475 after 500 hour exposure to R-134.
8	Varnish Disks(top to bottom) Iso-800, 923, Y-833, ER-610, Y-390 and U-475 after 500 hour exposure to R-134 plus the 24 hour air bake.
9	Tested Tie cords after 500 hour exposure to R-134 plus the 24 hour air bake.

10	Sleeving(top to bottom) Nomex/Mylar, Mylar and Nomex after 500 hour exposure to R-134 plus the 24 hour air bake.
11	Tapes(top to bottom) Glass, Polyester and Permacel after 500 hour exposure to R-134 plus the 24 hour air bake.
12	Lead Wires after 500 hour exposure to R-134 plus the 24 hour air bake.

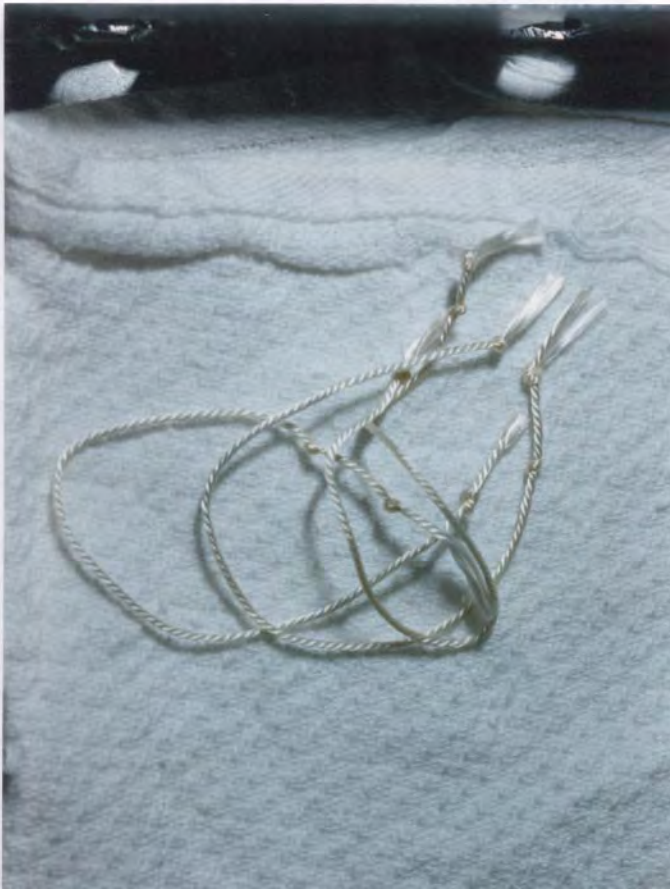
**Photograph #9(above)**  
**Photograph #10(below)**

<b><u>Photo #</u></b>	<b><u>Description</u></b>
1	Sheet Insulation(top to bottom)Melinex, Nomex-Mica, Nomex, Mylar, Dacron/Mylar/Dacron and Nomex/Mylar/Nomex after 500 hour exposure to R-32.
2	Tie cords after 500 hour exposure to R-32.
3	Sleeving(top to bottom) Nomex/Mylar, Mylar and Nomex after 500 hour exposure to R-32.
4	Tapes(top to bottom) Glass, Polyester and Permacel after 500 hour exposure to R-32.
5	Lead Wires after 500 hour exposure to R-32.
6	Sheet Insulation(top to bottom)Melinex, Nomex-Mica, Nomex, Dacron/Mylar/Dacron, Nomex/Mylar/Nomex after 500 hour exposure to R-32 plus a 24 hour air bake.
7	Varnish Disks(top to bottom-right) Iso-800, 923, Y-833,(top to bottom-left) ER-610, Y-390 and U-475 after 500 hour exposure to R-32.
8	Varnish Disks(top to bottom-right) Iso-800, 923, Y-833,(top to bottom-left)ER-610, Y-390 and U-475 after 500 hour exposure to R-32 plus the 24 hour air bake.
9	Tested Tie cords after 500 hour exposure to R-32 plus the 24 hour air bake.

10	Sleeving(top to bottom) Nomex/Mylar, Mylar and Nomex after 500 hour exposure to R-32 plus the 24 hour air bake.
11	Tapes(top to bottom) Glass, Polyester and Permacel after 500 hour exposure to R-32 plus the 24 hour air bake.
12	Lead Wires after 500 hour exposure to R-32 plus the 24 hour air bake.

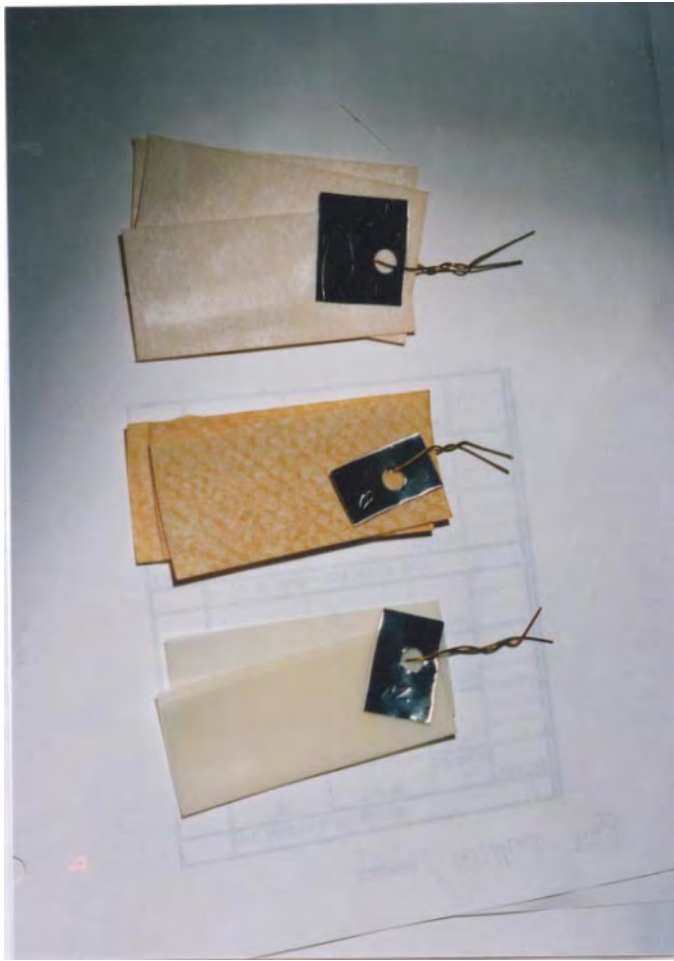
**Photograph #1(above)**  
**Photograph #2(below)**

<b><u>Photo #</u></b>	<b><u>Description</u></b>
1	Sheet Insulation(top to bottom) Mylar, Dacron/Mylar/Dacron and Nomex/Mylar/Nomex after 500 hour exposure to R-245ca
2	Tie cords after 500 hour exposure to R-245ca.
3	Sleeving(top to bottom) Nomex/Mylar, Mylar and Nomex after 500 hour exposure to R-245ca.
4	Tapes(top to bottom) Glass, Polyester and Permacel after 500 hour exposure to R-245ca.
5	Sheet Insulation(top to bottom)Melinex, Nomex-Mica, Nomex, after 500 hour exposure to R-245ca.
6	Sheet Insulation(top to bottom), Dacron/Mylar/Dacron, Nomex/Mylar/Nomex after 500 hour exposure to R-245ca plus a 24 hour air bake.
7	Sheet Insulation(top to bottom)Melinex, Nomex-Mica, Nomex, after 500 hour exposure to R-245ca plus a 24 hour air bake.
8	Tie cords after 500 hour exposure to R-245ca plus the 24 hour air bake.
9	Sleeving(top to bottom) Nomex/Mylar, Nomex and Mylar after 500 hour exposure to R-245ca plus the 24 hour air bake.

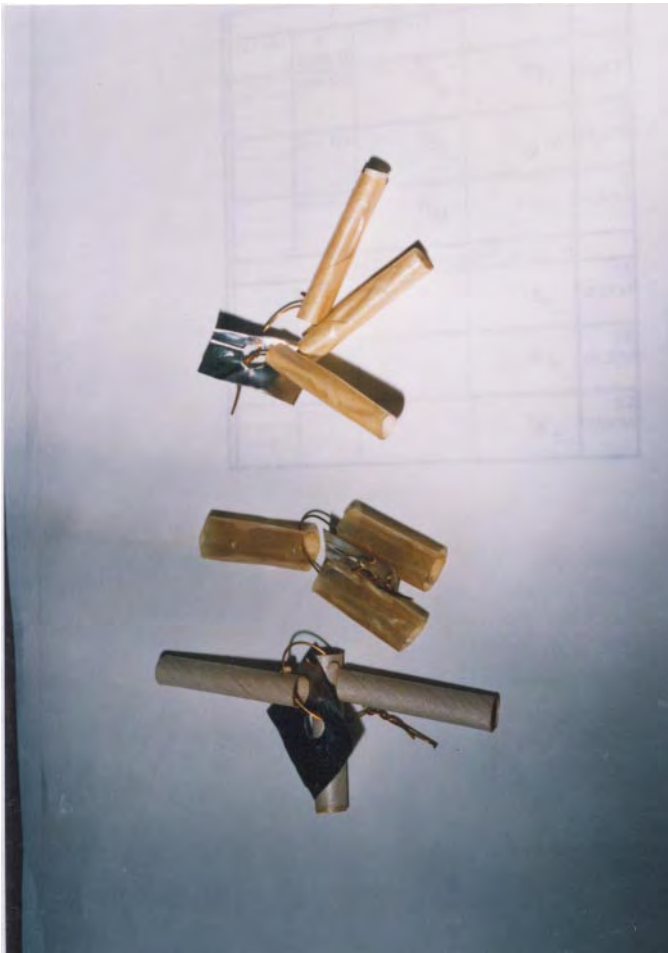
**Photograph #9(above)**  
**Photograph #10(below)**

10	Tapes(top to bottom) Glass, Polyester and Permacel after 500 hour exposure to R-245ca plus the 24 hour air bake.

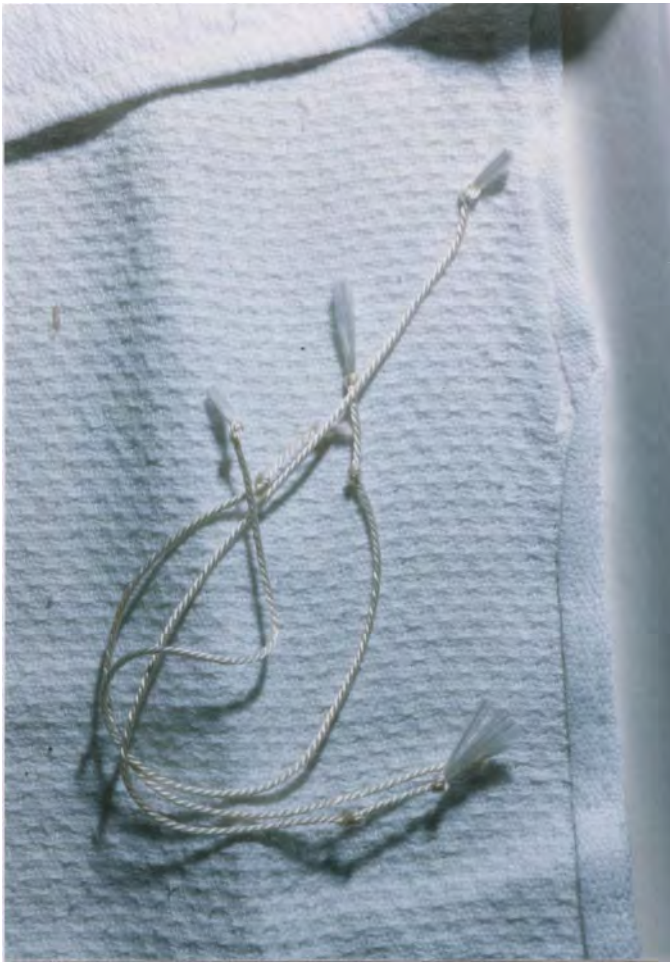
**Photograph #9(above)**  
**Photograph #10(below)**

<u>Photo #</u>	<u>Description</u>
1	Sheet Insulation(top to bottom)Melinex, Nomex-Mica, Nomex, Mylar, Dacron/Mylar/Dacron and Nomex/Mylar/Nomex after 500 hour exposure to Nitrogen.
2	Tie cords after 500 hour exposure to Nitrogen.
3	Sleeving(top to bottom) Nomex/Mylar, Mylar and Nomex after 500 hour exposure to Nitrogen.
4	Tapes(top to bottom) Glass, Polyester and Permacel after 500 hour exposure to Nitrogen.
5	Lead Wires after 500 hour exposure to Nitrogen.
6	Sheet Insulation(top to bottom)Melinex, Nomex-Mica, Nomex, Dacron/Mylar/Dacron, Nomex/Mylar/Nomex after 500 hour exposure to Nitrogen a plus a 24 hour air bake.
7	Varnish Disks(top to bottom) Iso-800, 923, Y-833, ER-610, Y-390 and U-475 after 500 hour exposure to Nitrogen.
8	Varnish Disks(top to bottom) Iso-800, 923, Y-833, ER-610, Y-390 and U-475 after 500 hour exposure to Nitrogen plus the 24 hour air bake.
9	Tie cords after 500 hour exposure to Nitrogen plus the 24 hour air bake.

10	Sleeving(top to bottom) Nomex/Mylar, Nomex and Mylar after 500 hour exposure to Nitrogen plus the 24 hour air bake.
11	Tapes(top to bottom) Glass, Polyester and Permacel after 500 hour exposure to Nitrogen plus the 24 hour air bake.
12	Lead Wires after 500 hour exposure to Nitrogen plus the 24 hour air bake.

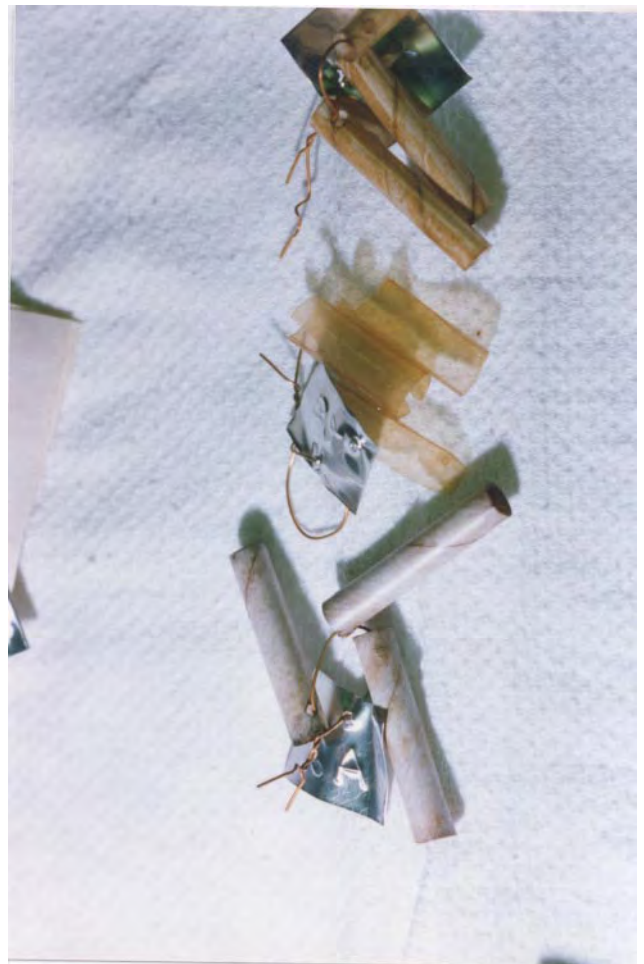
**Photograph #1(above)**  
**Photograph #2(below)**

<b><u>Photo #</u></b>	<b><u>Description</u></b>
1	Sheet Insulation(top to bottom-Right)Melinex, Nomex-Mica, Nomex,(top to bottom-left) Mylar, Dacron/Mylar/Dacron and Nomex/Mylar/Nomex after 500 hour exposure to Nitrogen.
2	Tie cords after 500 hour exposure to Nitrogen
3	Sleeving(top to bottom) Nomex/Mylar, Mylar and Nomex after 500 hour exposure to Nitrogen.
4	Tapes(top to bottom) Glass, Polyester and Permacel after 500 hour exposure to Nitrogen.
5	Lead Wires after 500 hour exposure to Nitrogen.
6	Sheet Insulation(top to bottom)Melinex, Nomex-Mica, Nomex, Dacron/Mylar/Dacron, Nomex/Mylar/Nomex after 500 hour exposure to Nitrogen plus a 24 hour air bake.
7	Varnish Disks(top to bottom-right) Iso-800, 923, Y-833,(top to bottom-left) ER-610, Y-390 and U-475 after 500 hour exposure to Nitrogen.

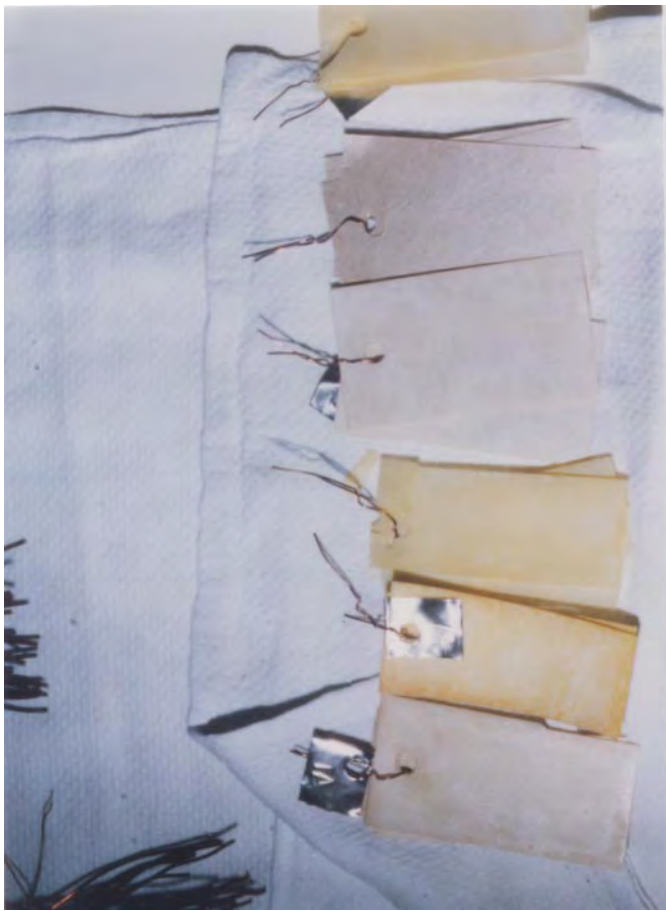
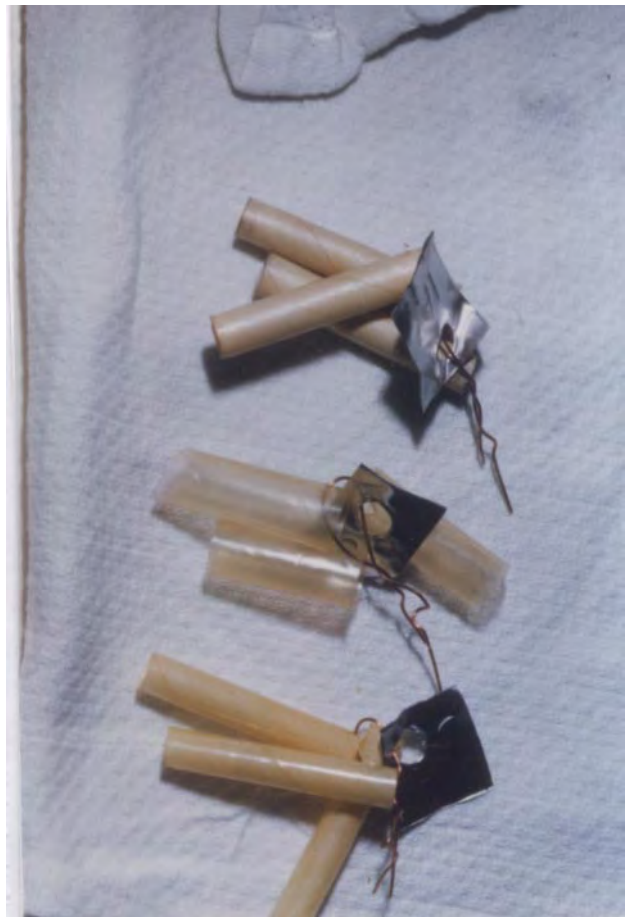
**Photograph #1 (above)**  
**Photograph #2 (below)**

<b><u>Photo #</u></b>	<b><u>Description</u></b>
1	Sheet Insulation(top to bottom)Melinex, Nomex-Mica, Nomex, Dacron/Mylar/Dacron, Nomex/Mylar/Nomex after 500 hour exposure to refrigerant/lubricant
2	Tie cords after 500 hour exposure to refrigerant/lubricant
3	Sleeving(top to bottom) Nomex/Mylar, Mylar and Nomex after 500 hour exposure to refrigerant/lubricant.
4	Tapes(top to bottom) Glass, Polyester and Permacel after 500 hour exposure to refrigerant/lubricant.
5	Sheet Insulation(top to bottom)Melinex, Nomex-Mica, and Nomex after 500 hour exposure to refrigerant-lubricant plus a 24 hour air bake.
6	Sheet Insulation(top to bottom) Dacron/Mylar/Dacron, Nomex/Mylar/Nomex after 500 hour exposure to refrigerant/lubricant plus a 24 hour air bake.
7	Varnish Disks(top to bottom-right) Iso-800, 923, Y-833,(top to bottom-left) ER-610, Y-390 and U-475 after 500 hour exposure to refrigerant/lubricant.
8	Varnish Disks(top to bottom-right) Iso-800, 923, Y-833,(top to bottom-left) ER-610, Y-390 and U-475 after 500 hour exposure to refrigerant/lubricant plus the 24 hour air bake.

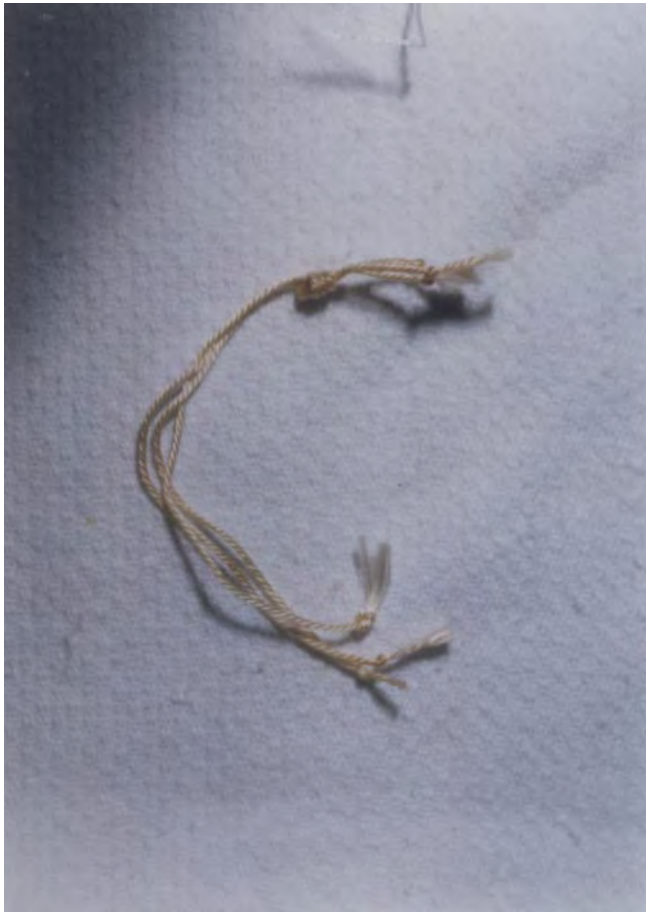
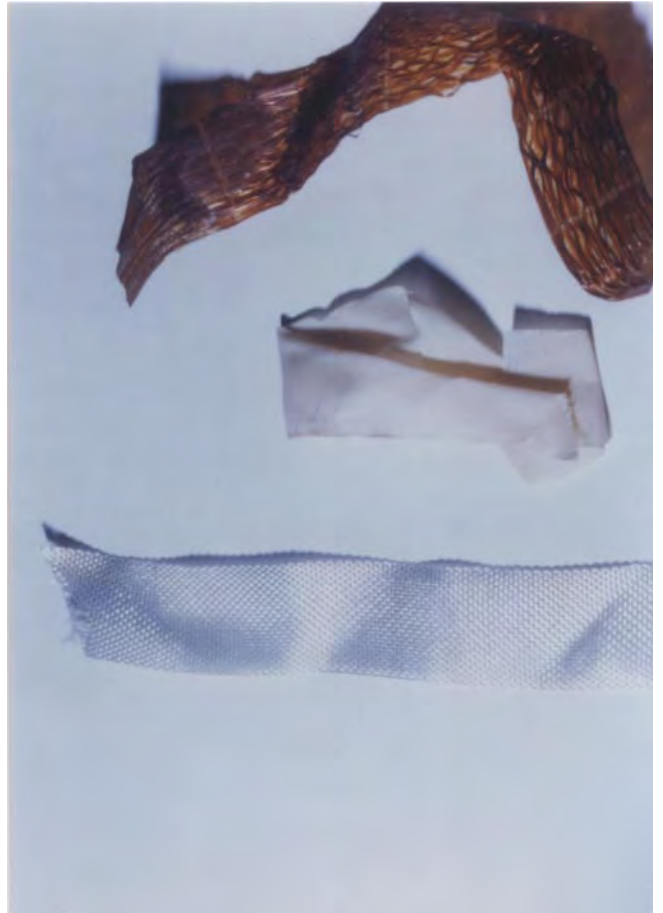
**Photograph #9(above)**  
**Photograph #10(below)**

9	Tie cords after 500 hour exposure to refrigerant-lubricant plus the 24 hour air bake.
10	Sleeving(top to bottom) Nomex/Mylar, Mylar and Nomex after 500 hour exposure to refrigerant-lubricant plus the 24 hour air bake.
11	Tapes(top to bottom) Glass, Polyester and Permacel after 500 hour exposure to refrigerant-lubricant plus the 24 hour air bake.
12	Lead Wires after 500 hour exposure to refrigerant-lubricant plus the 24 hour air bake.

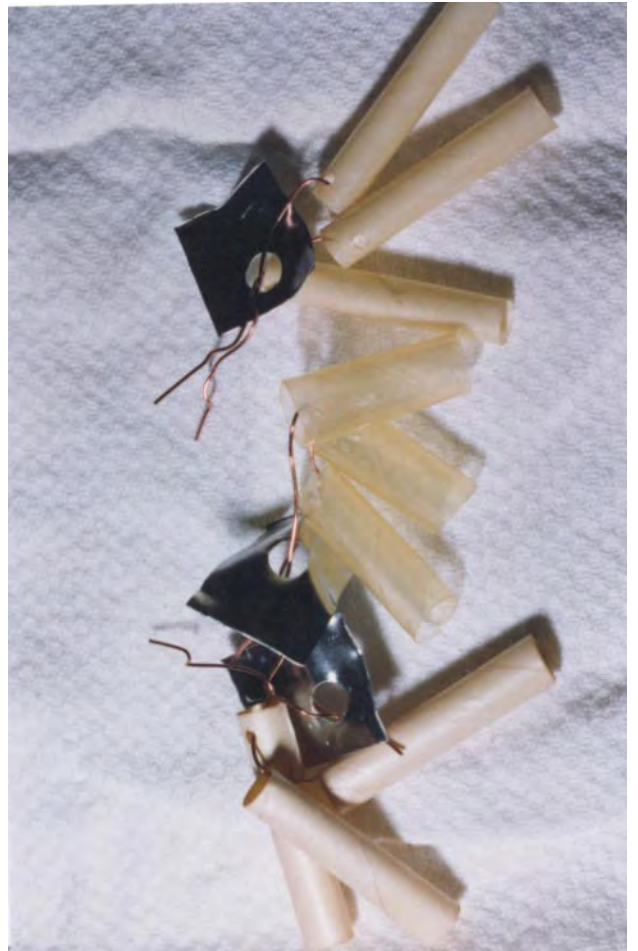
**Photograph #1(above)**  
**Photograph #2(below)**

<b><u>Photo #</u></b>	<b><u>Description</u></b>
1	Sheet Insulation(top to bottom)Melinex, Nomex-Mica, Nomex, after 500 hour exposure to refrigerant/lubricant
2	Tie cords after 500 hour exposure to refrigerant/lubricant
3	Sleeving(top to bottom) Nomex/Mylar, Mylar and Nomex after 500 hour exposure to refrigerant/lubricant.
4	Tapes(top to bottom) Glass, Polyester and Permacel after 500 hour exposure to refrigerant/lubricant.
5	Sheet Insulation(top to bottom) Mylar, Dacron/Mylar/Dacron, Nomex/Mylar/Nomex after 500 hour exposure to refrigerant lubricant
6	Varnish Disks(top to bottom-right) Iso-800, 923, Y-833,(top to bottom-left) ER-610, Y-390 and U-475 after 500 hour exposure to refrigerant/lubricant.
7	Lead wire after 500 hour exposure to refrigerant/lubricant.
8	Varnish Disks(top to bottom) Iso-800, 923, Y-833, after 500 hour exposure to refrigerant/lubricant plus the 24 hour air bake.
9	Varnish Disks(top to bottom) ER-610, Y-390, U-475, after 500 hour exposure to refrigerant/lubricant plus the 24 hour air bake.

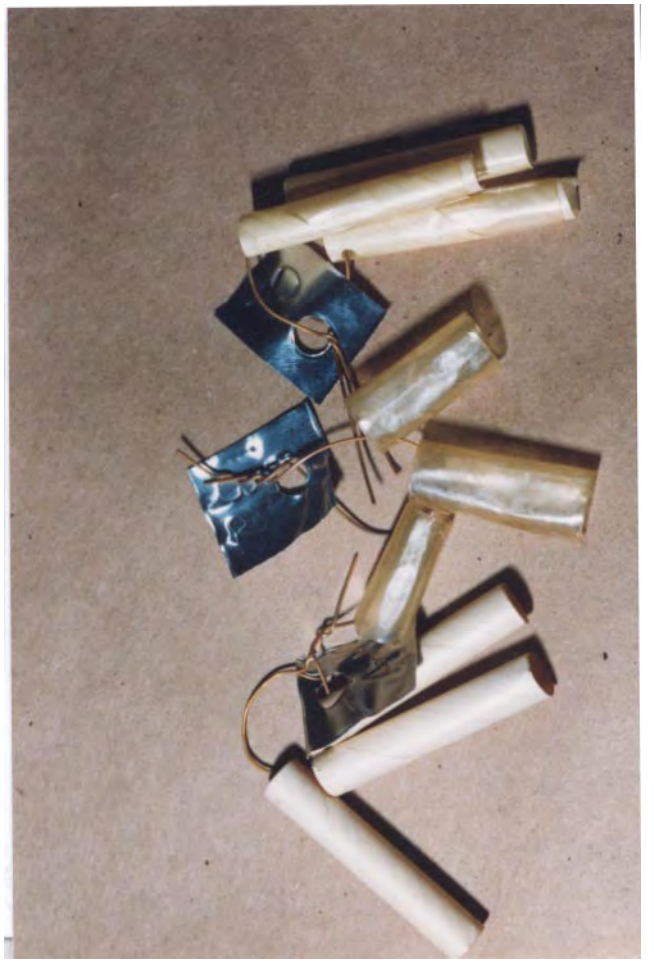
Photograph #9(above)  
Photograph #10(below)

10	Tested Tie Cords after 500 hour exposure to refrigerant lubricant plus the 24 hour air bake.
11	Sleeving(top to bottom) Nomex/Mylar, Mylar and Nomex after 500 hour exposure to refrigerant-lubricant plus the 24 hour air bake.
12	Tapes(top to bottom) Glass, Polyester and Permacel after 500 hour exposure to refrigerant-lubricant plus the 24 hour air bake.
13	Lead Wires after 500 hour exposure to refrigerant-lubricant plus the 24 hour air bake.
14	Sheet Insulation(top to bottom)Melinex, Nomex-Mica, Nomex, after 500 hour exposure to refrigerant/lubricant plus a 24 hour air bake.
15	Sheet Insulation(top to bottom) Mylar, Dacron/Mylar/Dacron, Nomex/Mylar/Nomex after 500 hour exposure to refrigerant lubricant plus a 24 hour air bake.

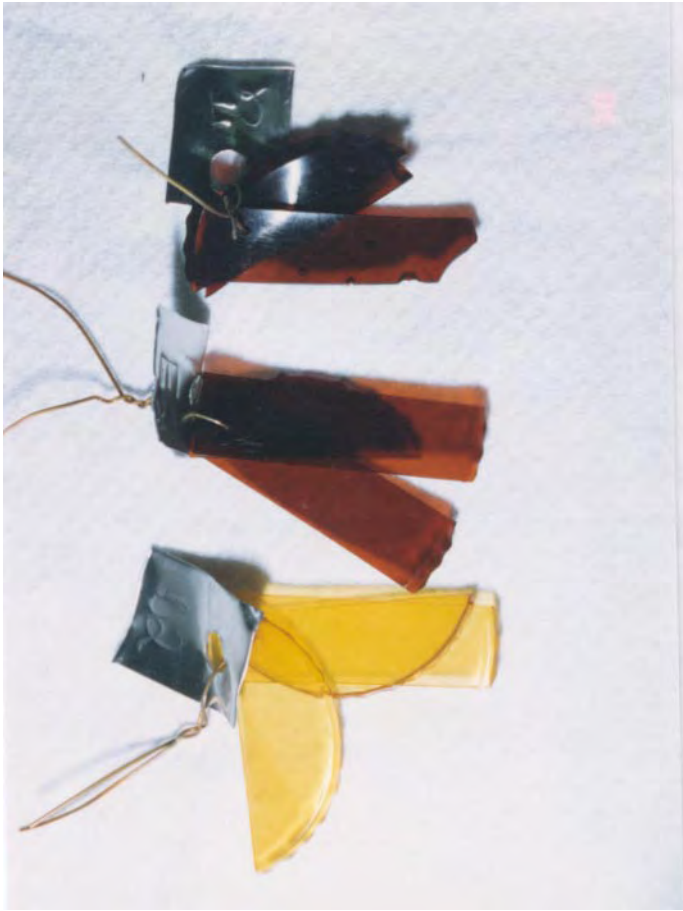
**Photograph #9(above)**  
**Photograph #10(below)**

<u>Photo #</u>	<u>Description</u>
1	Sheet Insulation(top to bottom)Melinex, Nomex-Mica, Nomex, after 500 hour exposure to refrigerant/lubricant
2	Tie cords after 500 hour exposure to refrigerant/lubricant
3	Sleeving(top to bottom) Nomex/Mylar, Mylar and Nomex after 500 hour exposure to refrigerant/lubricant.
4	Tapes(top to bottom) Glass, Polyester and Permacel after 500 hour exposure to refrigerant/lubricant.
5	Sheet Insulation(top to bottom) Mylar, Dacron/Mylar/Dacron, Nomex/Mylar/Nomex after 500 hour exposure to refrigerant lubricant
6	Lead wire after 500 hour exposure to refrigerant/lubricant.
7	Varnish Disks(top to bottom) Iso-800, 923, Y-833, after 500 hour exposure to refrigerant/lubricant.
8	Varnish Disks(top to bottom) ER-610, Y-390, U-475, after 500 hour exposure to refrigerant/lubricant.
9	Varnish Disks(top to bottom) Iso-800, 923, Y-833, after 500 hour exposure to refrigerant/lubricant plus the 24 hour air bake.

10	Varnish Disks(top to bottom) ER-610, Y-390, U-475, after 500 hour exposure to refrigerant/lubricant plus the 24 hour air bake.
11	Tested Tie Cords after 500 hour exposure to refrigerant-lubricant plus the 24 hour air bake.
12	Sleeving(top to bottom) Nomex/Mylar, Mylar and Nomex after 500 hour exposure to refrigerant-lubricant plus the 24 hour air bake.
13	Tapes(top to bottom) Glass, Polyester and Permacel after 500 hour exposure to refrigerant-lubricant plus the 24 hour air bake.
14	Lead Wires after 500 hour exposure to refrigerant-lubricant plus the 24 hour air bake.
15	Sheet Insulation(top to bottom)Melinex, Nomex-Mica, Nomex, after 500 hour exposure to refrigerant/lubricant plus a 24 hour air bake.
16	Sheet Insulation(top to bottom) Mylar, Dacron/Mylar/Dacron, Nomex/Mylar/Nomex after 500 hour exposure to refrigerant-lubricant plus a 24 hour air bake.

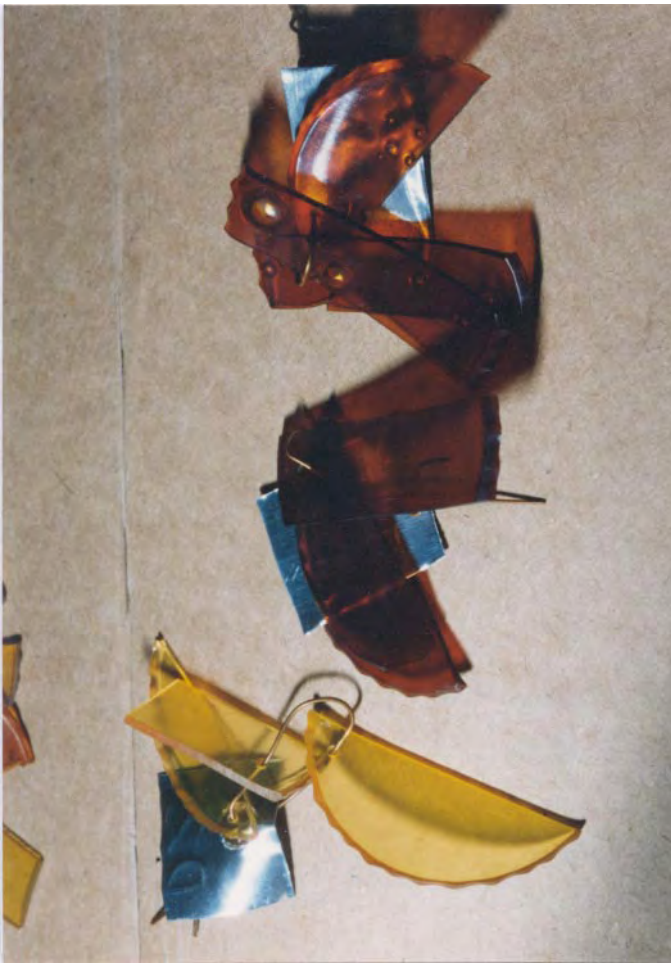
Photograph #9(above)  
Photograph #10(below)

<b><u>Photo #</u></b>	<b><u>Description</u></b>
1	Sheet Insulation(top to bottom)Melinex, Nomex-Mica, Nomex, after 500 hour exposure to refrigerant/lubricant
2	Tie cords after 500 hour exposure to refrigerant/lubricant
3	Sleeving(top to bottom) Nomex/Mylar, Mylar and Nomex after 500 hour exposure to refrigerant/lubricant.
4	Tapes(top to bottom) Glass, Polyester and Permacel after 500 hour exposure to refrigerant/lubricant.
5	Sheet Insulation(top to bottom) Mylar, Dacron/Mylar/Dacron, Nomex/Mylar/Nomex after 500 hour exposure to refrigerant lubricant
6	Lead wire after 500 hour exposure to refrigerant/lubricant.
7	Varnish Disks(top to bottom) Iso-800, 923, Y-833, after 500 hour exposure to refrigerant/lubricant.
8	Varnish Disks(top to bottom) ER-610, Y-390, U-475, after 500 hour exposure to refrigerant/lubricant.
9	Varnish Disks(top to bottom) Iso-800, 923, Y-833, after 500 hour exposure to refrigerant/lubricant plus the 24 hour air bake.

10	Varnish Disks(top to bottom) ER-610, Y-390, U-475, after 500 hour exposure to refrigerant/lubricant plus the 24 hour air bake.
11	Tested Tie Cords after 500 hour exposure to refrigerant lubricant plus the 24 hour air bake.
12	Sleeving(top to bottom) Nomex/Mylar, Mylar and Nomex after 500 hour exposure to refrigerant-lubricant plus the 24 hour air bake.
13	Tapes(top to bottom) Glass, Polyester and Permacel after 500 hour exposure to refrigerant-lubricant plus the 24 hour air bake.
14	Lead Wires after 500 hour exposure to refrigerant-lubricant plus the 24 hour air bake.
15	Sheet Insulation(top to bottom)Melinex, Nomex-Mica, Nomex, after 500 hour exposure to refrigerant/lubricant plus a 24 hour air bake.
16	Sheet Insulation(top to bottom) Mylar, Dacron/Mylar/Dacron, Nomex/Mylar/Nomex after 500 hour exposure to refrigerant lubricant plus a 24 hour air bake.

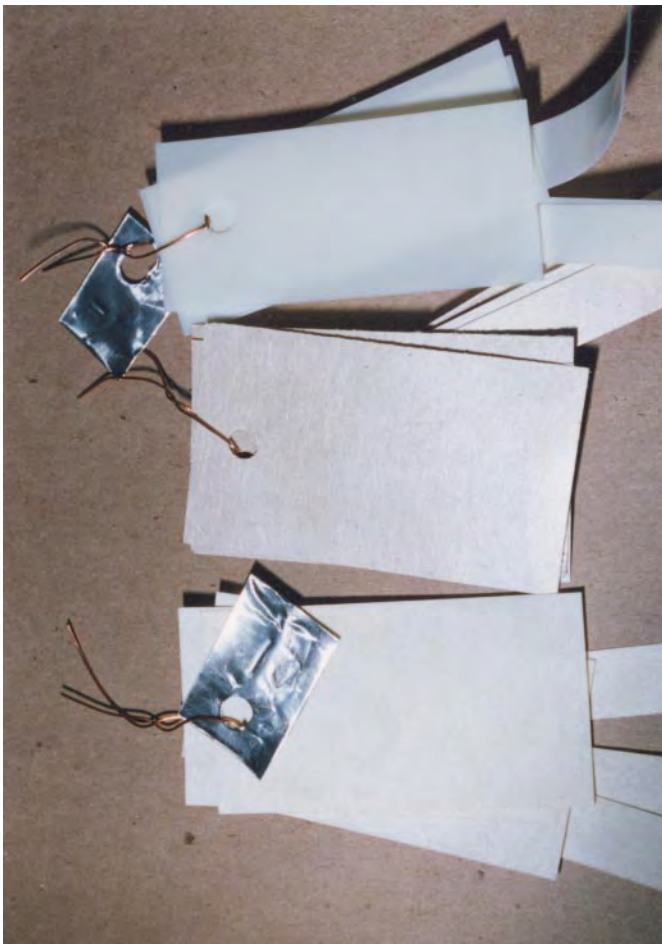
**Photograph #1(above)**  
**Photograph #2(below)**

<b><u>Photo #</u></b>	<b><u>Description</u></b>
1	Sheet Insulation(top to bottom)Melinex, Nomex-Mica, Nomex, after 500 hour exposure to refrigerant/lubricant
2	Tie cords after 500 hour exposure to refrigerant/lubricant
3	Sleeving(top to bottom) Nomex/Mylar, Mylar and Nomex after 500 hour exposure to refrigerant/lubricant.
4	Tapes(top to bottom) Glass, Polyester and Permacel after 500 hour exposure to refrigerant/lubricant.
5	Sheet Insulation(top to bottom) Mylar, Dacron/Mylar/Dacron, Nomex/Mylar/Nomex after 500 hour exposure to refrigerant lubricant
6	Lead wire after 500 hour exposure to refrigerant/lubricant.
7	Varnish Disks(top to bottom) Iso-800, 923, Y-833, after 500 hour exposure to refrigerant/lubricant.
8	Varnish Disks(top to bottom) ER-610, Y-390, U-475, after 500 hour exposure to refrigerant/lubricant.
9	Varnish Disks(top to bottom) Iso-800, 923, Y-833, after 500 hour exposure to refrigerant/lubricant plus the 24 hour air bake.

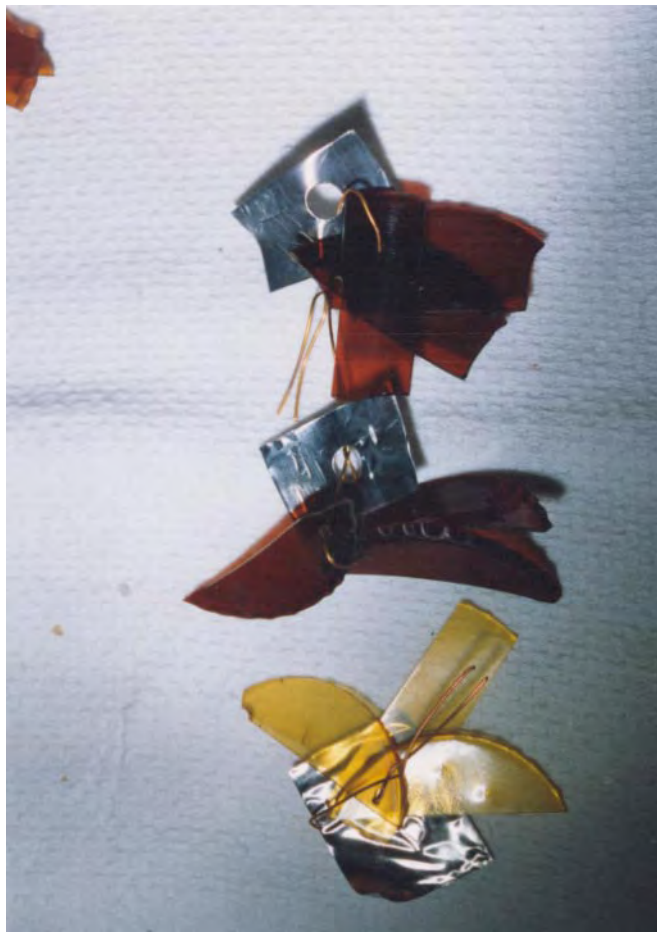
**Photograph #9(above)**  
**Photograph #10(below)**

10	Varnish Disks(top to bottom) ER-610, Y-390, U-475, after 500 hour exposure to refrigerant/lubricant plus the 24 hour air bake.
11	Tested Tie Cords after 500 hour exposure to refrigerant-lubricant plus the 24 hour air bake.
12	Sleeving(top to bottom) Nomex/Mylar, Mylar and Nomex after 500 hour exposure to refrigerant-lubricant plus the 24 hour air bake.
13	Tapes(top to bottom) Glass, Polyester and Permacel after 500 hour exposure to refrigerant-lubricant plus the 24 hour air bake.
14	Lead Wires after 500 hour exposure to refrigerant-lubricant plus the 24 hour air bake.
15	Sheet Insulation(top to bottom)Melinex, Nomex-Mica, Nomex, after 500 hour exposure to refrigerant/lubricant plus a 24 hour air bake.
16	Sheet Insulation(top to bottom) Mylar, Dacron/Mylar/Dacron, Nomex/Mylar/Nomex after 500 hour exposure to refrigerant-lubricant plus a 24 hour air bake.

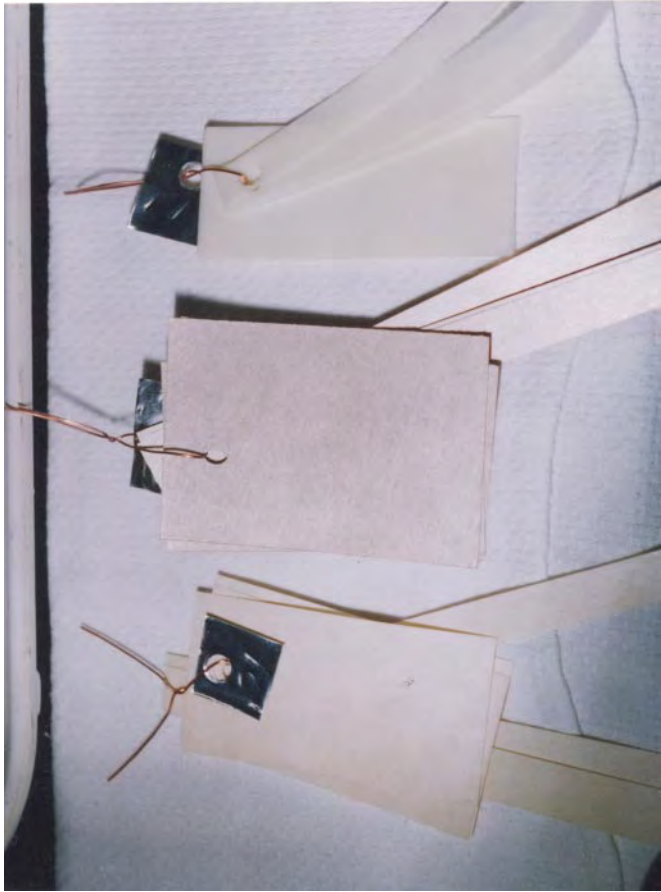
**Photograph #1(above)**  
**Photograph #2(below)**

<u>Photo #</u>	<u>Description</u>
1	Sheet Insulation(top to bottom)Melinex, Nomex-Mica, Nomex, after 500 hour exposure to refrigerant/lubricant
2	Tie cords after 500 hour exposure to refrigerant/lubricant
3	Sleeving(top to bottom) Nomex/Mylar, Mylar and Nomex after 500 hour exposure to refrigerant/lubricant.
4	Tapes(top to bottom) Glass, Polyester and Permacel after 500 hour exposure to refrigerant/lubricant.
5	Sheet Insulation(top to bottom) Mylar, Dacron/Mylar/Dacron, Nomex/Mylar/Nomex after 500 hour exposure to refrigerant lubricant
6	Lead wire after 500 hour exposure to refrigerant/lubricant.
7	Varnish Disks(top to bottom) Iso-800, 923, Y-833, after 500 hour exposure to refrigerant/lubricant.
8	Varnish Disks(top to bottom) ER-610, Y-390, U-475, after 500 hour exposure to refrigerant/lubricant.
9	Varnish Disks(top to bottom) Iso-800, 923, Y-833, after 500 hour exposure to refrigerant/lubricant plus the 24 hour air bake.

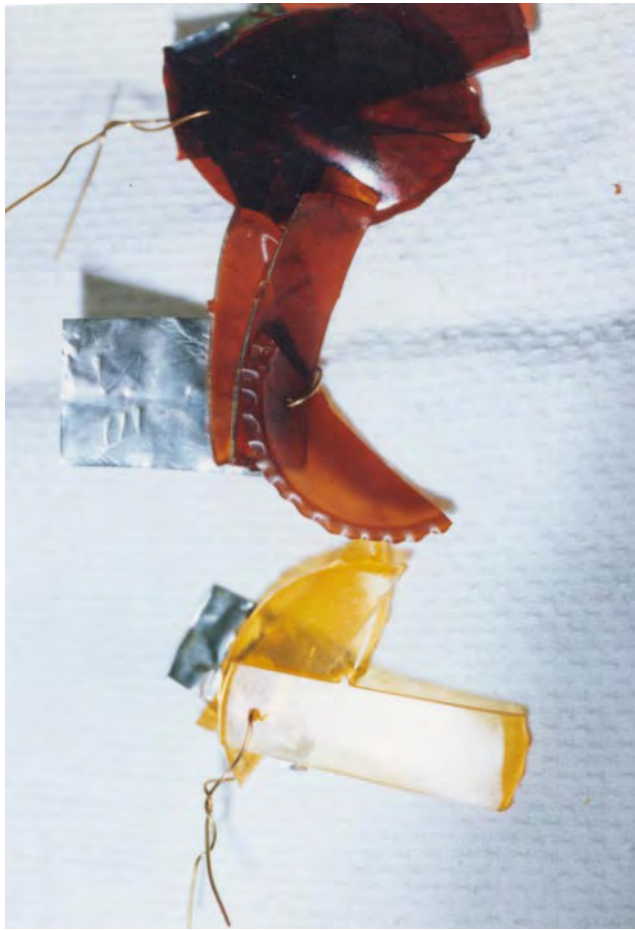
**Photograph #9(above)**  
**Photograph #10(below)**

10	Varnish Disks(top to bottom) ER-610, Y-390, U-475, after 500 hour exposure to refrigerant/lubricant plus the 24 hour air bake.
11	Tested Tie Cords after 500 hour exposure to refrigerant lubricant plus the 24 hour air bake.
12	Sleeving(top to bottom) Nomex/Mylar, Mylar and Nomex after 500 hour exposure to refrigerant-lubricant plus the 24 hour air bake.
13	Tapes(top to bottom) Glass, Polyester and Permacel after 500 hour exposure to refrigerant-lubricant plus the 24 hour air bake.
14	Lead Wires after 500 hour exposure to refrigerant-lubricant plus the 24 hour air bake.
15	Sheet Insulation(top to bottom)Melinex, Nomex-Mica, Nomex, after 500 hour exposure to refrigerant/lubricant plus a 24 hour air bake.
16	Sheet Insulation(top to bottom) Mylar, Dacron/Mylar/Dacron, Nomex/Mylar/Nomex after 500 hour exposure to refrigerant lubricant plus a 24 hour air bake.

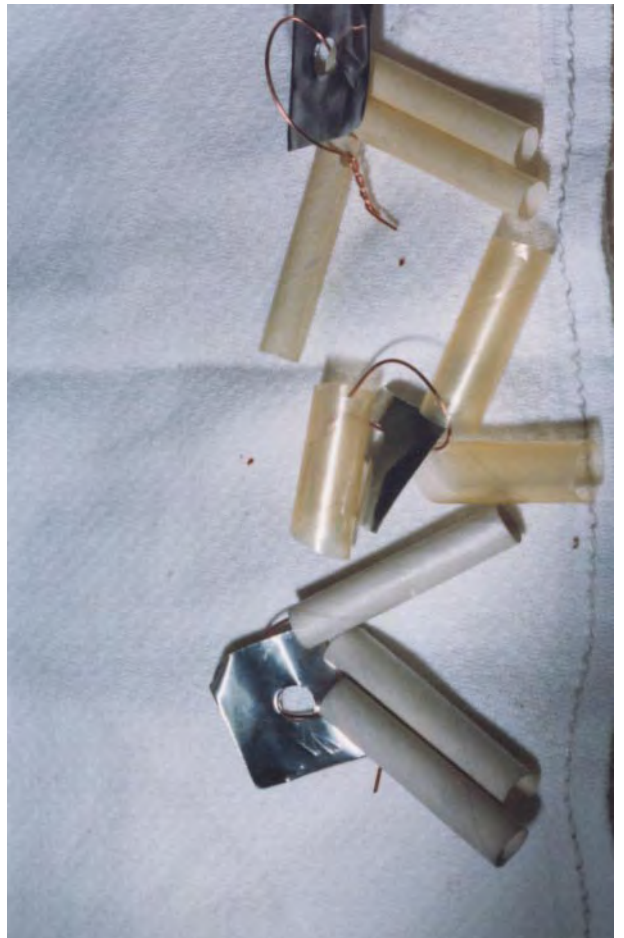
**Photograph #1(above)**  
**Photograph #2(below)**

<b><u>Photo #</u></b>	<b><u>Description</u></b>
1	Sheet Insulation(top to bottom)Melinex, Nomex-Mica, Nomex, after 500 hour exposure to refrigerant/lubricant
2	Tie cords after 500 hour exposure to refrigerant/lubricant
3	Sleeving(top to bottom) Nomex/Mylar, Mylar and Nomex after 500 hour exposure to refrigerant/lubricant.
4	Tapes(top to bottom) Glass, Polyester and Permacel after 500 hour exposure to refrigerant/lubricant.
5	Sheet Insulation(top to bottom) Mylar, Dacron/Mylar/Dacron, Nomex/Mylar/Nomex after 500 hour exposure to refrigerant lubricant
6	Lead wire after 500 hour exposure to refrigerant/lubricant.
7	Varnish Disks(top to bottom) Iso-800, 923, Y-833, after 500 hour exposure to refrigerant/lubricant.
8	Varnish Disks(top to bottom) ER-610, Y-390, U-475, after 500 hour exposure to refrigerant/lubricant.
9	Varnish Disks(top to bottom) Iso-800, 923, Y-833, after 500 hour exposure to refrigerant/lubricant plus the 24 hour air bake.
