**COMPATIBILITY OF REFRIGERANTS AND LUBRICANTS WITH  
MOTOR MATERIALS**

Photographs of Motor Materials after Exposure to Refrigerants  
and Refrigerant-Lubricants  
Volume IV

Robert Doerr and Stephen Kujak

Prepared for  
The Air-Conditioning and Refrigeration Technology Institute  
Under  
ARTI MCLR Project Number 650-50400

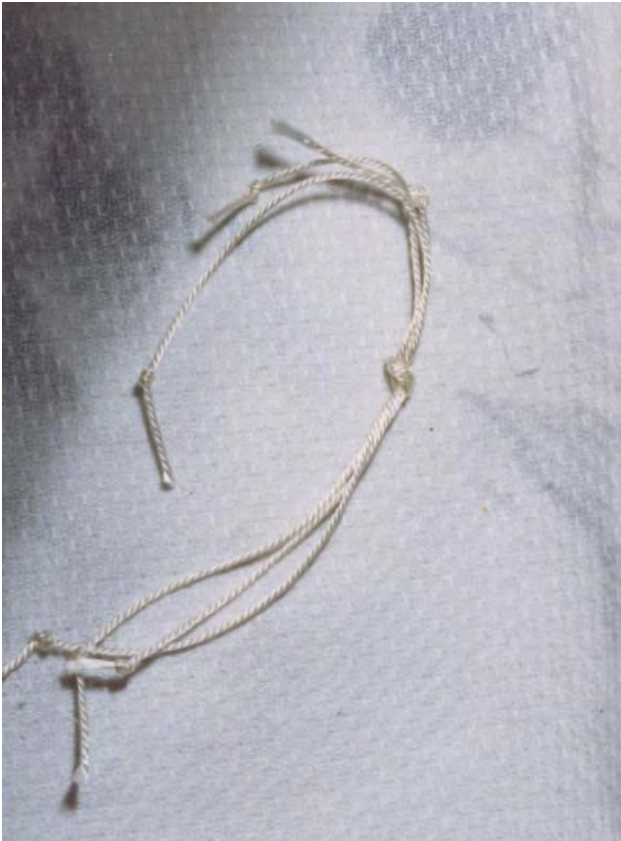
**Photograph #3(above)**  
**Photograph #4(below)**

<b><u>Photo #</u></b>	<b><u>Description</u></b>
1	Sheet Insulation(top to bottom)Melinex, Nomex-Mica, Nomex, after 500 hour exposure to refrigerant/lubricant
2	Tie cords after 500 hour exposure to refrigerant/lubricant
3	Sleeving(top to bottom) Nomex/Mylar, Mylar and Nomex after 500 hour exposure to refrigerant/lubricant.
4	Tapes(top to bottom) Glass, Polyester and Permacel after 500 hour exposure to refrigerant/lubricant.
5	Sheet Insulation(top to bottom) Mylar, Dacron/Mylar/Dacron, Nomex/Mylar/Nomex after 500 hour exposure to refrigerant lubricant
6	Lead wire after 500 hour exposure to refrigerant/lubricant.
7	Varnish Disks(top to bottom) Iso-800, 923, Y-833, after 500 hour exposure to refrigerant/lubricant.
8	Varnish Disks(top to bottom) ER-610, Y-390, U-475, after 500 hour exposure to refrigerant/lubricant.
9	Varnish Disks(top to bottom) Iso-800, 923, Y-833, after 500 hour exposure to refrigerant/lubricant plus the 24 hour air bake.

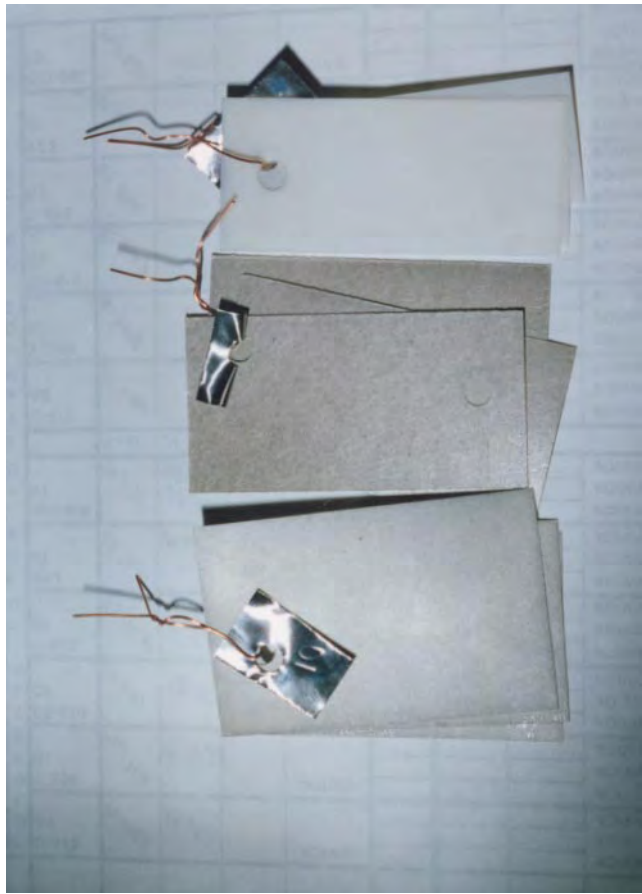
**Photograph #1(above)**  
**Photograph #2(below)**

<b><u>Photo #</u></b>	<b><u>Description</u></b>
1	Sheet Insulation(top to bottom)Melinex, Nomex-Mica, Nomex, after 500 hour exposure to refrigerant/lubricant
2	Tie cords after 500 hour exposure to refrigerant/lubricant
3	Sleeving(top to bottom) Nomex/Mylar, Mylar and Nomex after 500 hour exposure to refrigerant/lubricant.
4	Tapes(top to bottom) Glass, Polyester and Permacel after 500 hour exposure to refrigerant/lubricant.
5	Sheet Insulation(top to bottom) Mylar, Dacron/Mylar/Dacron, Nomex/Mylar/Nomex after 500 hour exposure to refrigerant lubricant
6	Lead wire after 500 hour exposure to refrigerant/lubricant.
7	Varnish Disks(top to bottom) Iso-800, 923, Y-833, after 500 hour exposure to refrigerant/lubricant.
8	Varnish Disks(top to bottom) ER-610, Y-390, U-475, after 500 hour exposure to refrigerant/lubricant.
9	Varnish Disks(top to bottom) Iso-800, 923, Y-833, after 500 hour exposure to refrigerant/lubricant plus the 24 hour air bake.

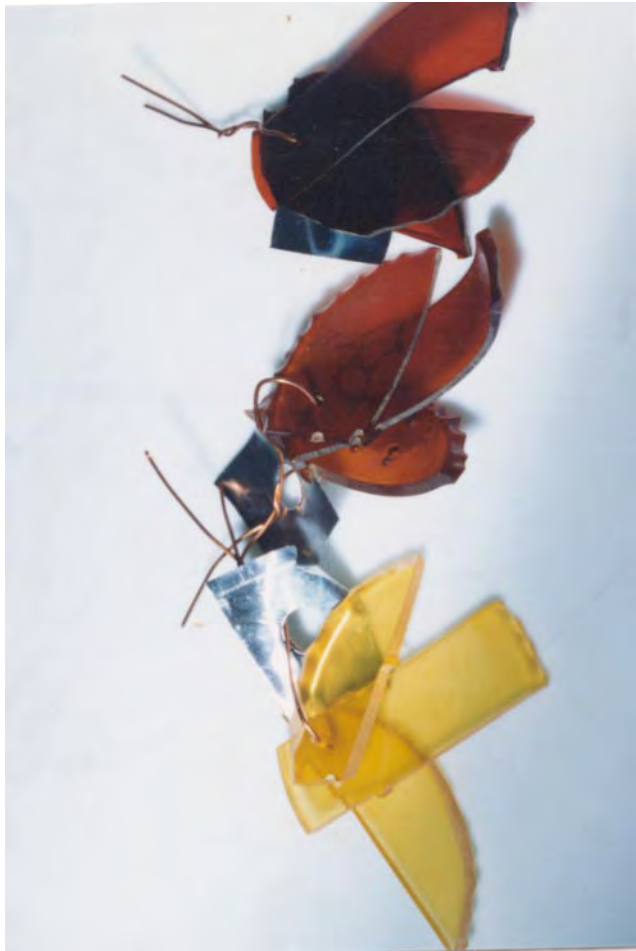
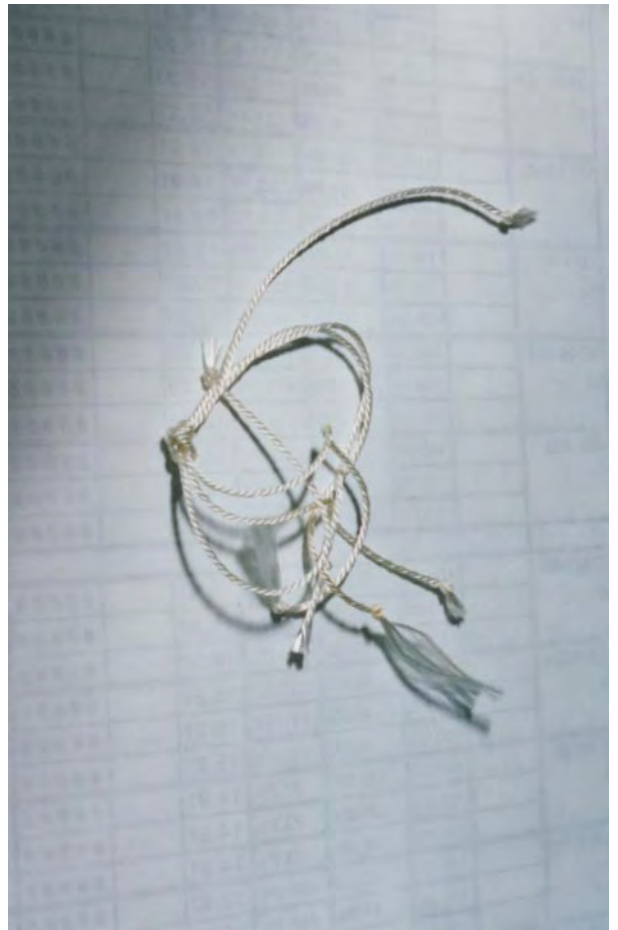
**Photograph #9(above)**  
**Photograph #10(below)**

<b><u>Photo #</u></b>	<b><u>Description</u></b>
1	Sheet Insulation(top to bottom)Melinex, Nomex-Mica, Nomex, after 500 hour exposure to refrigerant/lubricant
2	Tie cords after 500 hour exposure to refrigerant/lubricant
3	Sleeving(top to bottom). Nomex/Mylar, Mylar and Nomex after 500 hour exposure to refrigerant/lubricant.
4	Tapes(top to bottom) Glass, Polyester and Permacel after 500 hour exposure to refrigerant/lubricant.
5	Sheet Insulation(top to bottom) Mylar, Dacron/Mylar/Dacron, Nomex/Mylar/Nomex after 500 hour exposure to refrigerant lubricant
6	Lead wire after 500 hour exposure to refrigerant/lubricant.
7	Varnish Disks(top to bottom) Iso-800, 923, Y-833, after 500 hour exposure to refrigerant/lubricant.
8	Varnish Disks(top to bottom) ER-610, Y-390, U-475, after 500 hour exposure to refrigerant/lubricant.
9	Varnish Disks(top to bottom) Iso-800, 923, Y-833, after 500 hour exposure to refrigerant/lubricant plus the 24 hour air bake.

10	Varnish Disks(top to bottom) ER-610, Y-390, U-475, after 500 hour exposure to refrigerant/lubricant plus the 24 hour air bake.
11	Tested Tie Cords after 500 hour exposure to refrigerant lubricant plus the 24 hour air bake.
12	Sleeving(top to bottom) Nomex/Mylar, Mylar and Nomex after 500 hour exposure to refrigerant-lubricant plus the 24 hour air bake.
13	Tapes(top to bottom) Glass, Polyester and Permacel after 500 hour exposure to refrigerant-lubricant plus the 24 hour air bake.
14	Lead Wires after 500 hour exposure to refrigerant-lubricant plus the 24 hour air bake.
15	Sheet Insulation(top to bottom)Melinex, Nomex-Mica, Nomex, after 500 hour exposure to refrigerant/lubricant plus a 24 hour air bake.
16	Sheet Insulation(top to bottom) Mylar, Dacron/Mylar/Dacron, Nomex/Mylar/Nomex after 500 hour exposure to refrigerant lubricant plus a 24 hour air bake.

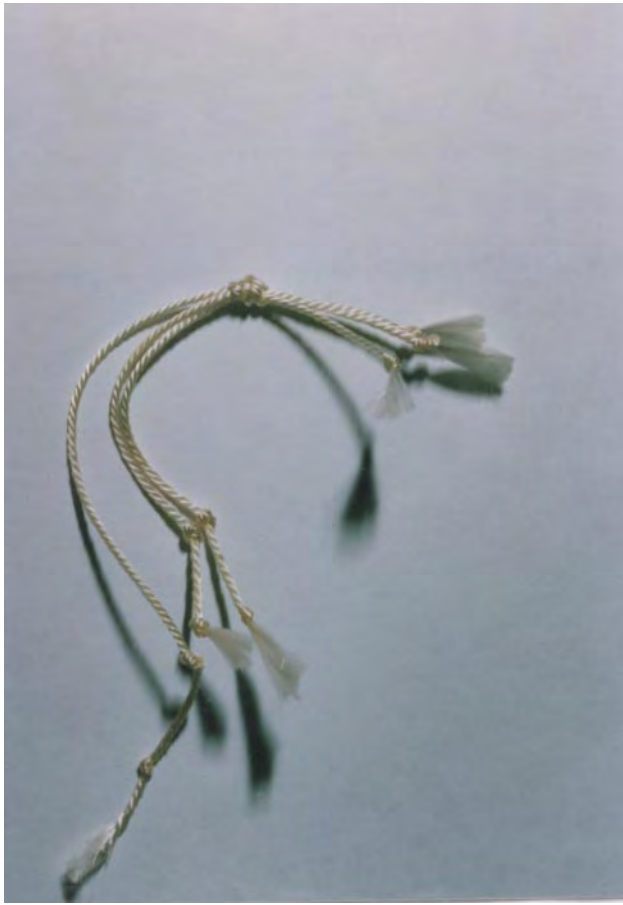
**Photograph #9(above)**  
**Photograph #10(below)**

<b><u>Photo #</u></b>	<b><u>Description</u></b>
1	Sheet Insulation(top to bottom)Melinex, Nomex-Mica, Nomex, after 500 hour exposure to refrigerant/lubricant
2	Tie cords after 500 hour exposure to refrigerant/lubricant
3	Sleeving(top to bottom) Nomex/Mylar, Mylar and Nomex after 500 hour exposure to refrigerant/lubricant.
4	Tapes(top to bottom) Glass, Polyester and Permacel after 500 hour exposure to refrigerant/lubricant.
5	Sheet Insulation(top to bottom) Mylar, Dacron/Mylar/Dacron, Nomex/Mylar/Nomex after 500 hour exposure to refrigerant lubricant
6	Lead wire after 500 hour exposure to refrigerant/lubricant.
7	Varnish Disks(top to bottom) Iso-800, 923, Y-833, ER-610, Y-390, U-475, after 500 hour exposure to refrigerant/lubricant.
8	Varnish Disks(top to bottom) Iso-800, 923, Y-833, ER-610, Y-390, U-475, after 500 hour exposure to refrigerant/lubricant plus the 24 hour air bake.
9	Tested Tie Cords after 500 hour exposure to refrigerant lubricant plus the 24 hour air bake.

10	Sleeving(top to bottom) Nomex/Mylar, Mylar and Nomex after 500 hour exposure to refrigerant-lubricant plus the 24 hour air bake.
11	Tapes(top to bottom) Glass, Polyester and Permacel after 500 hour exposure to refrigerant-lubricant plus the 24 hour air bake.
12	Lead Wires after 500 hour exposure to refrigerant-lubricant plus the 24 hour air bake.
13	Sheet Insulation(top to bottom)Melinex, Nomex-Mica, Nomex, after 500 hour exposure Mylar, Dacron/Mylar/Dacron, Nomex/Mylar/Nomex after 500 hour exposure to refrigerant lubricant plus a 24 hour air bake.

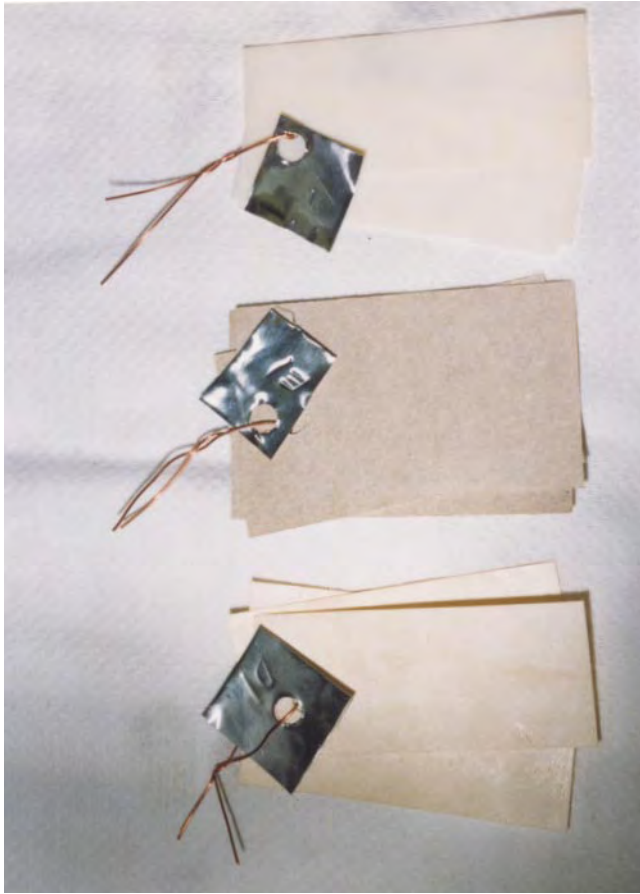
**Photograph #1(above)**  
**Photograph #2(below)**

<b><u>Photo #</u></b>	<b><u>Description</u></b>
1	Sheet Insulation(top to bottom)Melinex, Nomex-Mica, Nomex, after 500 hour exposure to refrigerant/lubricant
2	Tie cords after 500 hour exposure to refrigerant/lubricant
3	Sleeving(top to bottom) Nomex/Mylar, Mylar and Nomex after 500 hour exposure to refrigerant/lubricant.
4	Tapes(top to bottom) Glass, Polyester and Permacel after 500 hour exposure to refrigerant/lubricant.
5	Sheet Insulation(top to bottom) Mylar, Dacron/Mylar/Dacron, Nomex/Mylar/Nomex after 500 hour exposure to refrigerant lubricant
6	Lead wire after 500 hour exposure to refrigerant/lubricant.
7	Varnish Disks(top to bottom) Iso-800, 923, Y-833, after 500 hour exposure to refrigerant/lubricant.
8	Varnish Disks(top to bottom) ER-610, Y-390, U-475, after 500 hour exposure to refrigerant/lubricant.
9	Varnish Disks(top to bottom) Iso-800, 923, Y-833, after 500 hour exposure to refrigerant/lubricant plus the 24 hour air bake.

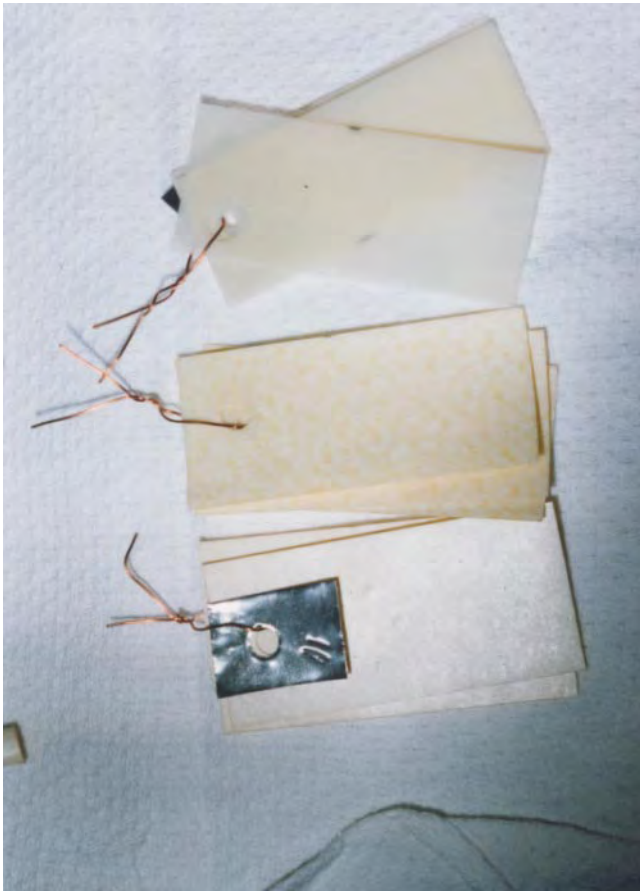
**Photograph #1(above)**  
**Photograph #2(below)**

<b><u>Photo #</u></b>	<b><u>Description</u></b>
1	Sheet Insulation(top to bottom) Mylar, Dacron/Mylar/Dacron, Nomex/Mylar/Nomex after 500 hour exposure to refrigerant lubricant
2	Sleeving(top to bottom) Nomex/Mylar, Mylar and Nomex after 500 hour exposure to refrigerant/lubricant.
3	Tapes(top to bottom) Glass, Polyester and Permacel after 500 hour exposure to refrigerant/lubricant.
4	Lead wire after 500 hour exposure to refrigerant/lubricant.
5	Varnish Disks(top to bottom) Iso-800, 923, Y-833, after 500 hour exposure to refrigerant/lubricant.
6	Varnish Disks(top to bottom) ER-610, Y-390, U-475, after 500 hour exposure to refrigerant/lubricant.
7	Varnish Disks(top to bottom) Iso-800, 923, Y-833, after 500 hour exposure to refrigerant/lubricant plus the 24 hour air bake.
8	Varnish Disks(top to bottom) ER-610, Y-390, U-475, after 500 hour exposure to refrigerant/lubricant plus the 24 hour air bake.
9	Sleeving(top to bottom) Nomex/Mylar, Mylar and Nomex after 500 hour exposure to refrigerant-lubricant plus the 24 hour air bake.

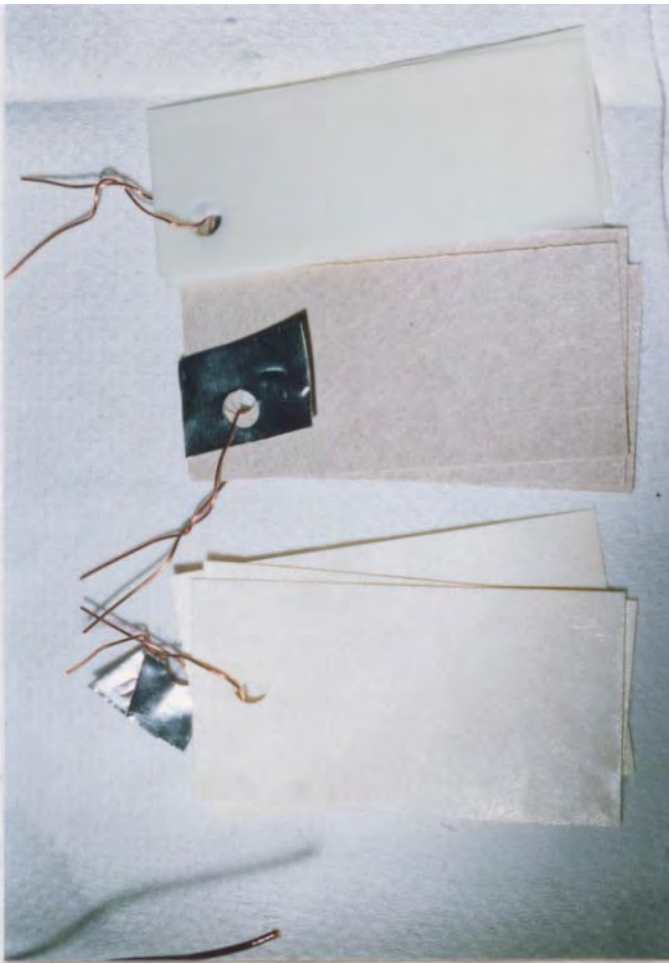
**Photograph #1(above)**  
**Photograph #2(below)**

<b><u>Photo #</u></b>	<b><u>Description</u></b>
1	Sheet Insulation(top to bottom)Melinex, Nomex-Mica, Nomex, after 500 hour exposure to refrigerant/lubricant
2	Tie cords after 500 hour exposure to refrigerant/lubricant
3	Sleeving(top to bottom) Nomex/Mylar, Mylar and Nomex after 500 hour exposure to refrigerant/lubricant.
4	Tapes(top to bottom) Glass, Polyester and Permacel after 500 hour exposure to refrigerant/lubricant.
5	Sheet Insulation(top to bottom) Mylar, Dacron/Mylar/Dacron, Nomex/Mylar/Nomex after 500 hour exposure to refrigerant lubricant
6	Lead wire after 500 hour exposure to refrigerant/lubricant.
7	Varnish Disks(top to bottom) Iso-800, 923, Y-833, after 500 hour exposure to refrigerant/lubricant.
8	Varnish Disks(top to bottom) ER-610, Y-390, U-475, after 500 hour exposure to refrigerant/ lubricant.
9	Varnish Disks(top to bottom) Iso-800, 923, Y-833, after 500 hour exposure to refrigerant/lubricant plus the 24 hour air bake.

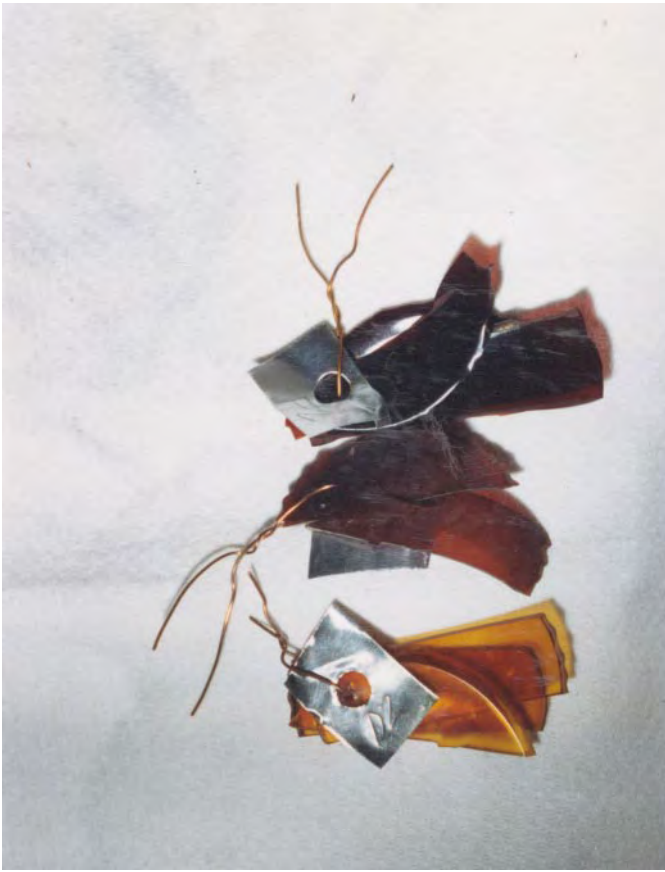
**Photograph #9(above)**  
**Photograph #10(below)**

10	Varnish Disks(top to bottom) ER-610, Y-390, U-475, after 500 hour exposure to refrigerant/lubricant plus the 24 hour air bake.
11	Tested Tie Cords after 500 hour exposure to refrigerant lubricant plus the 24 hour air bake.
12	Sleeving(top to bottom) Nomex/Mylar, Mylar and Nomex after 500 hour exposure to refrigerant-lubricant plus the 24 hour air bake.
13	Tapes(top to bottom) Glass, Polyester and Permacel after 500 hour exposure to refrigerant-lubricant plus the 24 hour air bake.
14	Lead Wires after 500 hour exposure to refrigerant-lubricant plus the 24 hour air bake.
15	Sheet Insulation(top to bottom)Melinex, Nomex-Mica, Nomex, after 500 hour exposure to refrigerant/lubricant plus a 24 hour air bake.
16	Sheet Insulation(top to bottom) Mylar, Dacron/Mylar/Dacron, Nomex/Mylar/Nomex after 500 hour exposure to refrigerant lubricant plus a 24 hour air bake.
