AHRI Report No. 8014

EFFECTS OF LOW RETURN AIR TEMPERATURE ON GAS FIRED FORCED AIR FURNACES

April 2017

GAS CONSULTANTS, INC.
Walton Hills, Ohio

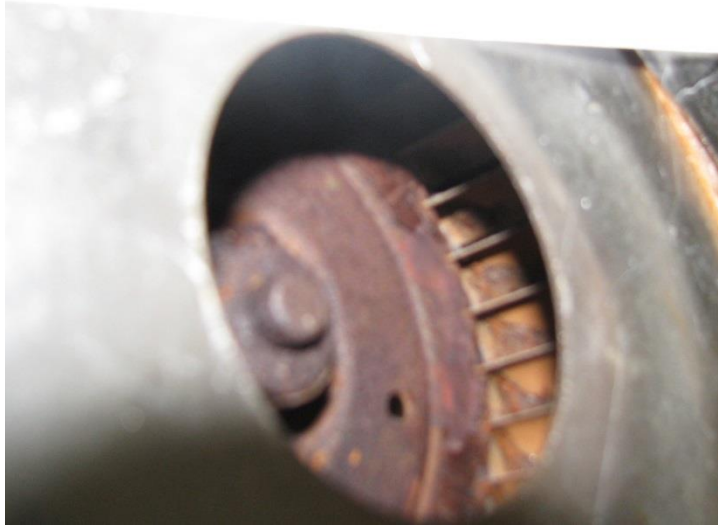
Photo A32

**Inlet to Combustion
Bower Assembly**

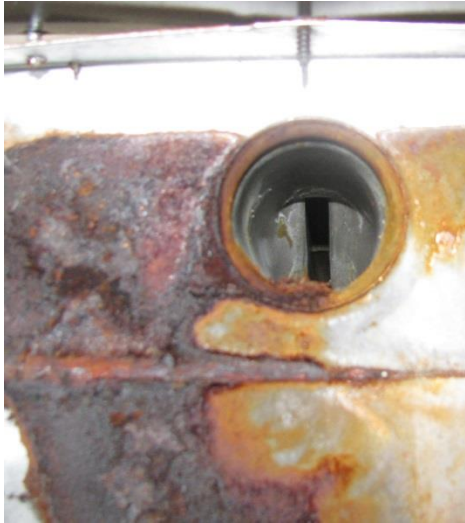
Photo A40

- The point where the heat exchanger tubes are swaged onto the header plate showed extensive rust on the flue gas side but none was found on the circulating air side. It is expected that if the system sat for 12 months in this condition and was not used, the rust condition would eventually penetrate at the swage point.

Extensive Corrosion Around Where Heat Exchanger Swaged to Header / Vestibule Plate, but No Loss of Integrity of Connection/Seal

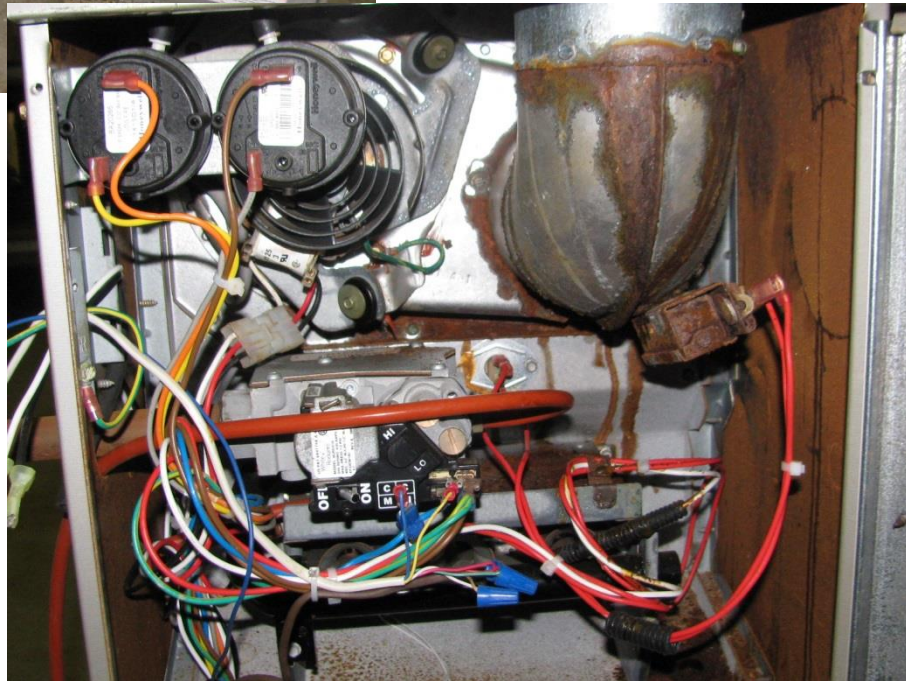
Photo A44

**Rust Found on Right, Inside
of Body Panel Caused by
Dripping Vent Pipe**

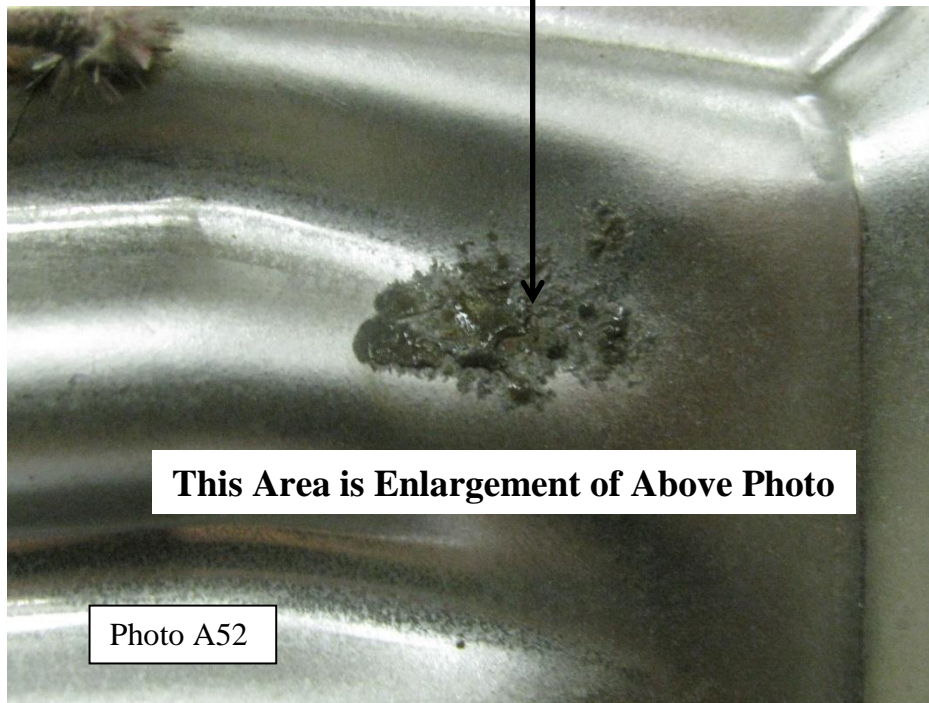
Photo A52

When Furnace 4 was further examined approximately 60 days after the corrosion cycling was finished, it was found that what appeared to be a slight spot of corrosion (metallic colored) with two pin holes (less than 1/8” each in diameter) had grown to a substantial spot of red/orange colored corrosion. When touched with a slight pressure, the “rust” spot the metal gave way and left a hole in the heat exchanger about a 1/2” in diameter. See Appendix Photos A52 and A53.

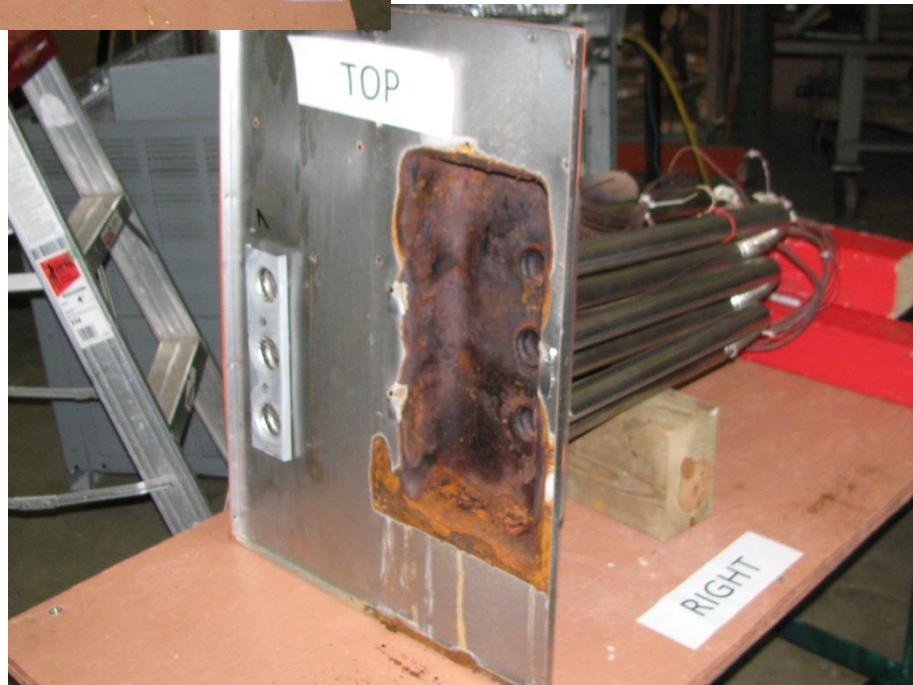
Photo A62

**Actual Heat Exchanger Tubes
Show No Signs Of
Perforations**
